DTC	B1278	COMBINATION SWITCH ECU COMMUNICATION STOP
------------	--------------	--

CIRCUIT DESCRIPTION

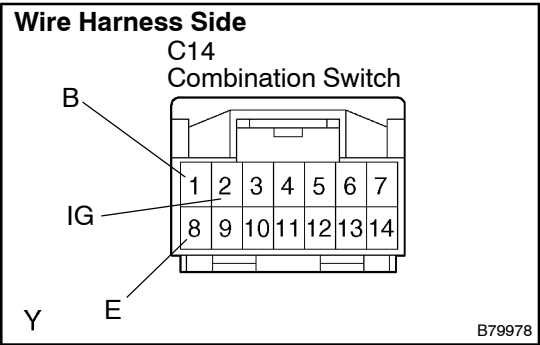
2 CHECK WIRE HARNESS (COMBINATION SWITCH ASSY - BODY GROUND)

- (a) Disconnect the C14 combination switch connector.
(b) Measure the resistance and voltage of the wire harness side connector.

Tester Connection	Condition	Specified Condition
C14-1 (B) - Body ground	Constant	10 to 14 V
C14-8 (E) - Body ground	Constant	Below 1 Ω
C14-2 (IG) - Bodyground	Ignition switch from OFF to ON	0V → 10 to 14 V
