No.	Work Procedure/ Illustration	Records/Remarks/ Quality Pointers																		
	<p>Checkpoints :</p> <p>Length of protruded core wire must be 0.5~1.0mm.</p>

NBC (Philippines)  
MASTER COPY

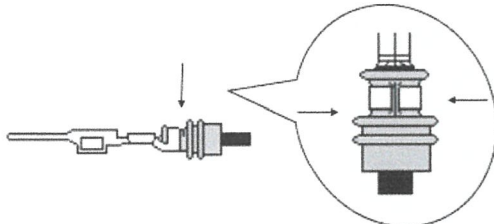
<p>3. Crack on Waterproof seal</p>

<p>* Need to check the crack by pulling the seal.</p>

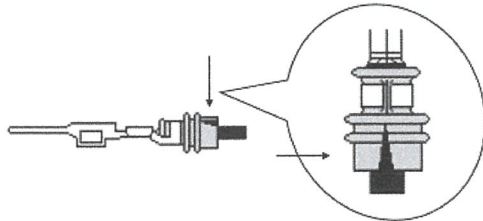
<p>* Crack may be found from different angles. Rotate the seal properly to check.</p> <p>4. Reverse Waterproof seal</p>
