## MPZA ('96 Honda Accord V-6 2.7L 103,000 miles)

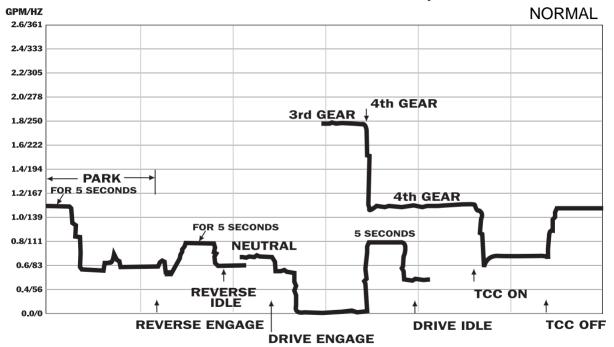
Notes: Park cooler flow was stable for 5 seconds at .8, then goes up for 5 seconds at 1.1, then down to .6. Reverse and neutral also go up for 5 seconds and then settle down.
