## Dynamic fracture of Ti-6Al-4V alloy in Taylor impact test

**Abstract:** The dynamic fracture behaviors of Ti-6Al-4V alloy at high strain rate loading were investigated systemically through Taylor impact test, over the range of impact velocities from 145 m/s to 306 m/s. The critical impact velocity of fracture ranges from 217 m/s to 236 m/s. Smooth surfaces and ductile dimple areas were observed on the fracture surfaces. As the impact velocity reached 260 m/s, the serious melting regions were also observed on the fracture surfaces. Self-organization of cracks emerges when the impact velocity reaches 260 m/s, while some special cracks whose “tips” are not sharp but arc and smooth, and without any evidence of deformation or adiabatic shear band were also observed on the impact end surfaces. Examination of the sections of these special cracks reveals that the cracks expand along the two maximum shear stress directions respectively, and finally intersect as a tridimensional “stagger ridge” structure.

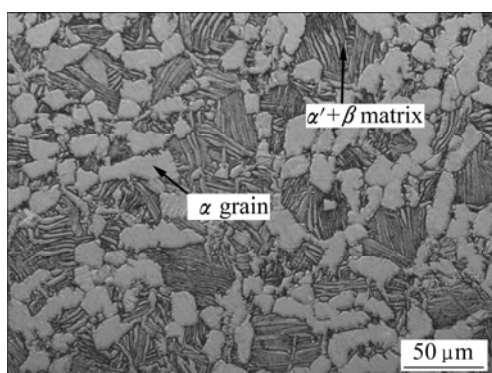
**Fig.1** Optical microstructure of Ti-6Al-4V alloy before test

In the current study, all specimens were made of the conventional commercial Ti-6Al-4V alloy, whose chemical compositions are listed in Table 1. Before being tested, the alloys are in the bimodal ( $\alpha+\beta$ ) state at room temperature after the following heat treatment process: annealed at 950 °C for 1 h in the  $\alpha+\beta$  region, and cooled down in the air to room temperature. Fig.1 shows the typical metallography of the bimodal microstructure of the alloy, consisting of the predominant equiaxed  $\alpha$ , whose grain size is between 20 and 50  $\mu\text{m}$ , and acicular  $\alpha'$  and transformed  $\beta$  matrix, whose length is between 30 and 40  $\mu\text{m}$ .

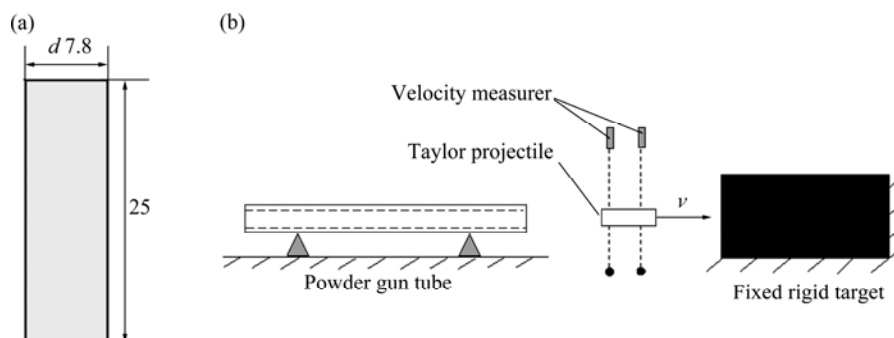
**Fig.2** Shape and dimensions of cylinder specimen used for Taylor impact test (unit: mm) (a) and schematic diagram of Taylor impact test device (b)

The cylindrical specimens (see Fig.2(a)) are 7.8 mm in diameter and 25 mm in length, and the ratio of length to diameter is approximate 3.2. A lathe was employed to

A traditional Taylor impact test device was used, as shown in Fig.2(b). The cylinder was fired with a powder gun against a rigid 603 Armored Steel target and a counter was employed to get the velocity of the specimen before impacting on the rigid target. The tests were performed over a broad range of impact velocities, from 145 m/s to 306 m/s. After being impacted, the deformed projectiles were all recovered; and if the specimen fractured, the fragments split away from the cylinder would be also recovered as more as possible.

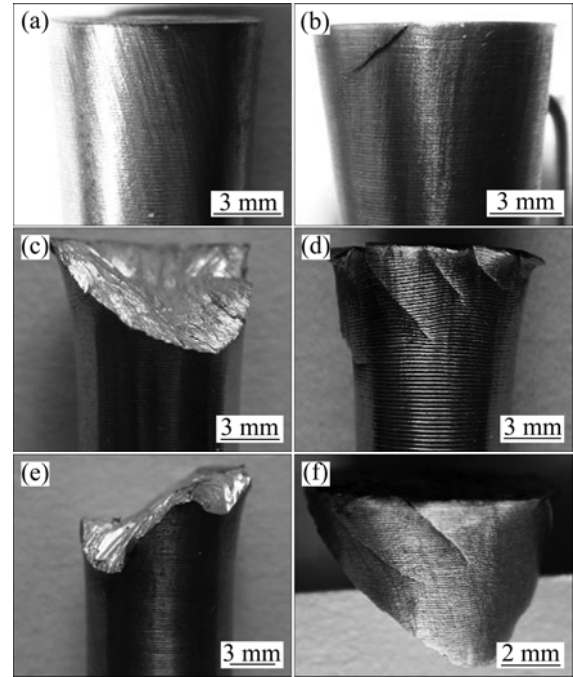
**Fig.3** Morphologies of plastic deformed and fractured projectiles with increase of impact velocity: (a)  $v=198$  m/s; (b)  $v=224$  m/s; (c) and (d)  $v=260$  m/s; (e)  $v=282$  m/s; (f) Fragment splitting away from cylinder,  $v=282$  m/s

According to the plastic deformation and fracture characteristics, which are also listed in Table 2, the projectiles with the increase of impact velocity can be classified into three main stages, as shown in Fig.3. When the impact velocity is low, ranging from 145 m/s to 214 m/s, only plastic deformation is observed on the head of the projectiles, which is called “only plastic deformed stage”. As shown in Fig.3(a), in this stage, there are several clusters of plastic flow lines observed on the lateral surface of the projectile along the direction of compression. Fig.4 presents the relationship between the impact velocity ( $v$ ) and the total plastic strain of the yielded portion ( $\varepsilon_p$ ) which is calculated by Eq.(1). It can be seen from Fig.4 that the extent of plastic deformation

ranges from 217 m/s to 236 m/s. Fig.3(b) presents the typical specimen in this stage: only one or two cracks can be examined on the head lateral surface of the projectile with an angle of about  $45^\circ$  with the impact end surface, which is the evident characteristic of specimens in critical fractured stage. When the impact velocity exceeds 236 m/s, specimens fracture seriously, and the head of all projectiles splits off. Fig.3(c) shows the specimen loaded with the velocity in “complete fractured stage”. The specimen presents a typical sheared fracture surface and Fig.3(d) reveals that more than one parallel cracks can be observed on the head lateral surface of the projectile in this stage. As we further increase the impact

velocity to larger than 260 m/s, the fracture surface of projectiles is rugged, and cracks also appear on the lateral surface of the fragment splitting away from the cylinder, as shown in Figs.3(e) and (f).

In addition, it is recognized that the shear stress field in the specimen during the loading process is so complicated that there maybe exist many shear planes on the different shear directions[14]. These shear planes intersect each other and the cracks expand through the specimen along these shear planes, resulting in more than one fragments splitting away from the specimen, and finally forming a rugged fracture surface, as shown in Fig.3(e).

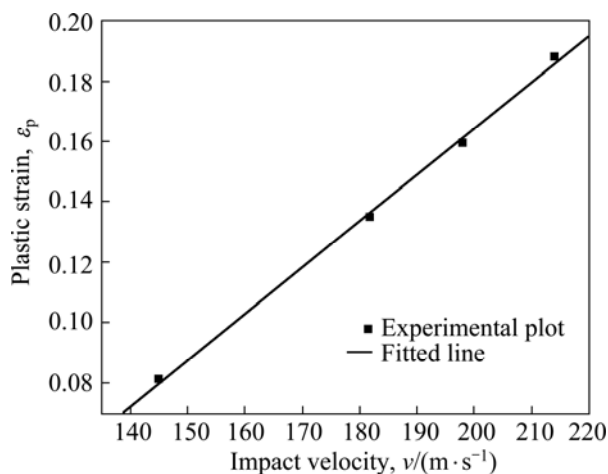
**Fig.4** Approximate linear dependence between the impact velocity ( $v$ ) and the plastic strain of the specimen ( $\epsilon_p$ ) when impact velocity being low

of the head of specimen is approximate linear dependence on the increase of the impact velocity in only plastic deformed stage. As the impact velocity increases, the alloy begins to fracture and turns into the “critical fractured stage”. The critical impact velocity of fracture

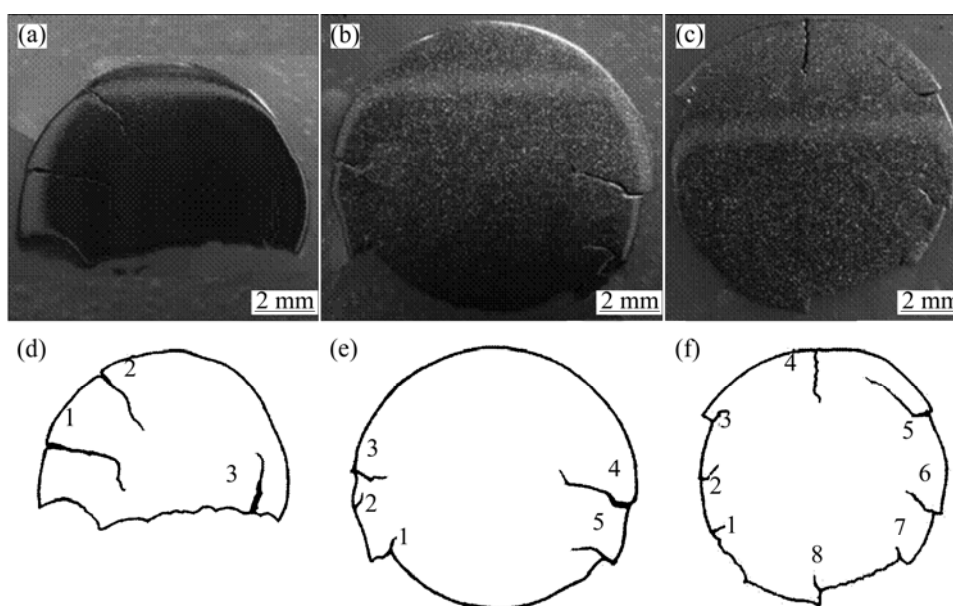
**Fig.5** Distribution of cracks on impact end surface with different impact velocities: (a)  $v=261$  m/s; (b)  $v=267$  m/s; (c)  $v=282$  m/s; (d), (e), (f) Schematic diagrams of (a), (b) and (c), respectively

Some researchers[15–19] have noticed that, on certain loading conditions, such as the radial collapse of a thick-walled cylinder, the shear bands do not expand randomly, but with a well established and characteristic pattern, which is called “self-organization”. In the current test, we also observed a similar phenomenon. Fig.3(d) shows some regularly distributed cracks emerging on the lateral surface of the projectile when the impact velocity exceeds 236 m/s. As we further increase the impact velocity, the distribution of cracks around the edge of the impact end surface is also not random, but symmetrical. Fig.5 presents the main cracks almost expanding towards the centre of the specimens on the impact end surface as a “self-organization” pattern. At the same time, the higher the impact velocity achieves, the more symmetrical the cracks distribute. The cracks expand along the shear bands, so the regularly spaced adiabatic shear bands result in these self-organized cracks.

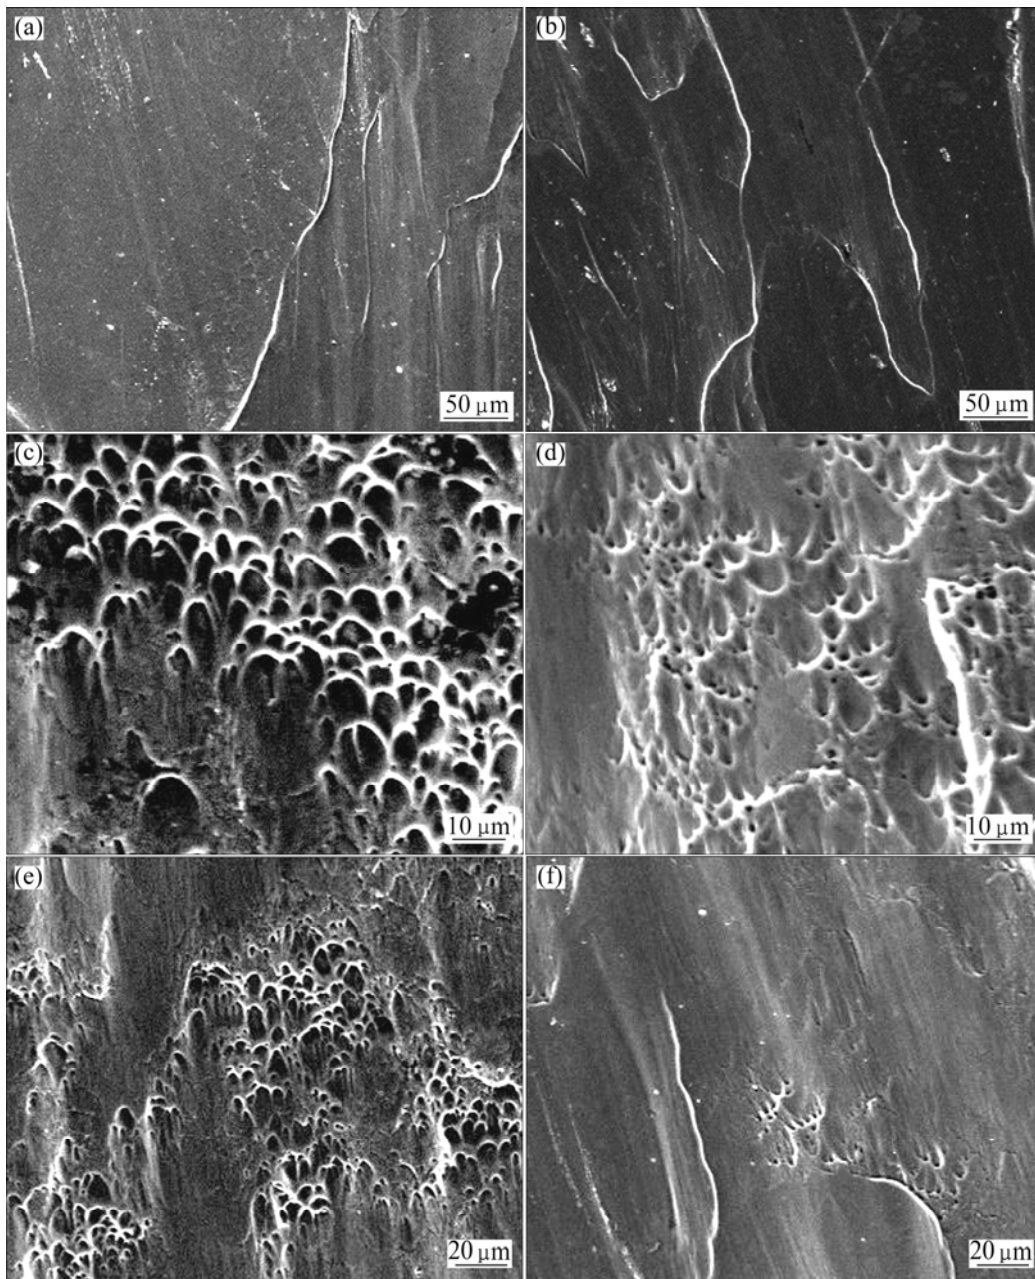
**Fig.6** SEM fractographs of fracture surface with relatively low impact velocities: (a) Smooth smeared surface,  $v=244$  m/s; (b) Smooth smeared surface,  $v=253$  m/s; (c) Ductile dimple area,  $v=244$  m/s; (d) Ductile dimple area,  $v=253$  m/s; (e) Boundary between these two areas,  $v=244$  m/s; (f) Boundary between these two areas,  $v=253$  m/s

Microscopic analyses of fracture surface of the recovered cylinders in the complete fractured stage were carried out by SEM, as shown in Fig.6. In a relatively low impact velocity range, the fracture surface can be classified into two main areas, namely the “smooth and smeared surface” and the “ductile dimple area”, which

have been reported by other investigators[2, 13] (see Figs.6(a)–(d)). The smooth and smeared surface corresponds to the upper and center location of the fracture surface. Meanwhile, the ductile dimple area is on the side and nether fringe of the fracture surface and around the smooth and smeared area. On the whole fracture surface, the area of smooth and smeared surface is larger than ductile dimple area, and the boundary between these two areas is dim. In addition, as shown in Figs.6(e) and (f), several clusters of dimples distributing along the edges of the smooth surfaces were observed, and in certain areas, some elongated dimples were also

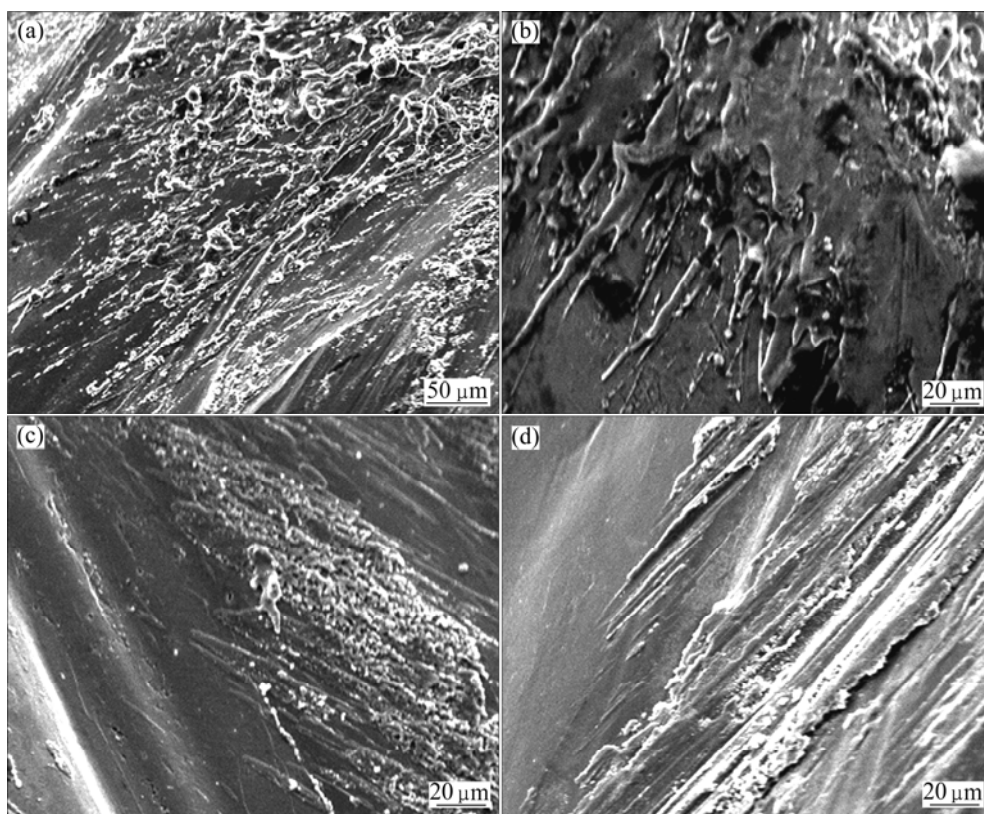
**Fig.7** SEM micrographs of serious melting regions on fracture surface with high impact velocities: (a)  $v=260$  m/s; (b) Amplificatory micrograph of (a); (c)  $v=282$  m/s; (d)  $v=306$  m/s

Fig.7 and Fig.8 present fracture surfaces of projectile loaded with higher impact velocities. As shown in Fig.7, when the impact velocity exceeds 260 m/s, there appears a new area, namely the “serious melting region”, besides the “smooth and smeared surface” and the “ductile dimple area”. These serious melting regions were always observed on the upper side of the smooth and smeared surface, which indicates that a significant melting of the original shear area material takes place prior to shear fracture of the specimen. In addition, in Figs.7(b) and (c), a large number of

“splat-like and knobbly” deposits and “splash” structures were observed, implying pressing and rubbing caused by mating displacement between the fragment and the fracture surface of the specimen in the shear fracture process, which maybe results in splashing of the melting alloy drops along the shear fracture direction, and Fig.7(d) reveals the trace of rubbing evidently.

deformation takes place, the temperature rises more sharply. In the present test, the sudden temperature rise within the ASB even exceeds over the melting point of the Ti-6Al-4V alloy, and makes for the absolute melting of the alloy in the main shear plane, as shown in Fig.7. The melted alloy liquid is propelled by the shear stress and flows on the shear plane along the direction of maximal shear stress, ultimately forms the main smooth and smeared surface on the center of the fracture surface (see Figs.6(a), 6(b), 8(a) and 8(b)). Meanwhile, on account of the tensile stresses in the tension zone surrounding the shear zone[4, 20], the ductile dimple areas form and distribute around the smooth and smeared surface. When the impact velocity reaches a relatively high speed, some small smooth planes appear in the ductile dimple area at the boundaries between the smooth surface and the dimple areas, as shown in Fig.8(e). Those small smooth surfaces may be caused by rubbing between the fragment and the fracture surface while the fracture surfaces are still soft due to the high temperature in the shear region[13]. On the other hand, the augment of the tensile stress, as a result of the increase of the impact velocity, accounts for the more elongation of the ductile dimples and then results in the alternate emergence of the smooth areas and the ductile dimple areas (Fig.8(f)). In addition, as shown in Fig.9, the

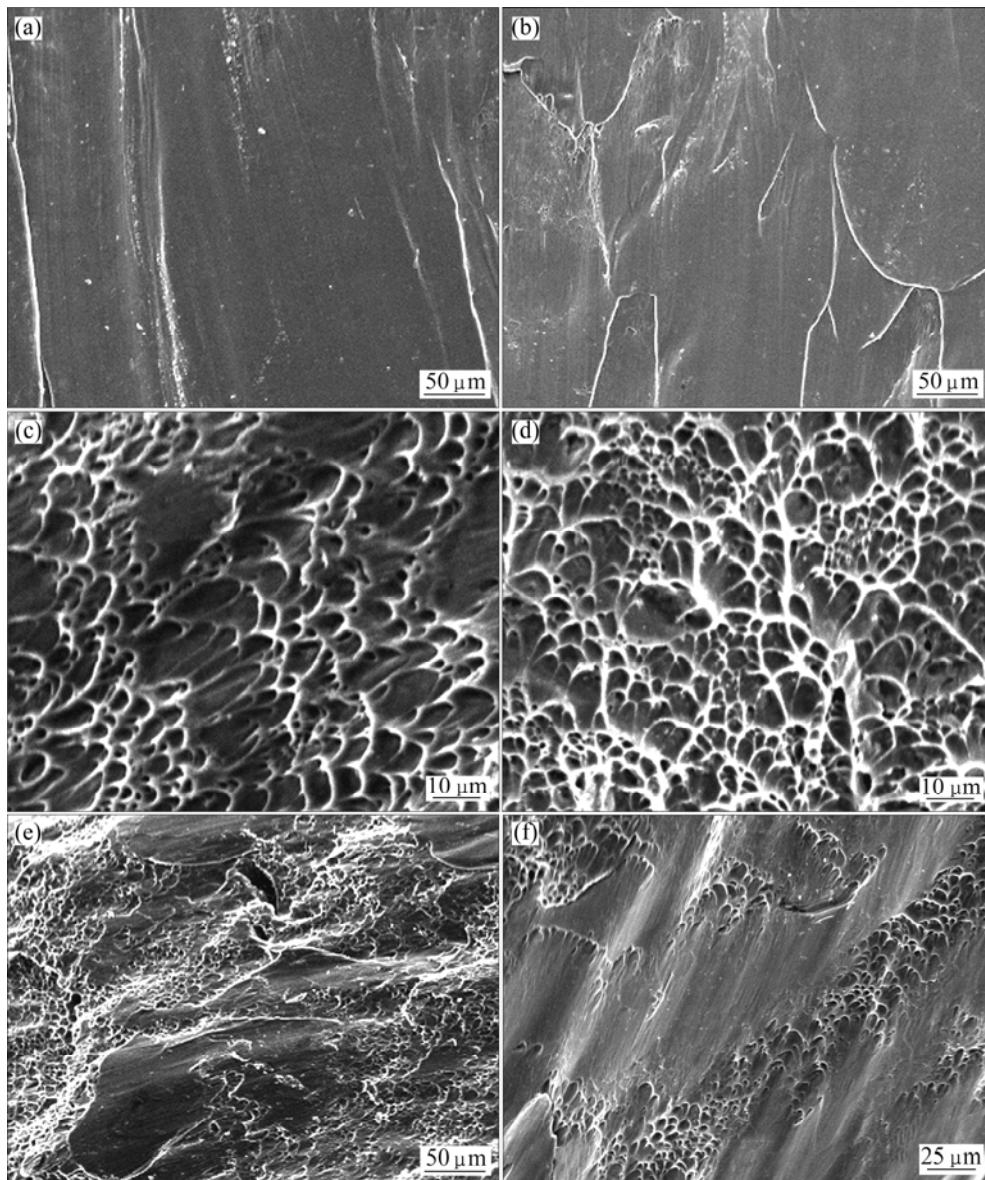
**Fig.8** SEM fractographs of fracture surface with high impact velocities: (a) Smooth and smeared surface,  $v=282$  m/s; (b) Smooth and smeared surface,  $v=306$  m/s; (c) Ductile dimple area,  $v=282$  m/s; (d) Ductile dimple area,  $v=306$  m/s; (e) Small smooth planes in ductile dimple area,  $v=282$  m/s; (f) Alternate smooth areas and ductile dimple areas,  $v=306$  m/s

Figs.8 (a) and (b) show the smooth and smeared surfaces under a high speed impact condition. By comparing with the instance at a relative low impact velocity, it presents no significant changes. But as shown in Figs.8(c) and (d), more and more dense and elongated dimples were observed, which indicates that the tensile stress within the shear band augments as the impact velocity increases. In the high impact velocity range, the boundaries between the smooth area and the ductile dimple area become clear. Besides, Figs.8(e) and (f) reveal that some relatively small smooth planes appear in the ductile dimple area, even the smooth areas and the ductile dimple areas emergence alternately in certain areas.

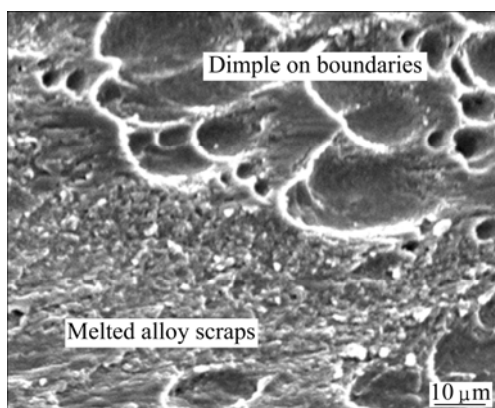
**Fig.9** SEM micrograph of melted alloy scraps filling in dimples at impact velocity of 306 m/s

mating displacement between the fragment and the fracture surface of the specimen can also “transport” scraps of the melted alloy from the melting regions to the boundaries between the smooth surface and the dimple areas, and those melted alloy scraps filling in the dimples can also form some smooth planes on the boundaries between the smooth surface and the dimple areas.

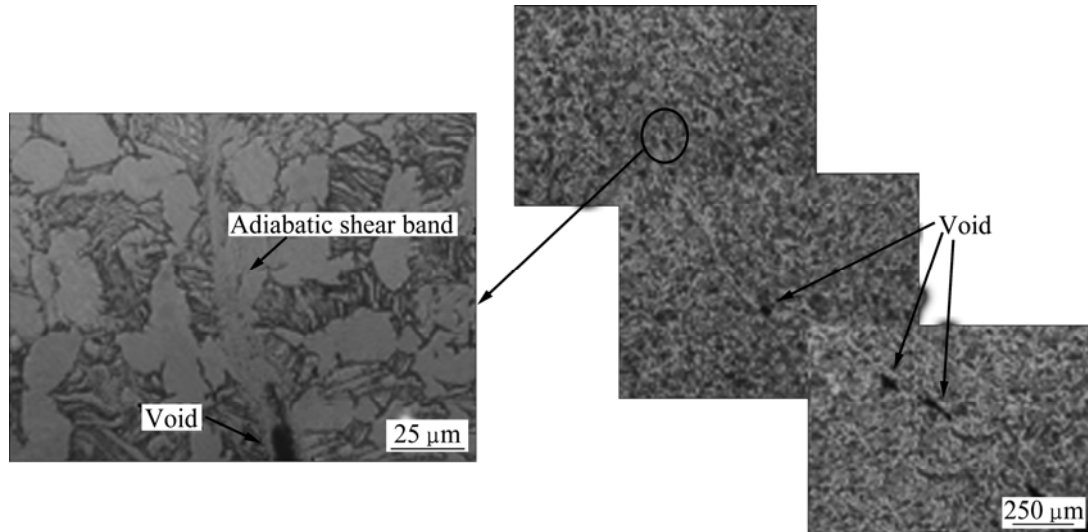
**Fig.10** Optical micrographs of adiabatic shear band on impact end surface of critical fractured stage specimen at impact velocity of 236 m/s

The metallographic analyses of the impact end surface of specimens in the “critical fractured stage” and the “complete fractured stage” were studied by optical microscope. Fig.10 shows the single white adiabatic shear band without branching off, which is observed in

the critical fractured stage specimens. By comparing with those formed on the SHB loading condition, reported in Ref.[13], the shear bands formed in the Taylor test are narrower and longer due to the more acute shear localization deformation in Taylor impact condition. Several dispersive voids distribute along the shear bands, which indicates that the specimen is in the

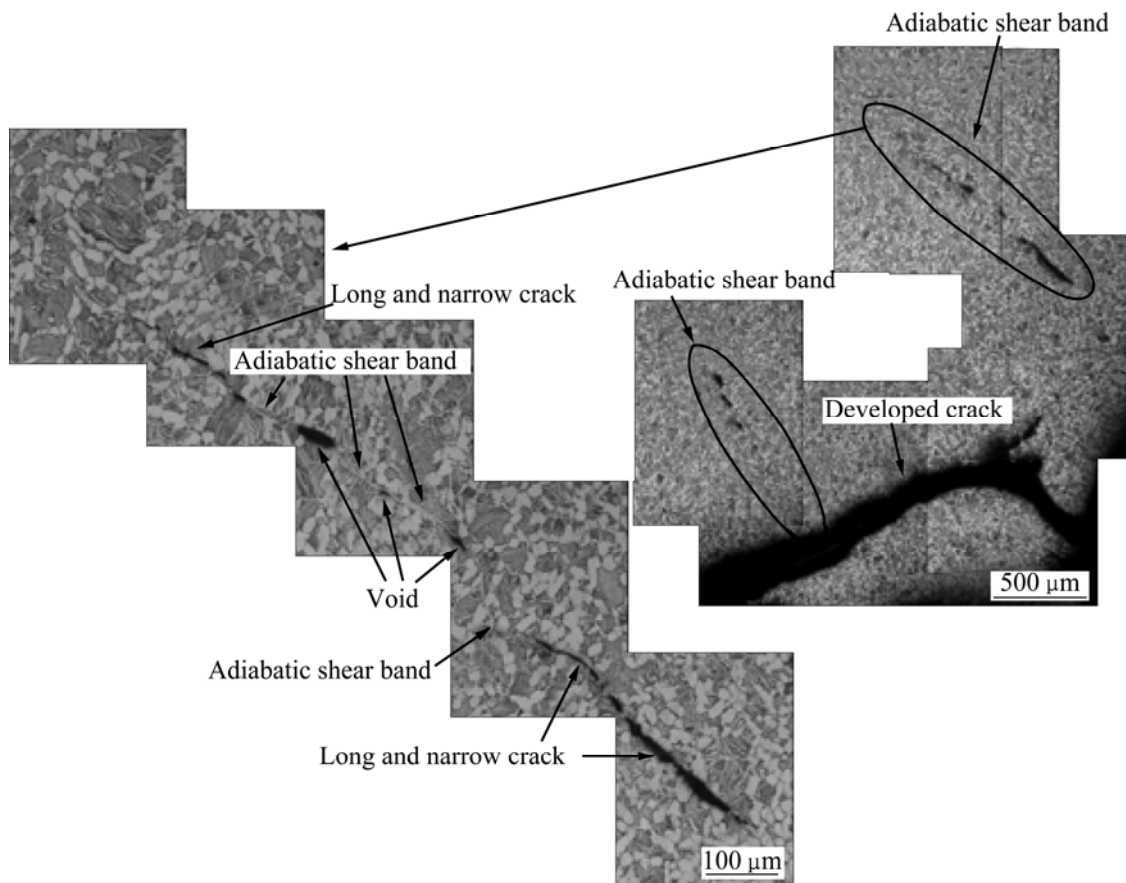
**Fig.11** Optical micrographs of main crack and adiabatic shear bands branching off from main crack at impact velocity of 253 m/s

Fig.11 shows that some developed cracks and more shear bands were observed in the complete fractured stage specimens with increasing impact velocity. These shear bands are longer than those in the critical fractured stage specimens. A few dispersive voids and a series of long and narrow small cracks distribute along the shear

band, which imply the nucleation, growth and coalescence of voids along adiabatic shear bands is the major reason for the fracture of the Taylor projectiles.

When the impact velocity reaches 260 m/s, some interesting phenomena are noticed. Besides developed cracks and relatively small normal cracks with shear bands on the tip of crack, as shown in Fig.11, there are some distinct cracks. Fig.12 presents these special cracks, whose tips are not sharp but arc and smooth, and any evidence of deformation or ASB are not observed in the microstructures surrounding these tips of cracks. A more detailed discussion about these special cracks is given in section 4.

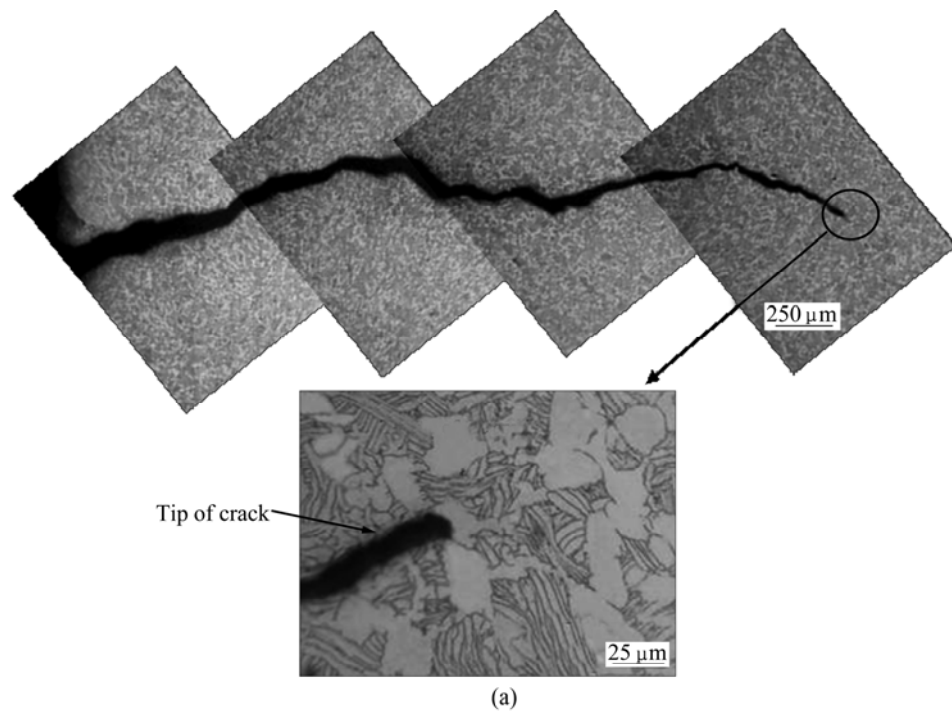
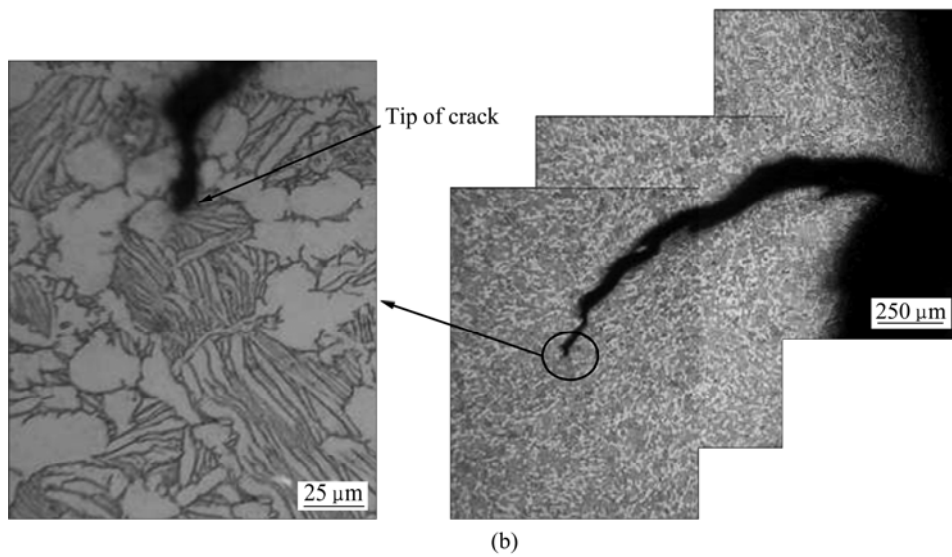
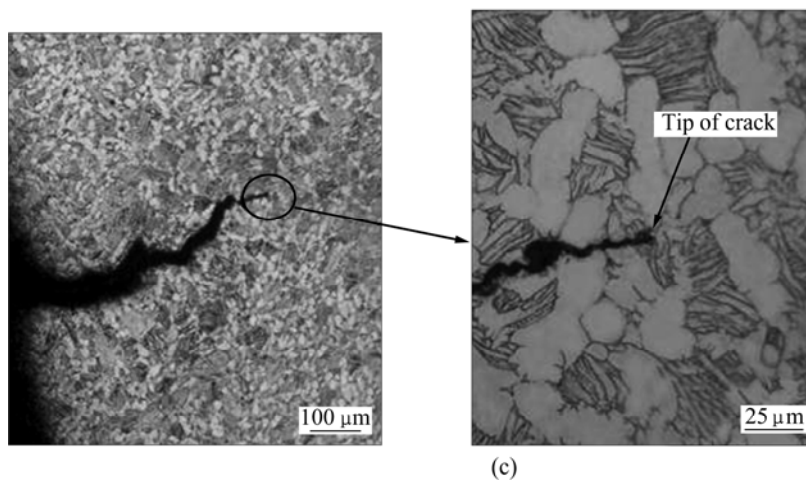
**Fig.12** Optical micrographs of crack without any deformation or ASB surrounding tip of it: (a)  $v=261$  m/s; (b)  $v=267$  m/s; (c)  $v=282$  m/s

The cracks on the impact end surface are actually a cross-section and top-view of the real three-dimensional stagger ridge structure, meantime, the view of the sections is a series of side-view of the real three-dimensional stagger ridge structure. So the single crack on the impact end surface is corresponding to the vertical view of a roof ridge and is the intersection line between the two shear planes practically. Therefore, the “tip” of the crack on the impact end surface is in fact the origination site of another crack (such as crack 2 discussed above). We could not observe any evidence of deformation or ASB in the microstructures surrounding these tips of cracks (see Fig.12) because the crack expands along the opposite direction.

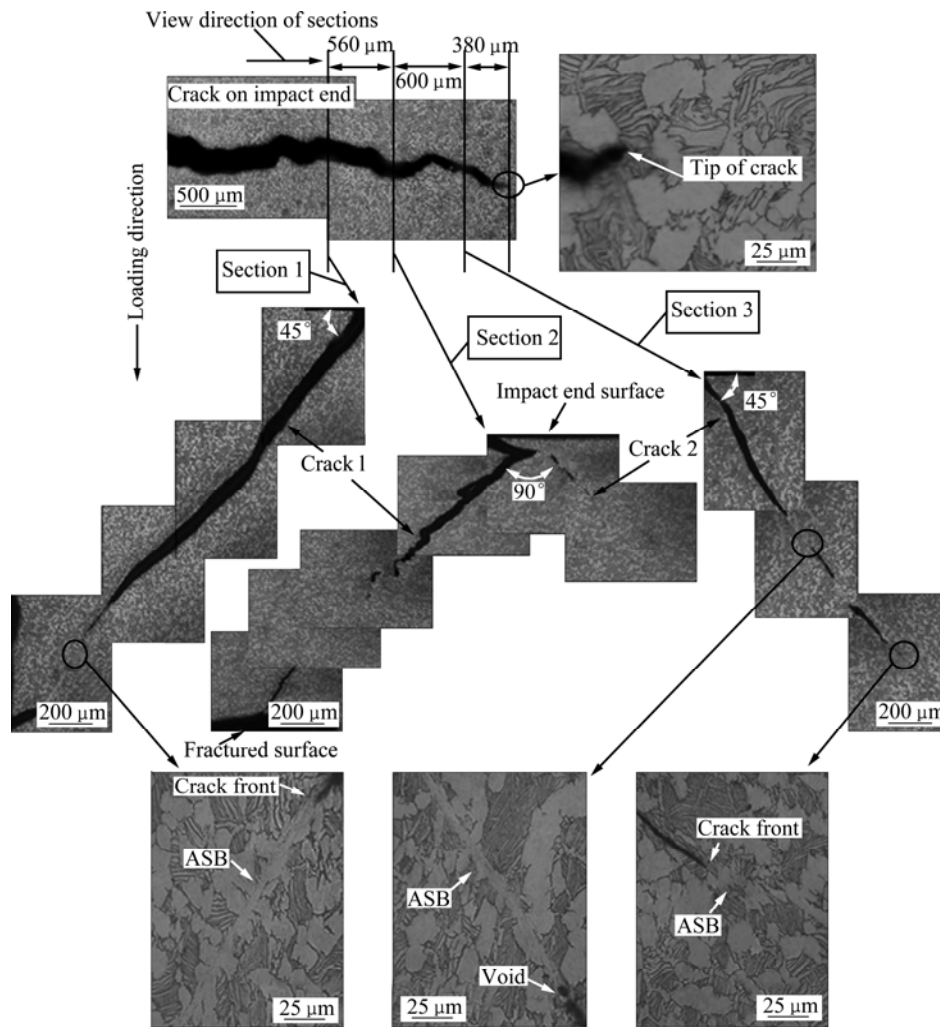
**Fig.13** Optical micrographs of sections of crack on impact end surface at impact velocity of 260 m/s

To investigate the expansion mode of the cracks within the specimens, the longitudinal sections of the fragment splitting away from the projectile were also examined systemically by optical microscope. Fig.13 shows that three sections were cut from one of the cracks on the impact end surface of the specimen along the “expansion direction” of the crack. On section 1, which is far from the crack “tip”, there is a developed crack with an adiabatic shear band in the front of it, and the crack makes an angle of about  $45^\circ$  with the impact end surface, denoted as crack 1. This crack expanded on a shear plane (denoted as shear plane 1) along the direction of the maximum shear stress, as reported in Refs.[12, 14], and linked another crack with the shear band finally. On the section 3 which is the nearest to the crack “tip”, a similar adequately grown crack was observed. But this crack expanded on the opposite direction against the crack 1. According to the uniform view direction of section 1 and section 3, it identifies that this is a new crack, denoted as crack 2, expanding along another shear plane (shear plane 2). There is also an adiabatic shear band in the front of the crack 2 and some long and narrow cracks caused by microvoids connection were observed. On the section 2 which locates between section 1 and section 3, the junction of crack 1 and crack 2 is presented clearly. According to the diverse extension length of crack 1 on the section 1 and section 2, we can make sure that the crack 1 expanded from external and upside to inside and lower side of the specimen, at the same time, the crack 2 expanded from internal and upper to external and downward of the specimen verified by the diverse extension length of crack 2 on the section 2 and section 3. The two shear planes are cuneiform and make an angle of about  $45^\circ$  with the impact end surface. Finally, these two cracks intersected and formed a tridimensional “stagger ridge” structure. The normal

stress forms two maximum shear stresses on the opposite direction with an angle of  $90^\circ$ ; so the two cracks, which expanded respectively along the shear plane 1 and the shear plane 2, intersected even at an angle of about  $90^\circ$ , as shown on section 2 in Fig.13.

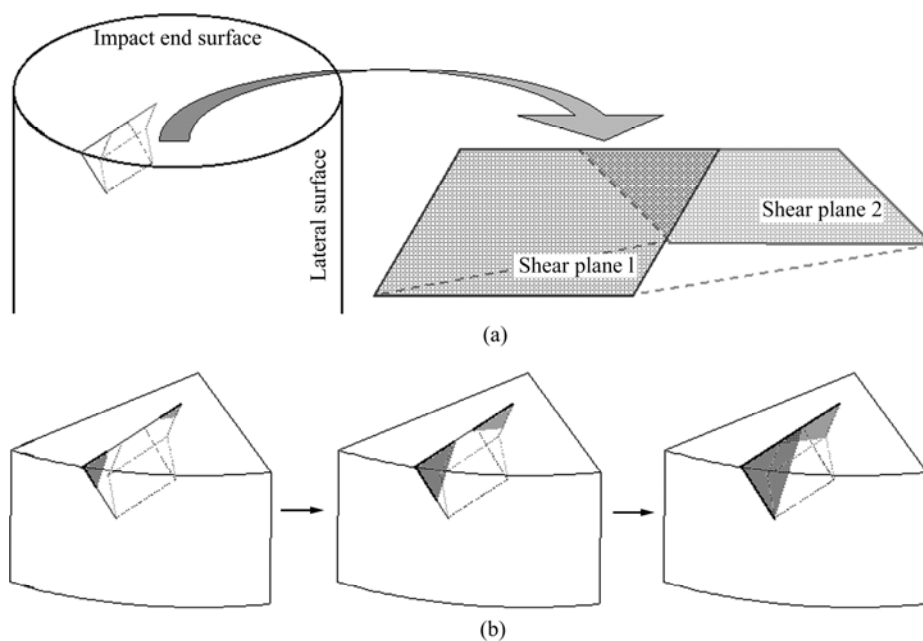
**Fig.14** Schematic diagrams of tridimensional "stagger ridge" structure (a), and expanding process of cracks and forming process of tridimensional "stagger ridge" structure (b)

Fig.14 presents the expansion of cracks and the forming process of the tridimensional stagger ridge structure schematically. As shown in Fig.14(a), the stagger ridge structure consists of two shear planes. These two shear planes intersect at an angle of  $90^\circ$ , and the intersecting sides of these two shear planes are not coincident absolutely. Fig.14(b) shows the expanding process of cracks and forming process of the tridimensional “stagger ridge” structure. Firstly, two cracks nucleate on the two different maximum shear stress planes (marked as shear plane 1 and shear plane 2, respectively). Then, these two cracks expand head-on along the maximum shear stress planes. Finally, these two cuneiform cracks encounter and intersect as a three-dimensional “stagger ridge” structure. And on the impact end surface, the intersecting line looks like a single crack. Based on the above discussion, under certain loading conditions, some “special cracks” without adiabatic shear band on its tip can form due to the complicated stress state. So, we should not simply consider that there is independent between those cracks and adiabatic shearing, and more in-depth studies are required.
