PART NUMBER 56947-01

Manual Valve Index

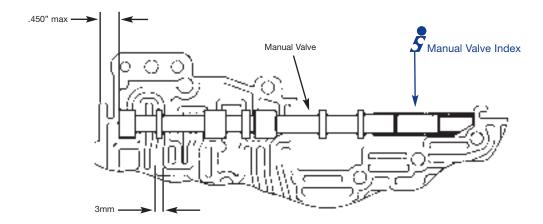
1 Manual Valve Index

To verify if you have a problem unit, with the selector lever in park and slight forward pressure on the -S- link, measure from the end of the valve body casting to the end of the manual valve. This measurement should not exceed .450". Anything beyond this will allow the line to forward clutch circuit to open. It is also recommended to use the redesigned (1988) manual valve. The indicated land was made thinner on the 2nd design (3mm) for improved direct clutch durability. There is also an identification groove on the new design. This manual valve (E8TZ-7C389-A_) will retrofit all valve bodies.

- 1. Disconnect the manual control lever assembly ("rooster comb") from the manual valve.
- 2. Pull the manual valve out of the valve bore just enough to slip the manual valve index over the end with the -S- link attachment hole.
- 3. Rotate the manual valve until the flat cut-out side of the manual valve index is facing the valve body.
- 4. Reattach the manual control lever assembly by pushing the -S- link through the holes in the manual valve index and manual valve.
- 5. The common industry suggestion of bending the -S- link is not necessary. The manual valve should now center without any bending modifications.

Either the early or late style "rooster comb" may be used with the manual valve index. However, -S- link wear at the "rooster comb" is very common. If the -S- link is worn significantly, it should be replaced with a new OEM part (D4ZZ-7E333-A). The common industry suggestion of bending the "rooster comb" stop may not reduce freeplay enough to retain the manul valve position. In most cases, the metal will crack before the dimension is obtained.
