## Automated Detection of Corrosion Damage in Power Transmission Lattice Towers Using Image Processing

Bhavana Valeti<sup>1</sup> and Shamim Pakzad<sup>2</sup>

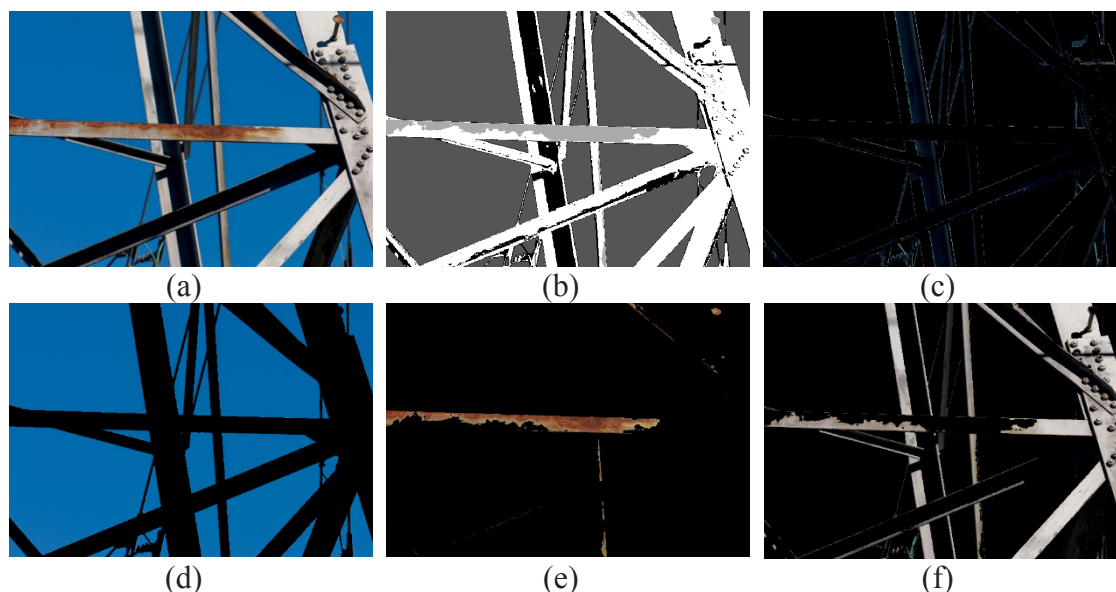
Figure 1 (a) Image of a lattice structure with corrosion. (Photo courtesy of PPG Industries, Inc.), (b) Image color indexed image based on clusters, (c) Segment of cluster 1, (d) Segment of cluster 2, (e) Segment of cluster 3 (f) and Segment of cluster 4.

Where  $x_i^{(j)}$  is  $i^{\text{th}}$  data point in cluster  $j$  of centroid  $c_j$ . From experience  $K$  is fixed to 4 color clusters. Each of the pixel is color coded with its cluster number as shown in Figure 1(b). Each color segment of the actual image is individually extracted to separate RGB images and pixels corresponding to other clusters are black as shown in Figure 1 (c)-(d).

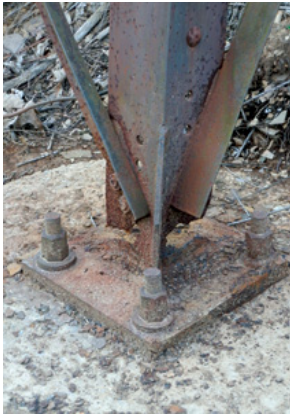
Corrosion at the base.  False Positives: Soil in the background.
(4)

Some of these issues can be eliminated by pre-processing methods and by meeting certain image acquisition conditions. False positives due to objects in the background such as those experienced in test images 3 and 4 can be eliminated by subtracting the background of the structure in the pre-processing. Also, the false positives, usually insulators in case of transmission towers can be eliminated by shape based identification of insulators and elimination from the image along with the background given the images are acquired under previously described conditions. The problem with insufficient number of clusters can be dealt with automating the estimation of optimum number of K-means clusters.

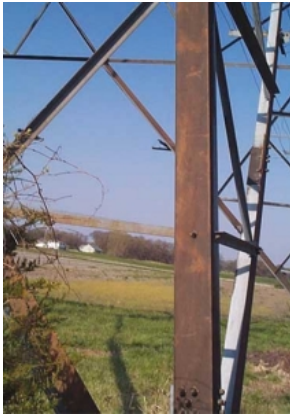
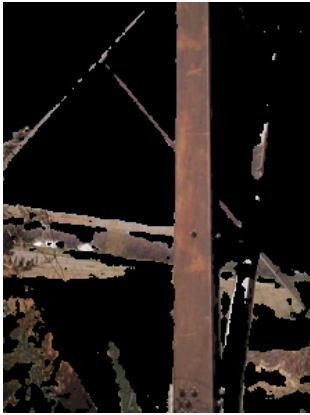
Focusing only one of the corroded members.  False Positives: Objects in the structure background due to insufficient color segmentation clusters.

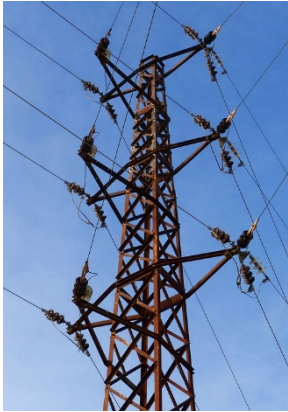
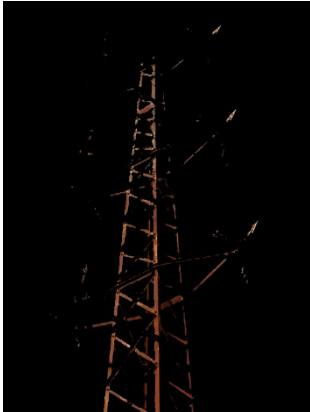
Test Image	Identified Corroded Region	Details
(5)

Image of coorced structure from ground.  False Positives: Insulators with hues close to corrosion.
(Photo courtesy of <a href="http://www.pixabay.com">www.pixabay.com</a> )
