PART NUMBERS 69903-01K, 93903-01K

Servo Pins

Sonnax Part Summary

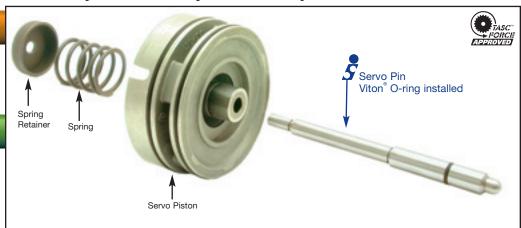
The bore becomes out-of-round due to the band apply force and pin bore wear, reducing servo release oil and high clutch apply force.

2-3 bind up, high clutch failure, overheated band

• Excess servo pin bore wear • Drop in 3rd clutch oil pressure • Excess oil loss at servo release

Common problems in many Jatco units are 2-3 bind-up, high clutch failure and overheated band caused by a worn servo pin bore. Due to the inherent problems regarding sealing rings, line rise and shift timing, oil control is critical for this unit. Sonnax now offers a servo pin with an o-ring 69903-01K for RE4R01A & RE4R03A units and 93903-01K for RE4F02A & RL4F02A units to compensate for egg-shaped wear in the case bore. An o-ring is placed onto the servo pin, at the location of most bore wear.

Servo pins have Viton® seal to eliminate servo release oil loss.

- Viton® o-ring conforms to egg-shaped bore.
- Allows a slightly worn case to be reused.
