PART NUMBER 56947J-BST2

TCC Back Pressure Valve Bore Sizing Tool

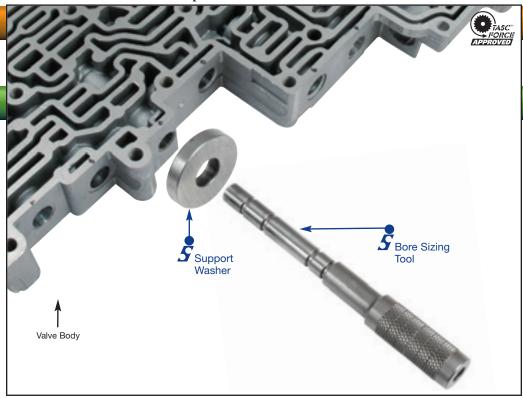
The valve sticks on ridges in the bore created by wear and valve warpage.

Excess TCC slip RPM, harsh TCC apply, unuseable cores

• TCC solenoid cannot control slip RPM

Resize and/or remove ridges and burnish the OEM bore with the Sonnax bore sizing tool.
