Development of the Corrosion Deterioration Inspection Tool for Transmission Tower Steel Members

Abstract

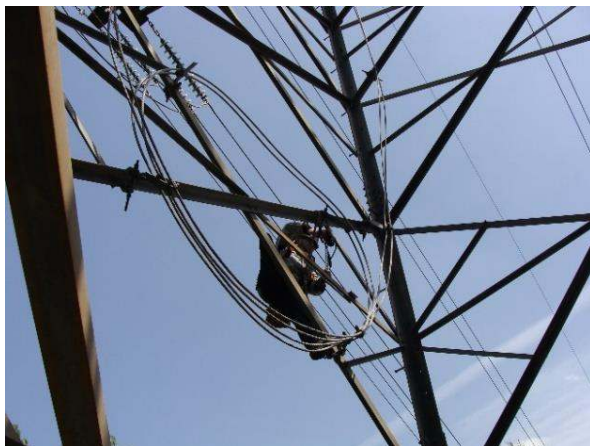
(a) Safety Inspection Scene

Figure 1. Camera Equipment for Corrosion Deterioration Inspection Tool

As shown in Tables 1 and 2, deterioration grade of a transmission tower is determined according to rusting or damaged area ratio within a section of a horizontally 1 meter long member. Thus, it is necessary to develop the equipment for determining deterioration grade of a transmission tower to be able to photograph a horizontally 1 meter long member. However, as shown in Figure 1(a), it is very difficult to photograph a 1meter long member at one time by climbing the transmission tower. Thus, in this study, 0.5meter long member was consecutively photographed to evaluate and diagnose deterioration grade of the transmission tower as shown in Figure 1(b).

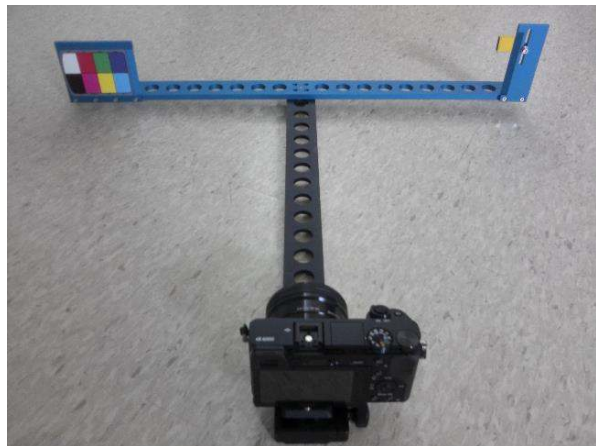
(b) Camera Equipment

As shown in Figure 1(b), the camera equipment was produced in a blue rectangular frame shape so that the region of interest (ROI) of the photographed transmission tower member could be automatically extracted by image processing technique, and the yellow marker in the upper right side of the rectangular frame was used to set the width of the transmission tower member for image processing. In particular, the color chart on the left side of the rectangular frame provided a standard RGB information for compensating image distortion due to change in illumination.

A magnet was installed on the lower bottom of the rectangular frame for convenience of operating the camera equipment, and the digital camera support was designed to be detachable at the center of the rectangular frame. The digital camera used for the camera equipment was attached to the vertical support in the center of the rectangular frame such that the transmission tower member was photographed with identical angle of view and ratio at regular intervals to always obtain a standardized deterioration image.

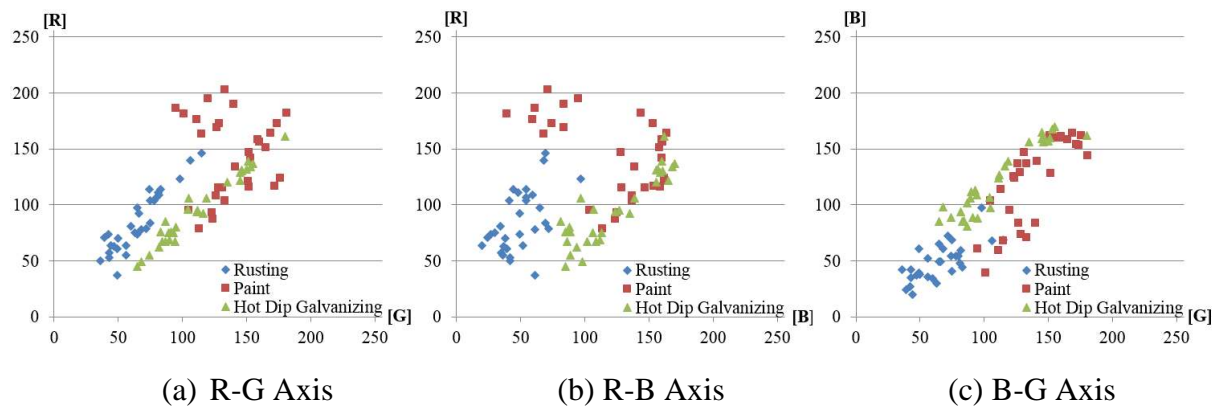
Figure 2. RGB Value of Transmission Tower Steel Member

Color characteristics of rusting, painting and hot dip galvanization must be obtained in order to carry out color image processing for determining deterioration grade from the deterioration images using the characteristic color change of the steel surface according to the deterioration of painted member and hot dip galvanized member of the steel tower transmission. In this study, images were taken from commonly used transmission towers to analyze RGB color values of rusting, paint and hot dip galvanization. The results are shown in Figure 2, Table 3.

As shown in Figure 2 and Table 3, RGB values of rusting is distinguishable from the RGB values of painting and hot dip galvanization. Further, the paint applied to the transmission tower is various in color (green, orange, white, ivory, etc.) according to the objective so the RGB values are widely distributed. Figure 3 shows the distribution state of the RGB values for rusting. Therefore, the key in color image processing for determining deterioration grade of the transmission tower is to distinguish the RGB value of rusting and the RGB value of painting from the deterioration images of the hot dip galvanizing and painted members.

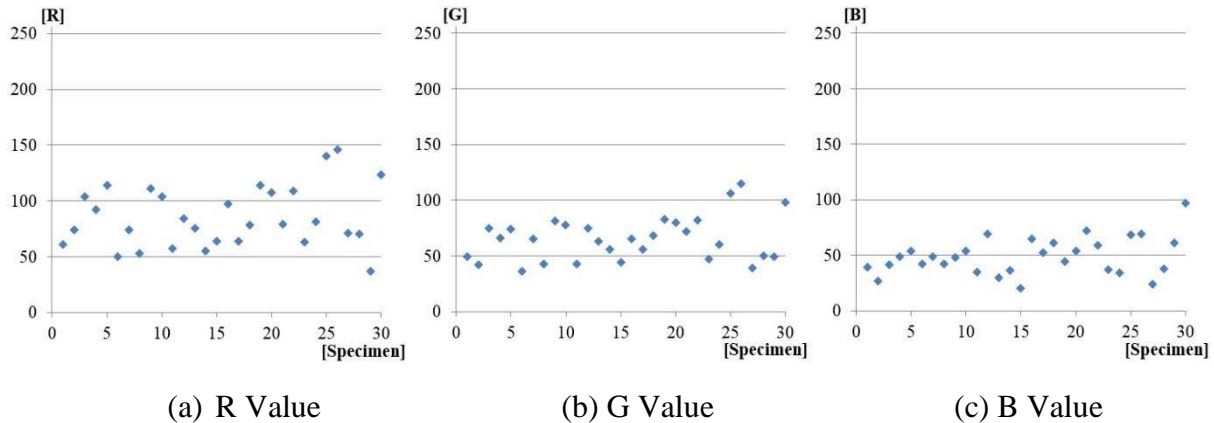
Figure 3. RGB Value of Rusting for Transmission Tower Steel Member

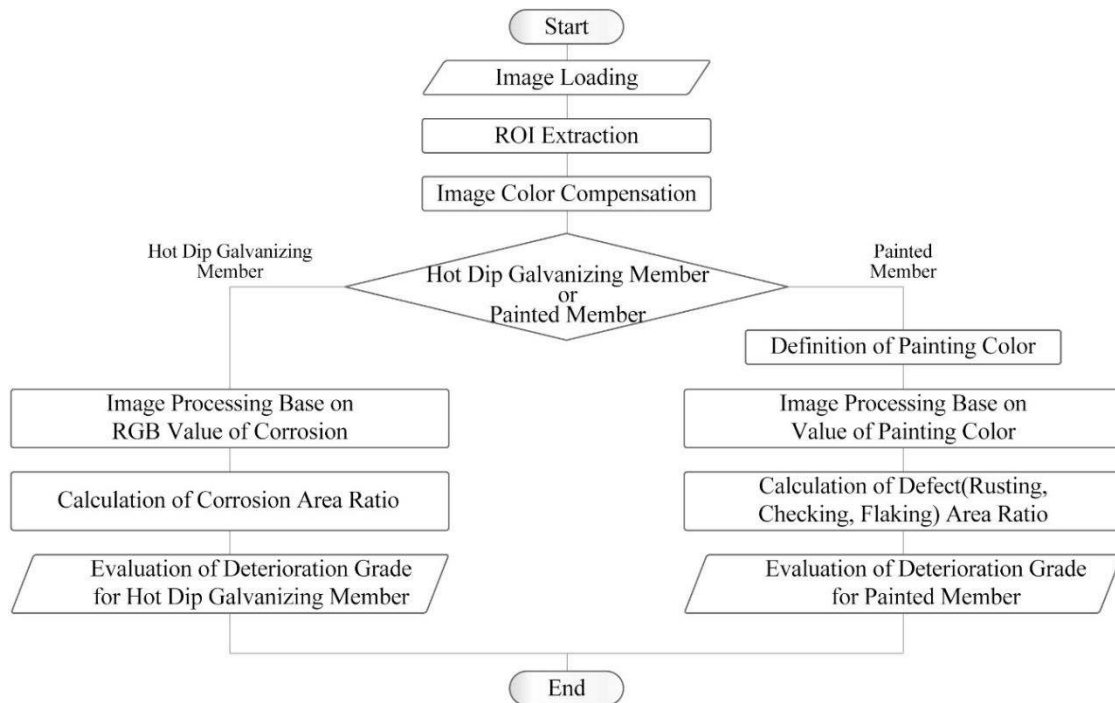
Figure 4. Flow Chart on the Computer-Aided Diagnosis System of Corrosion Deterioration

Color image processed corrosion deterioration diagnosis system was prepared for determining deterioration grade from the deterioration images of the hot dip galvanizing and painted members of the transmission tower. User accessibility was improved by developing it for web-based use in a Windows environment. Figure 4 illustrates deterioration grade detection process of the transmission tower member in the color image processed corrosion deterioration diagnosis system. Transmission tower deterioration detection process of the corrosion deterioration diagnosis system is dualized for hot dip galvanizing member and painted member, but the main processing process is identical. That is, deterioration image of the transmission tower member is taken, inputted into the corrosion deterioration diagnosis system, and region of interest is extracted from the inputted image. Image compensation is performed for the region of interest using the color chart, then hot dip galvanizing member and painted member are separated to carry out color image processing, and rusting and damage area ratio is calculated to evaluate deterioration grade for hot dip galvanizing member and painted member according to deterioration grade criteria.

Difference in image processing for the hot dip galvanizing member and painted member is due to hot dip galvanizing member having inherent RGB value, while painted member has RGB values varying according to the applied paint. Therefore, color image processing for evaluating deterioration grade of the painted transmission tower member requires the process of defining RGB value of the painted member, and color image processing is conducted based on the determined RGB value of the painted member to carry out image processing of the damaged region. Figure 5 shows a graphic user interface (GUI) of the corrosion deterioration diagnosis system, and Figures 6 (a) and (b) respectively show the deterioration grade

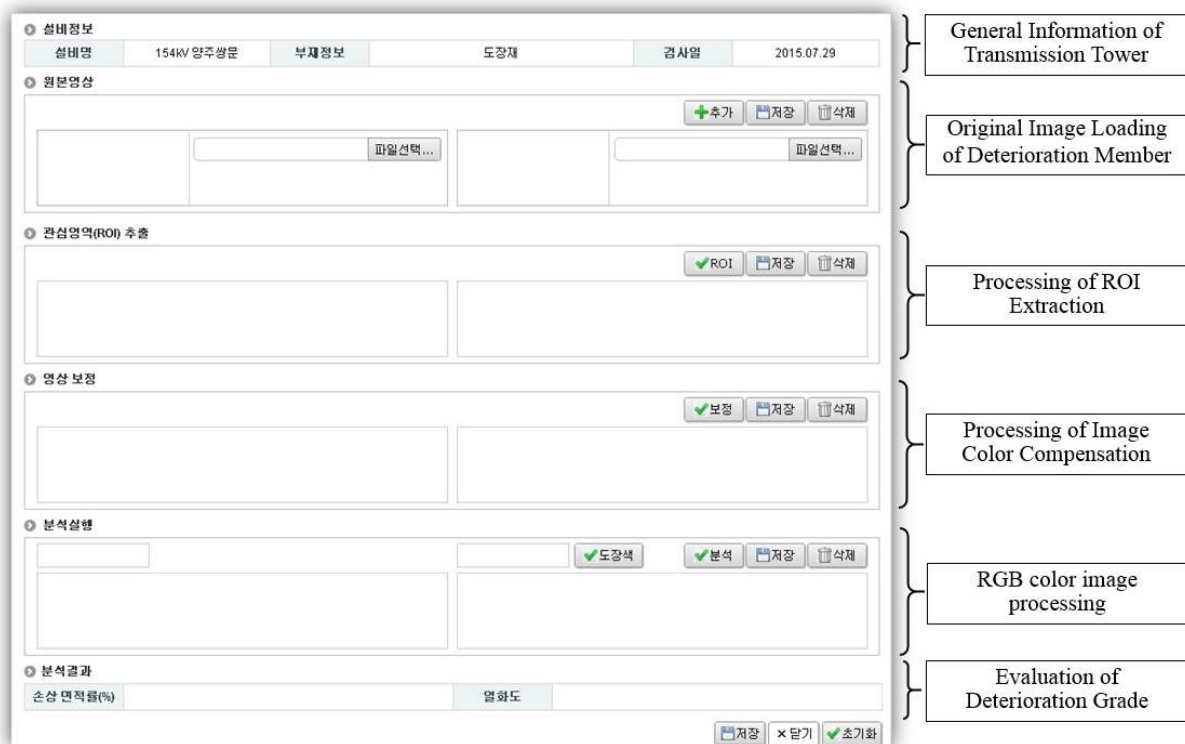
Figure 5. GUI of Computer-Aided Diagnosis System

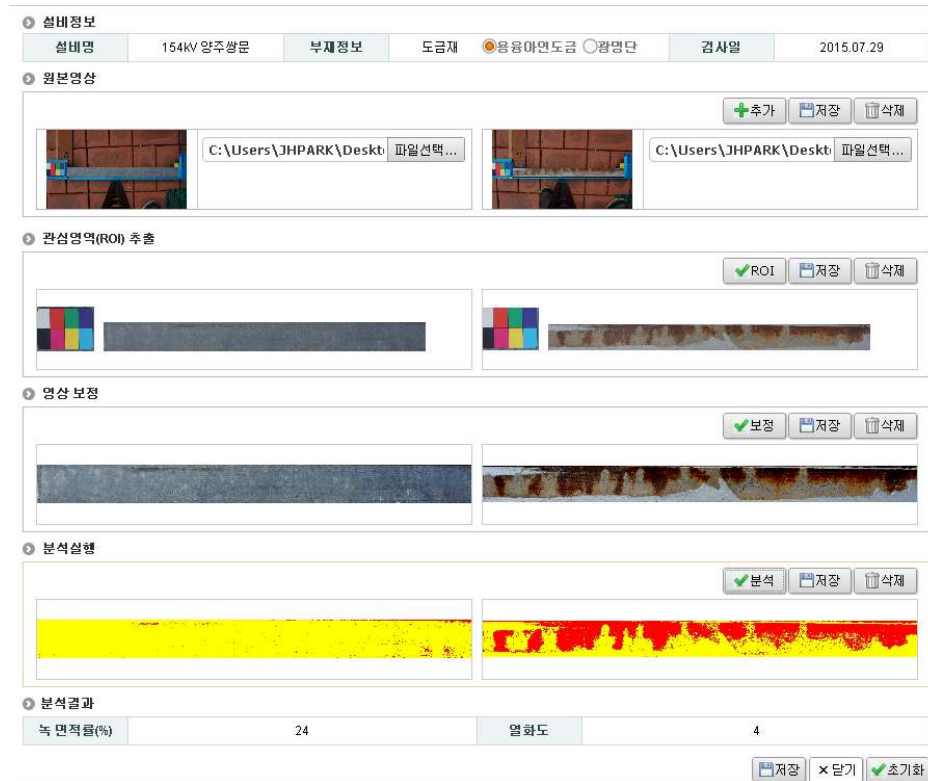
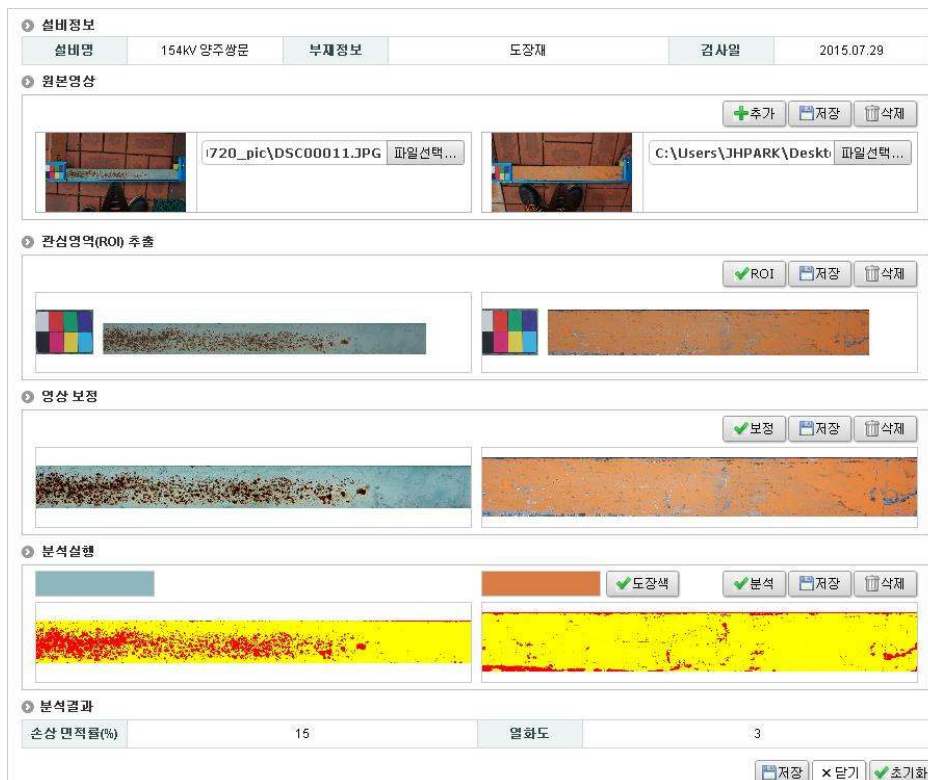
(a) Hot Dip Galvanizing Member

(b) Painted Member

Figure 6. Analysis Result of Corrosion Deterioration for Transmission Tower Steel Member

classifying of hot dip galvanizing member and painted member of the transmission tower using the corrosion deterioration diagnosis system.
