4T60-E ('97 BONNEVILLE)

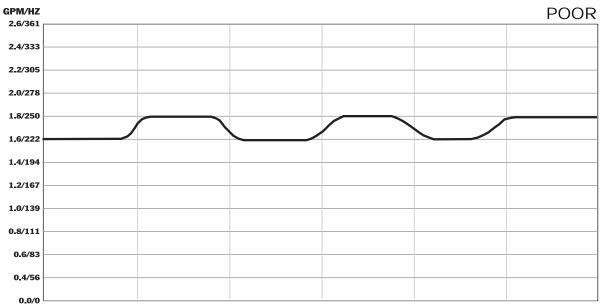
Event: Surging with TCC cycling in and out every few seconds. **Condition:** 45 mph steady load, very hot with TCC command on.

Notes: As temperature increased, TCC would cycle for longer times. When cooled, surge felt like engine miss.

Correction: Replace worn TCC apply valve.
