PART NUMBERS 77917-06, -07, -TL

# **Pressure Regulator Valve Kits**

**77917-06** 4L60 **77917-07** 4L60-E

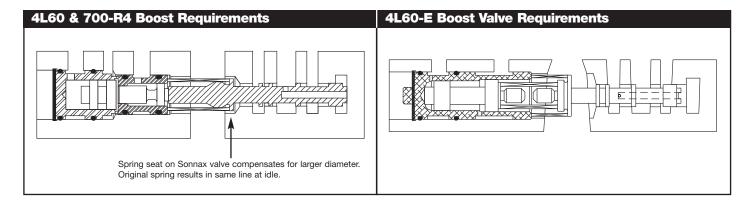
#### To repair worn bore with transmission still in vehicle

Worn valve bore.

- 1. Remove cooler-out (bottom line).
- 2. Remove pressure regulator and boost valves.
- 3. Install reamer guide, then reamer.
- 4. Have assistant blow low air psi into the cooler line fitting, which will force chips way from cooler circuit.
- 5. Drive reamer with low speed drill with 3/8" chuck.
- 6. After reaming the bore, blow air into the pump suction inlet to force out chips.
- 7. Clean and reflush area with brake cleaner.
