PART NUMBERS 56947-02K, -03K, -04K, -05K

Large & Small Boost Valve Kits

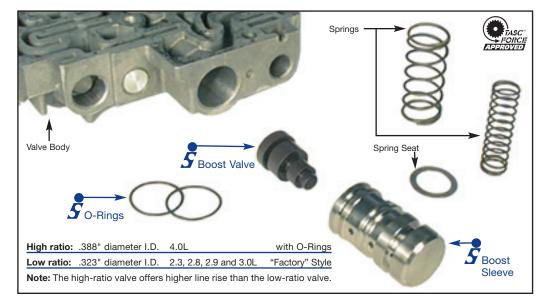
Note: During Wet Air Test of reverse circuit, if excessive oil loss is visible at the reverse engagement control plug, the plug is either installed backward (should be large diameter outward) or the plug or bore is worn. This wear will reduce reverse boost effectiveness.

With the manual valve in the reverse position and the separator plate still bolted to the valve body, place a small amount of oil into the "A" orifice. Follow with low air pressure. There should be no oil or air leakage in the exhaust port at "B". If there is, the boost valve is worn at the reverse land and should be replaced. Place a small amount of oil in checkball hole "C" or "D". Follow with low air pressure while plugging the opposing hole. There should be no oil or air leakage at cutback valve "E" location. If leakage occurs, the boost valve assembly is worn and should be replaced.

Note: To ensure that the pressure regulator valve balance circuit is functional, perform a Wet Air Test at "F". A worn bore will leak to filter suction hole. Many poor converter charge and engagement concerns are related to bore valve wear here.

Perform a Wet Air Test to determine if the boost valve assembly is worn and needs to be replaced. Remove the worn boost valve and sleeve from the valve body. Replace with the Sonnax boost valve kit. Refer to the illustration below to ensure that all parts are returned in the proper order and correct orientation.
