I/O misalignments might occur on properly aligned LUNs

ONTAP 9

NetApp
December 01, 2021

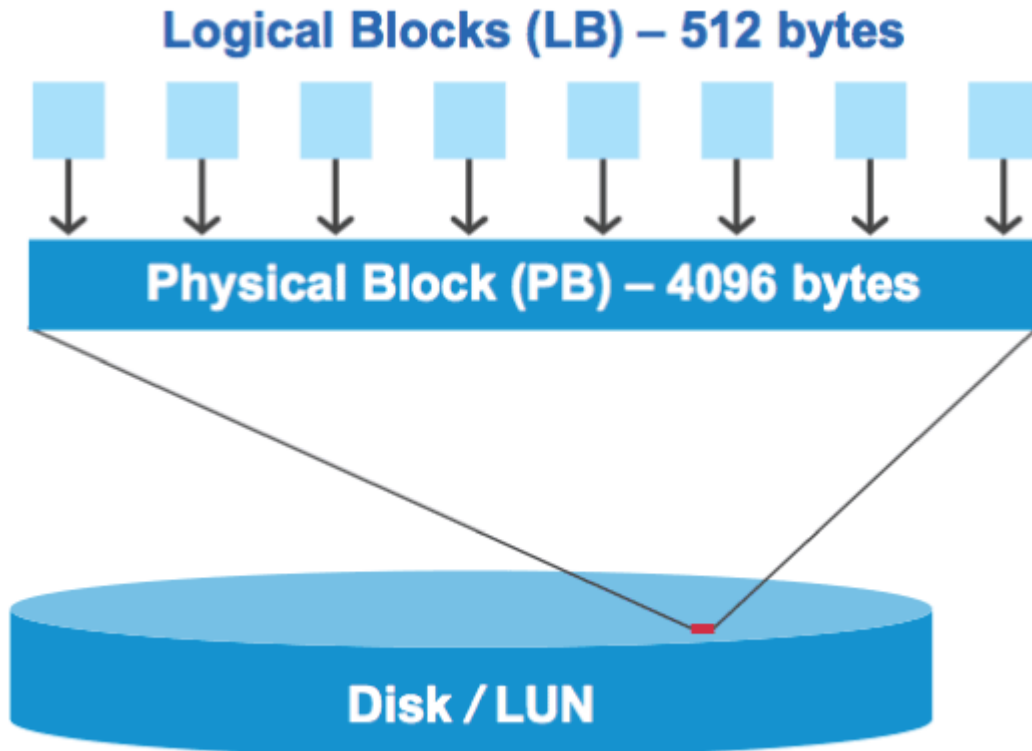
LUNs and hard disks both provide storage as blocks. Because the block size for disks on the host is 512 bytes, LUNs present blocks of that size to the host while actually using larger, 4-KB blocks to store data. The 512-byte data block used by the host is referred to as a logical block. The 4-KB data block used by the LUN to store data is referred to as a physical block. This means that there are eight 512-byte logical blocks in each 4-KB physical block.

The host operating system can begin a read or write I/O operation at any logical block. I/O operations are only considered aligned when they begin at the first logical block in the physical block. If an I/O operation begins at a logical block that is not also the start of a physical block, the I/O is considered misaligned. ONTAP automatically detects the misalignment and reports it on the LUN. However, the presence of misaligned I/O does not necessarily mean that the LUN is also misaligned. It is possible for misaligned I/O to be reported on properly aligned LUNs.
