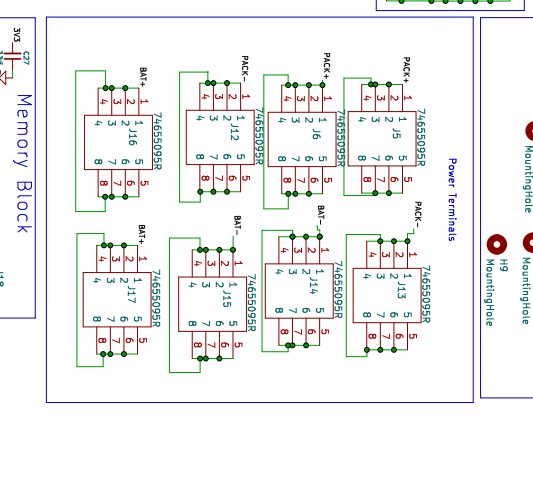
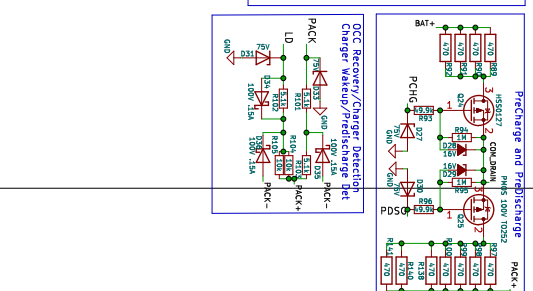
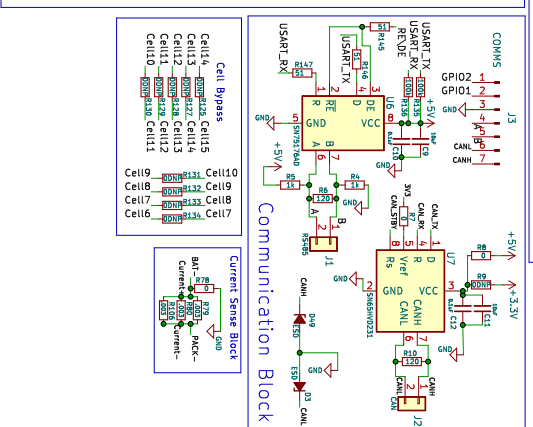
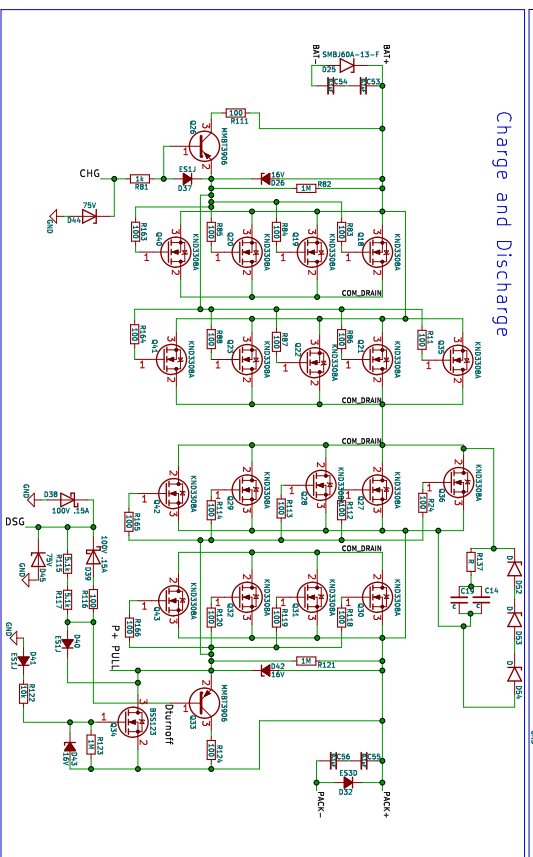
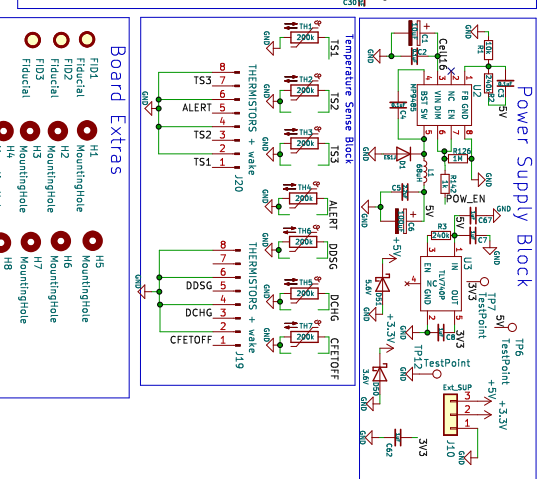
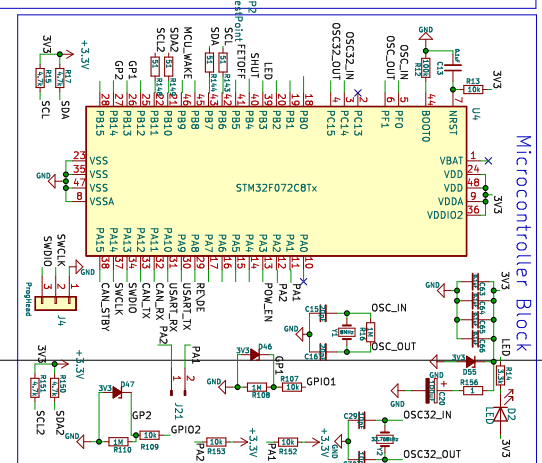
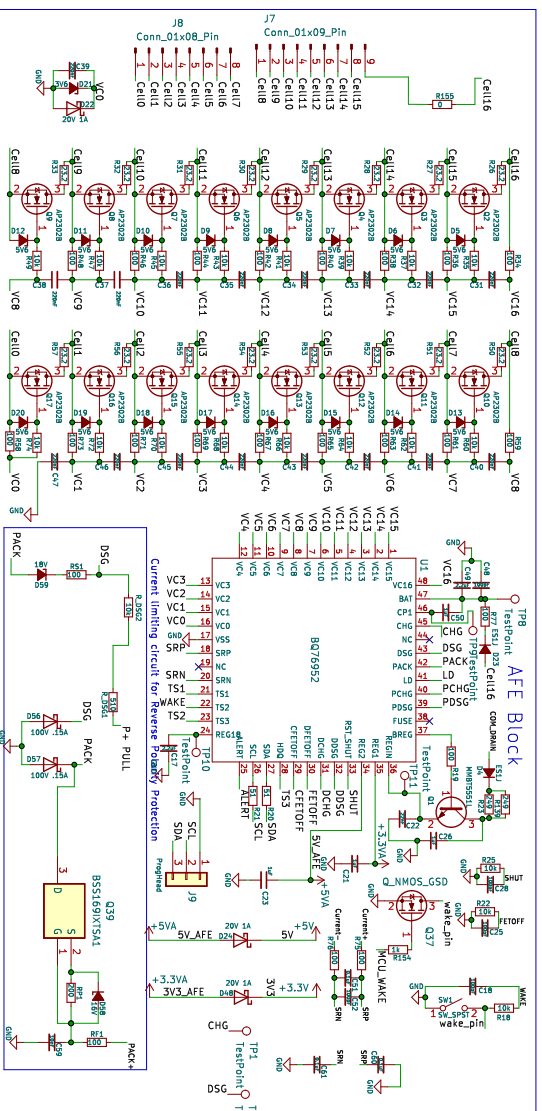
1. Place 0.1uF capacitors from SRP to GND and SRN to GND to suppress transients
2. Noise on FETOFF and SHUT causing random AFE reset during SCD test.
3. Connect 0 ohm to R25,R22,C25,C28 to directly ground FETOFF and SHUT pins to avoid noise.
4. R103,R104,R105,R115,R117 were heating during reverse polarity
