# Experimental Results on Aluminum Alloy Laser Paint Ablation

Kanha Bhatt

*University of Washington*

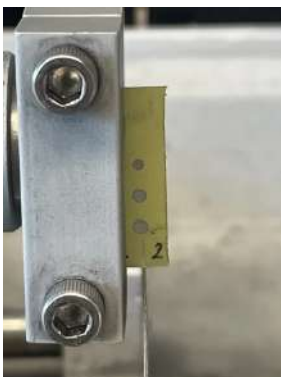
**Fig. 1:** Cross-sectional cutting using low-speed saw

After laser testing was complete, optical images of the ablation sites were carried out using a Nikon Eclipse ME600 microscope. Furthermore, to characterize the damage underneath the primer coating, cross-sectional optical imaging was done. The cutting tool used was a Buehler IsoMet 1000 Precision Saw. With the use of a low-speed saw, the Aluminum samples were cut across each ablated spot. The cutting speed ranged from 300 - 400 rpm. In order to achieve a clean cross-sectional cut, it is recommended to firmly secure the sample within the chuck and properly sharpen the diamond blade. Figure 1 displays the mounting orientation of the Aluminum sample so the diamond blade saw can cut through it. Prior to cutting, the ablation spots were aligned with the center of the saw blade. Figure 2 displays the orientation of the sliced aluminum as it is prepared for optical imaging.

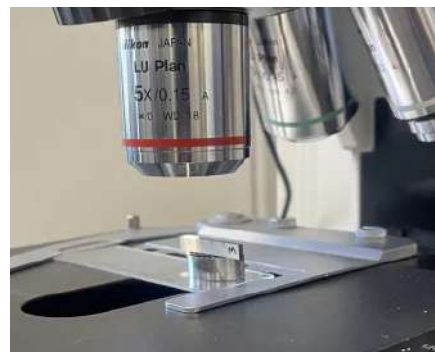
**Fig. 2:** Placement of cross-section for optical imaging

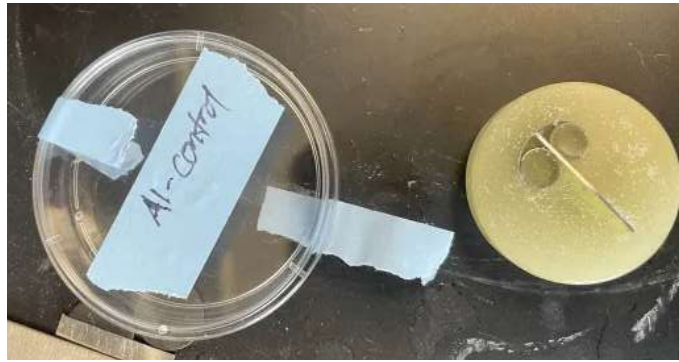
**Fig. 3:** Control- Aluminum substrate with BMS10-103 primer coating

aluminum samples were embedded within the Epoxy Resin mixture. Figure 3 displays a Control Aluminum substrate with the BMS 10-103 primer coating; the sample was not subjected to any laser ablation. Figure 4-6 displays the specific samples created in the study.

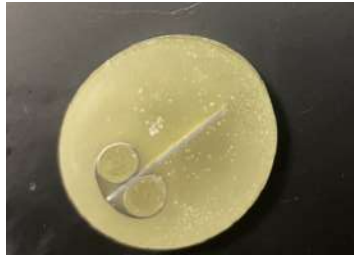
**Fig. 5:** Tempest Sample 1, Row 1 - Puck (250mJ, 1-4 shot)

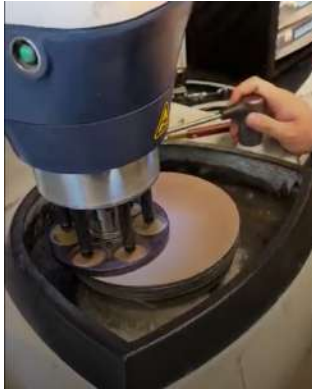
The Polisher used was a Buehler EcoMet 250 Polisher as seen in Figure 9. The base speed was set to ~150 rpm and the head speed was set to ~30 rpm. The applied force ranged from 6 to 10 lb. The sample pucks were polished with 1000  $\mu\text{m}$  grit, 9  $\mu\text{m}$  Diamond grit, 3  $\mu\text{m}$  Diamond grit, 1  $\mu\text{m}$  Diamond grit, and 0.05  $\mu\text{m}$  Diamond grit. In order to prevent contamination between grits, the samples were placed in an Ultrasonic bath for 5-10 minutes between each polish; this can be seen in Figure 10. The goal of the polishing was to smooth down the sample and ensure that the Aluminum cross-section is properly exposed for nanoindentation.

**Fig. 9:** Polishing tool

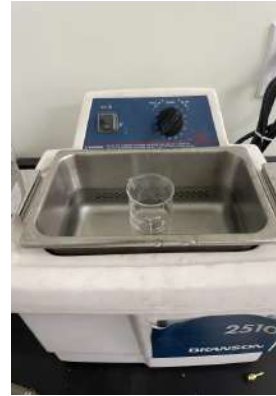
**Fig. 10:** Ultrasonic Bath

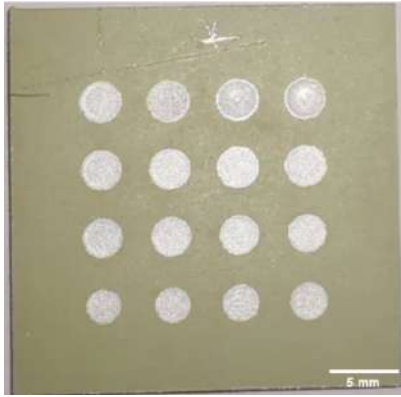
**Fig. 11:** Tempest: Sample 1

The first test that was performed was on the Tempest laser. A total of sixteen ablation marks were made on the sample; each ablation mark had a different laser energy or pulse number. The Tempest Sample 1 substrate can be seen in Figure 11; the corresponding Sample 1 Spot Map can be seen in Figure 12. A table of the test parameters can be seen in Figure 13. Each index value in Figure 13, corresponds to the value written in Figure 12. For example, Index 16 on the spot map represents a 1 pulse at 70 mJ test. The first row of Sample 1 shows ablated spots at 250 mJ (max energy) ranging from 1 - 4 pulses. Index 5-16 shows the energy being incrementally decreased, while keeping the number of pulses constant; the laser energy is reduced by 15 mJ with each index.

As observed by Figure 11, the Tempest testing induced a range of damage modes. At 250 mJ, the thermal effects are apparent. A darkened ablation spot is produced (Index #1-4) due to the high energy and increasing shot count. Index 4 represents the highest energy shot; at a total energy of 1000 mJ, the surface shows visible damage. At 190 to 235 mJ, the spot size remains at approximately 3 mm, however the dark ablation marks do not seem to appear. At 130 to 175 mJ, the spot size seems to decrease slightly by approximately 0.25 mm. The ablated spots are much cleaner and initial inspection shows no significant substrate damage. At 70 to 115 mJ, the ablation spot size further reduces. The primer layer is completely removed and no significant damage is visible. The results from Sample 1 indicate that only 1 pulse is required to fully ablate the primer using the Tempest Laser. As pulse count increases, the extent of thermal damage also increases.

As seen by Figure 11, the left side of the ablated spot seems to show the most damage. As a result, the left side of the ablated spot was indented. Figure 68 to 70 show the nanoindentation location and force selection. A total of six indents were made with two unique forces being tested. Figure 71 also shows the misaligned curves that were seen during the Control clad testing. Specifically, lines generated at 4000 uN are heavily skewed and do not align.

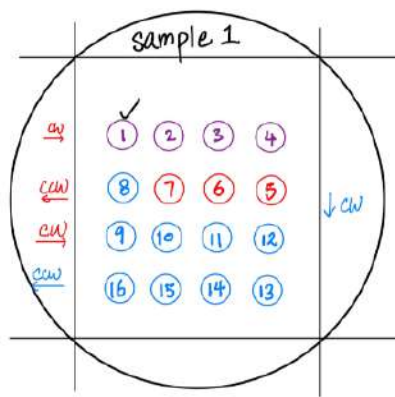
**Fig. 12:** Tempest: Sample 1 Spot Map

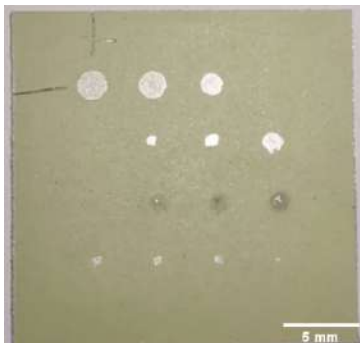
**Fig. 14:** Tempest: Sample 2

A second sample was tested to continue the incremental reduction of laser energy. The second sample tested on the Tempest can be seen in Figure 14; the corresponding Sample 2 Spot Map can be seen in Figure 15. A table of the test parameters can be seen in Figure 16. Index 17-24 show ablation spots, each decreasing by 15 mJ. As indicated on the Sample 2 Spot Map, Index 20 is invisible. Index 25-29 show ablation spots at 13 mJ where the number of pulses ranges from two to seventeen. Index 26 and 27 were fired at the same spot with a total shot number of seven. Index 29 was shot 17 times using the Tempest Burst Mode setting; the burst mode had a repetition rate of 5 Hz. Index 30 - 33 were shot with all the same parameters: 14 mJ and 1 shot.

As observed by Figure 14, at lower laser energy, the spot size reduces significantly. At 55 mJ, the spot size is nearly 2.5 mm. At the minimum energy 10 mJ (Index 20) and 13 mJ (Index 24), the ablated spot is invisible. This indicates that the primer ablation threshold was not satisfied. Index 21-24 aims to determine the ablation threshold of the BMS10-103 coating; the approximate primer removal threshold is 16-22 mJ. Index 25 - 29 aimed to determine if multiple pulses could achieve the same quality of primer removal as a single shot. The results indicate that this is not possible. At 13 mJ with 17 pulses (using burst mode), ablation is not achieved; burn marks are visibly apparent due to the high pulse count. Finally, Index 30-33 are all taken at 14 mJ with 1 pulse. The ablated regions show a fairly identical spot pattern; each spot is a small ablated mark that is less than 1 mm in diameter.

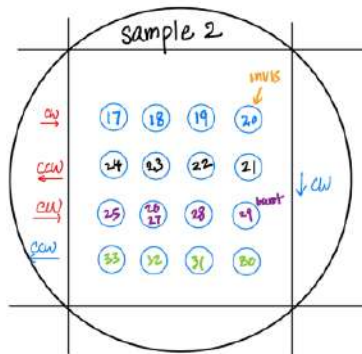
**Fig. 15:** Tempest: Sample 2 Spot Map

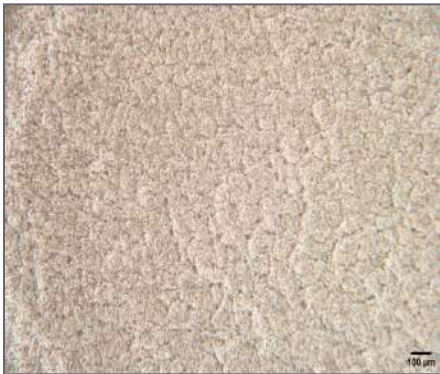
**Fig. 17:** Index 1: 250 mJ - 1 pulse

The images shown in Figure 17 to 20 are taken at 5x magnification. These images show common damage mechanisms during laser ablation. For example, thermal damage such as burn marks, resolidification, surface waves, and newly formed ridges can be seen in the images.

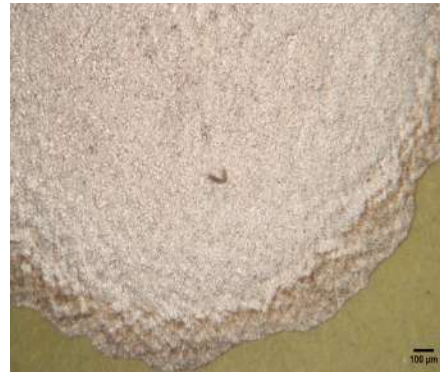
**Fig. 18:** Index 4: 250 mJ - 4 pulses

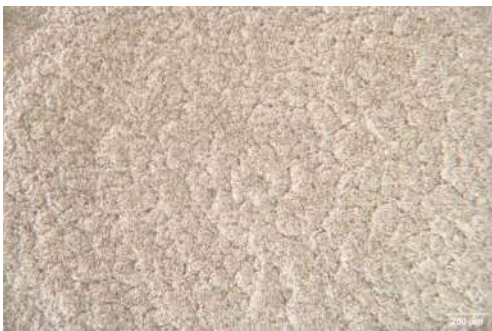
**Fig. 19:** 175 mJ

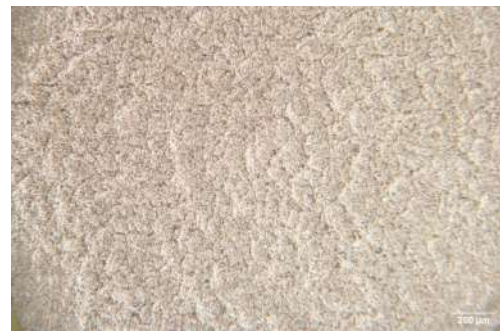
**Fig. 20:** 130 mJ

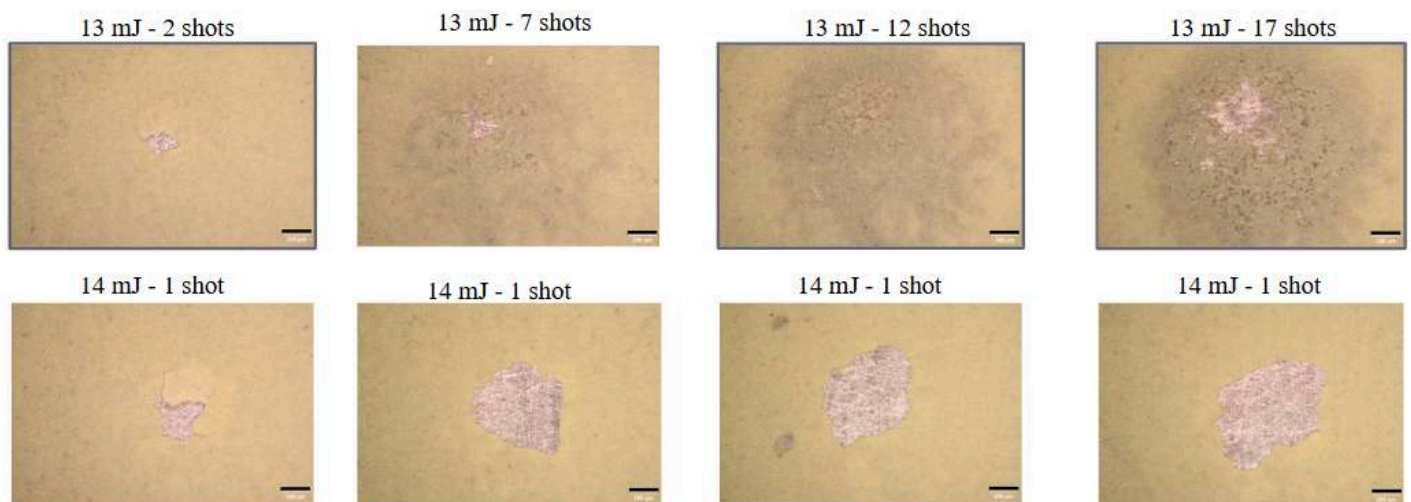
In Figure 22, the optical microscopy of the low energy pulses can be seen. The scale bar is located in the bottom right and reads 200  $\mu\text{m}$ . These images support that multiple pulses do not sufficiently remove the primer coating. At 13 mJ and 17 pulses, a severe burn mark is observed on the surface and the substrate can be seen partially. At 14 mJ and 1 shot, peeling and cracking of the primer can be seen.

**Fig. 22:** Optical Microscopy of Tempest laser ablation

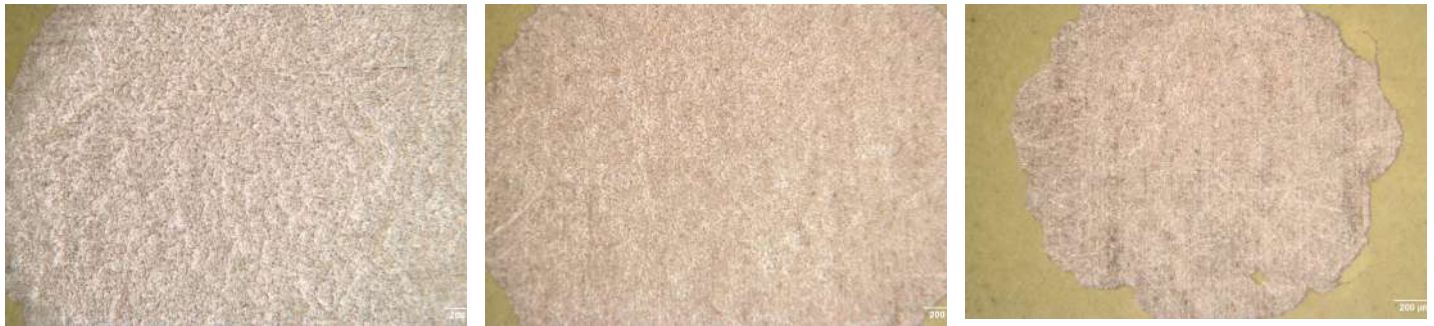
induced by the laser. Additionally, at high energies, re-solidification and substrate damage is visible; at lower energies, paint peeling and cracking is observed. Figure 23 displays three optical images that represent various mechanisms during laser ablation. The scale bar is located in the bottom right and reads 200  $\mu\text{m}$ .

85 mJ - Resolidification

55 mJ - Ideal shot

25 mJ - Peeling on bottom right

**Fig. 23:** Optical Images showing range of laser energies

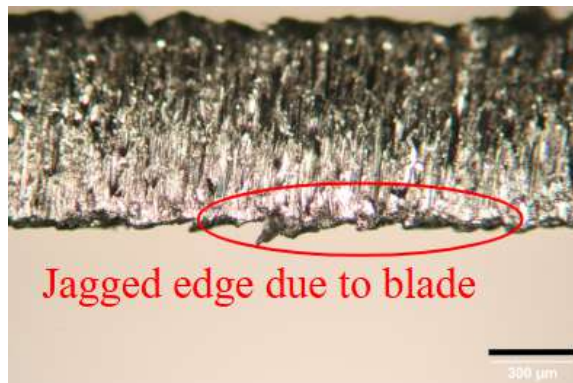
**Fig. 24:** Cross-section at 250 mJ , 3 pulse

As seen in Figure 24-27, the ductility of the Aluminum substrate raised some challenges while cutting. The scale bar is located in the bottom right and reads 300  $\mu\text{m}$ . The figures do not show noticeable cracking or significant deformation in the Aluminum substrate. The sample seems largely intact even at high energies, as seen by Figure 25.

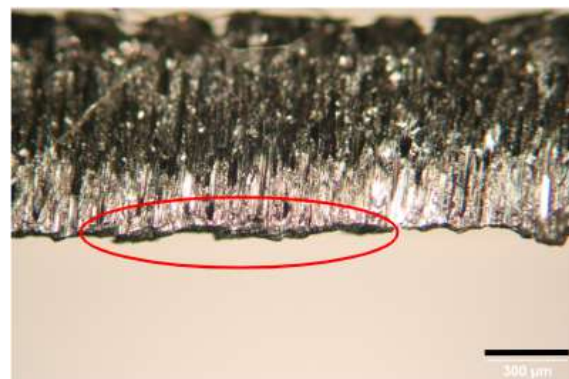
**Fig. 25:** Cross-section at 250 mJ , 4 pulse

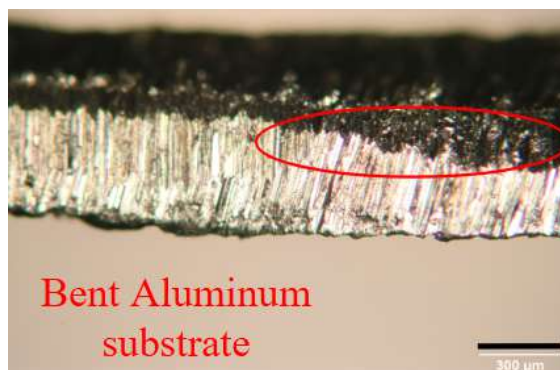
**Fig. 26:** Cross-section at 85 mJ

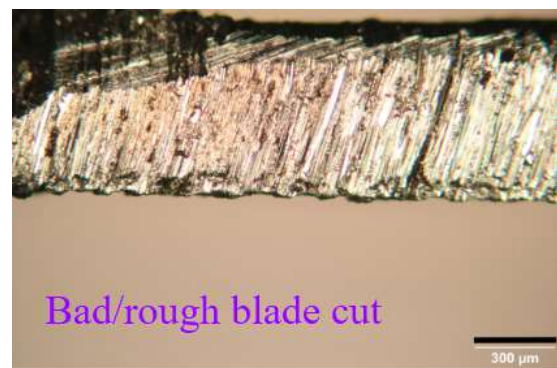
**Fig. 27:** Cross-section at 100 mJ

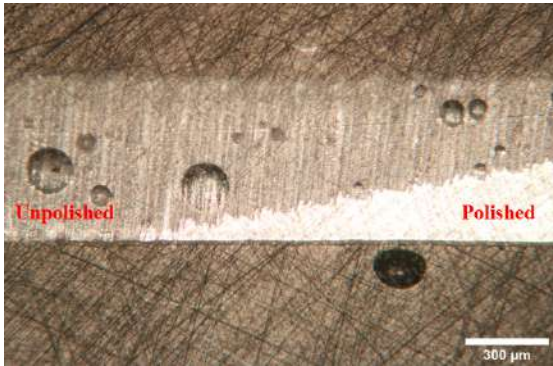
**Fig. 28:** Aluminum Control Sample (5x)

Due to the rough cutting from the low-speed saw, the polishing of the Aluminum pucks posed a challenge. The sample surfaces were uneven and jagged causing non-uniform polishing across the sample. Figure 28 shows the Aluminum Control sample that had both polished and unpolished regions. Figure 29 shows the 12-20  $\mu\text{m}$  primer coating that was applied to the substrate. Figure 30 and 31 show 20x magnification images of the primer coating on an unpolished Aluminum. As seen in Figure 28, a properly polished surface is apparent due to the reflectivity and high color contrast of the Aluminum.

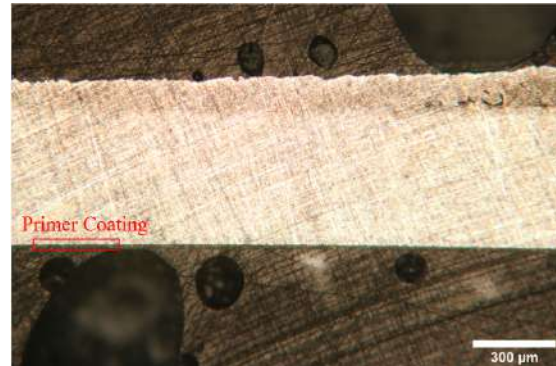
**Fig. 29:** Primer coating on Al substrate (5x)

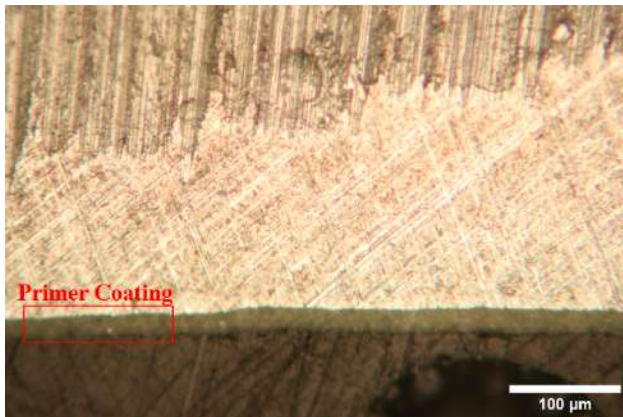
**Fig. 30:** Unpolished Al Control Sample (20x)

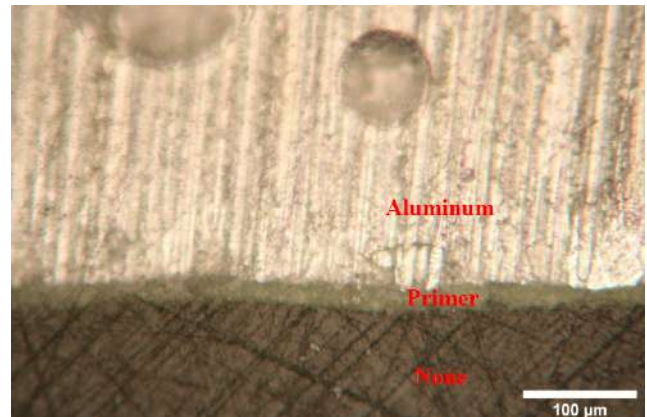
**Fig. 31:** Unpolished Al Control Sample layers (20x)

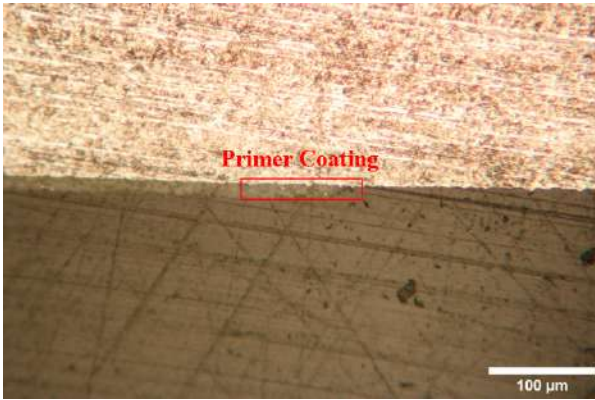
**Fig. 32:** Index #16, Left Side of Shot (20x)

The Tempest Sample 1, Row 5 puck was partially polished and imaging was done to display the removal of the primer coating. Figure 32 and 33 display the unpolished left and right side of the ablated spot. As seen by the images, the primer coating is clearly observed until the ablated spot; in the ablated region, the primer is completely removed.

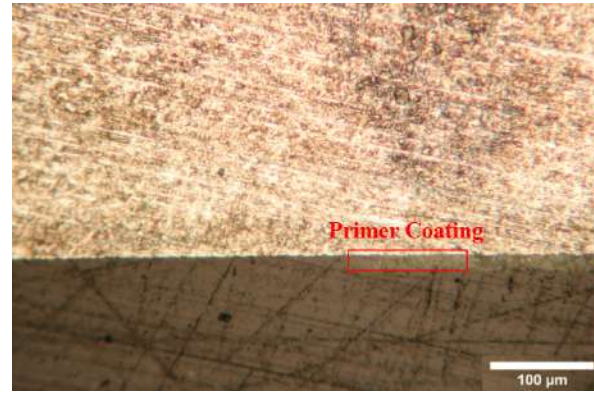
**Fig. 33:** Index #16, Right Side of Shot (20x)

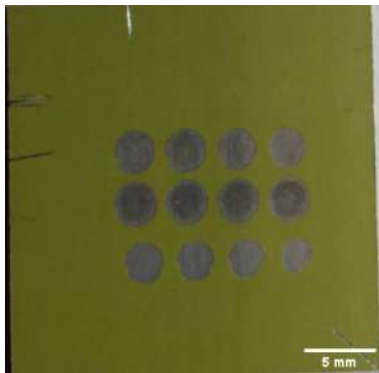
**Fig. 34:** Leopard Sample

The Leopard laser was used to test a single sample of Aluminum with the BMS 10-103 primer coating. A total of eight laser energies were tested on the sample; each laser energy was tested twice which yielded 16 individual ablation spots. The sample tested on the Leopard can be seen in Figure 34; the corresponding Leopard Sample Spot Map can be seen in Figure 35. A table of the test parameters can be seen in Figure 36. Each index value in Figure 36, corresponds to the value written in Figure 35.

As observed by Figure 34, from 2.8 to 15.2 mJ the ablated spot is nearly invisible. At 15.2 mJ a faint mark can be seen on the ablated spot however the energy was not sufficient to fully remove the primer. At 77 to 155 mJ (Index 5-8), the primer coating is removed. Specifically, 155 mJ shows darkened burn spots in the center of the ablated region; these burns are much less apparent on the 77 mJ spots. From 220 to 245 mJ (Index 9-12), the most severe damage is seen; the spot size is approximately 3.5 mm. Finally, from 23.5 to 61 mJ (Index 13-16), the ablation marks do not show significant damage to the substrate. However, at 23.5 and 35 mJ, bits of primer coating could be seen flying off the sample as the laser made contact. Additionally, it can be observed that the Leopard spot diameter is irregular for all index values.

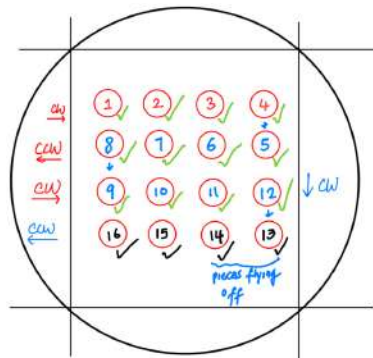
**Fig. 35:** Leopard: Sample Spot Map

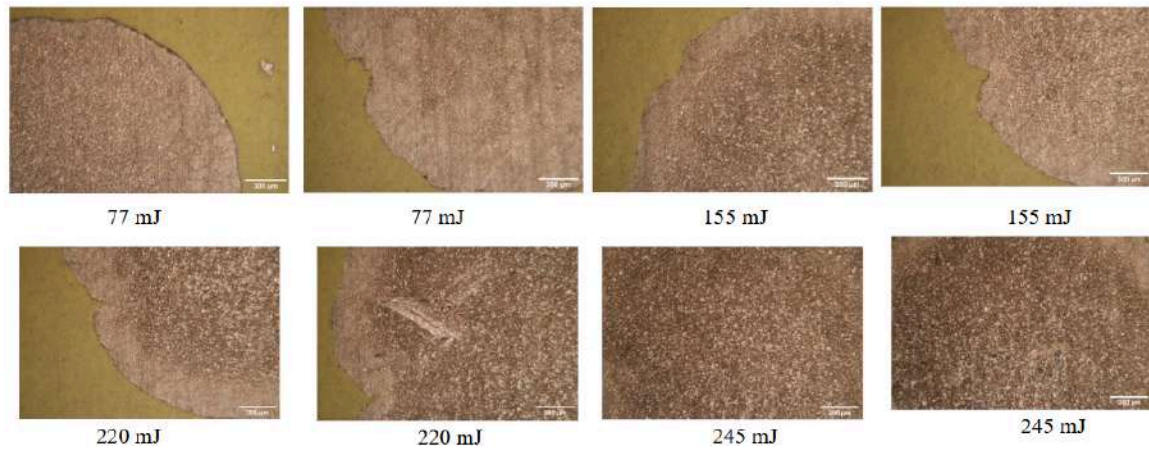
**Fig. 38:** High energy optical images of laser spots using Leopard (5x)

Figure 37 and 38 display optical images taken of all the laser spots. The scale bar is located in the bottom right and reads 300 μm. The images show common damage mechanisms during laser ablation. Similar to the tempest images, thermal damage such as burn marks, resolidification, surface waves, and newly formed ridges can be seen.

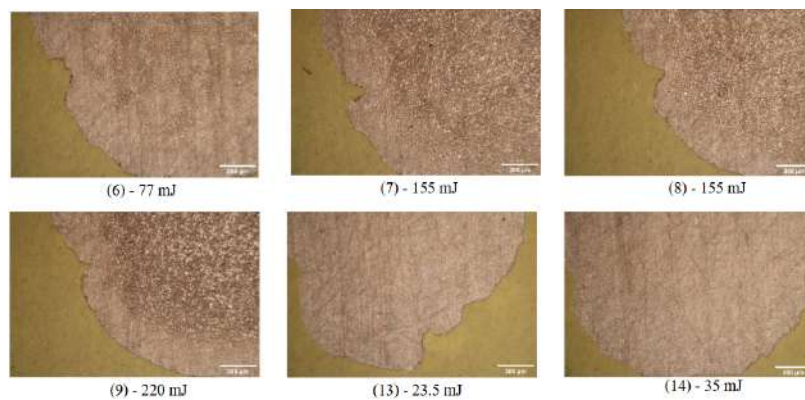
Figure 39 displays the consistent irregular spot size that appeared across all tests. The irregularity is most likely due to the variation of laser energy within the laser pulse. The laser beam has a Gaussian energy profile, meaning the energy is highest at the center and gradually decreases toward the edges. This can lead to uneven ablation and irregular spot shapes depending on slight fluctuations in pulse energy or beam alignment.

**Fig. 39:** Irregular laser spots using Leopard (5x)

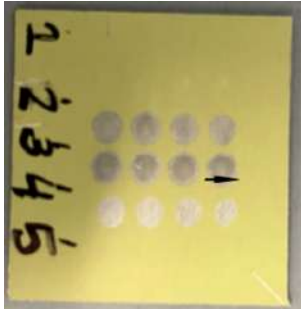
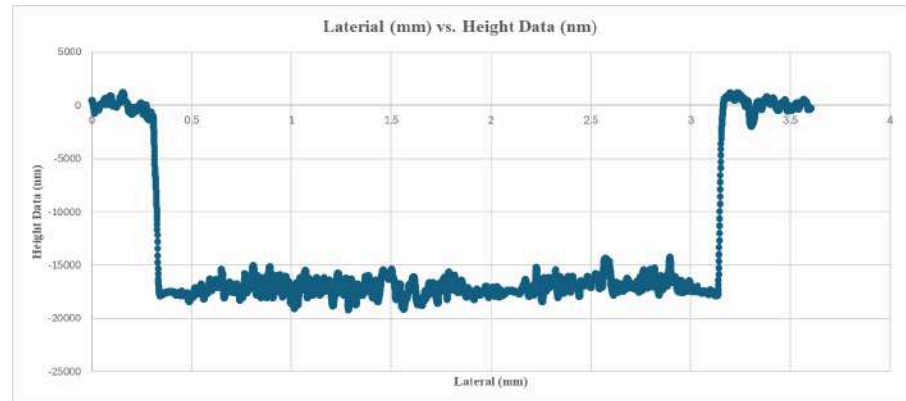
A surface profilometer was used to examine the surface profile of the ablated spots. The profile scans were done three times and the average of the 3 runs were plotted. Figure 40 displays the surface profilometry of the highest energy laser shot. At 245 mJ, the surface profile seems to be highly irregular. The spot size is approximately 2.9 mm.

**Fig. 40:** Surface profile of 245 mJ ablation spot (Index #12)

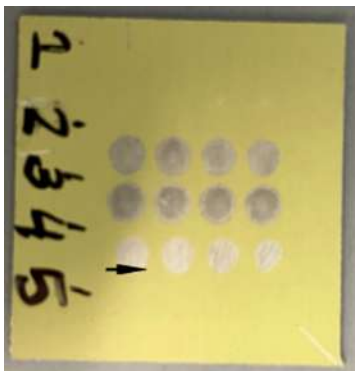
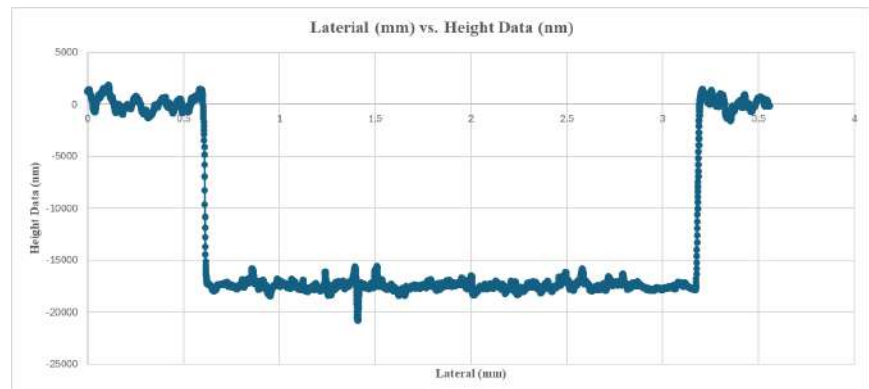
Figure 41 displays the surface profilometry at a moderate laser energy; the ablated spot does not have severe resolidification or thermal damage. As a result, the profile scan seems to be more steady. The spot size is approximately 2.55 mm.

**Fig. 41:** Surface profile of 61 mJ ablation spot (Index #16)

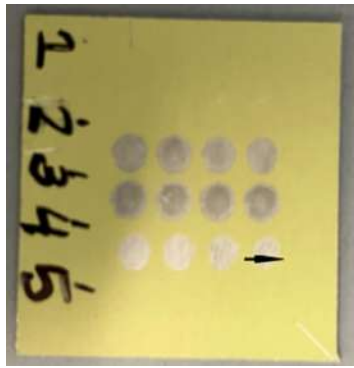
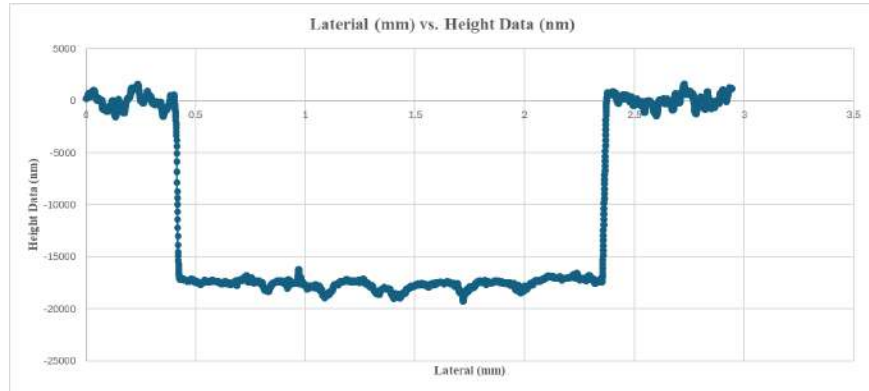
Figure 42 displays the surface profilometry of a very low energy laser shot. At 23.5 mJ, the spot is not fully ablated and it is unlikely that any significant damage occurred on the substrate. For this reason, the surface scan is very smooth. The spot size is approximately 1.95 mm.

**Fig. 42:** Surface profile of 23.5 mJ ablation spot (Index #13)

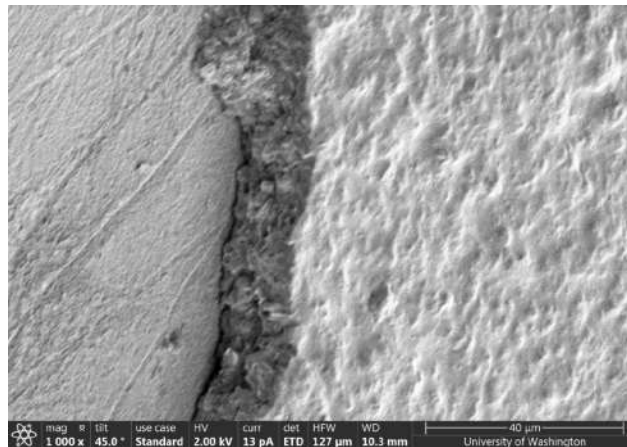
SEM imaging was done on two ablated spots to determine the surface morphology and assess the extent of material removal, melting, or redeposition resulting from the laser ablation process. Figure 43 displays an SEM image of the ablation spot generated at the highest laser energy setting of 245 mJ. The image captures the lower half of the spot, revealing both the primer coating and the underlying aluminum substrate. The primer surface appears rough and uneven, with areas of surface texture possibly resulting from thermal effects or partial material removal. In contrast, the exposed aluminum surface is smooth, with no significant defects or damage visible; this could indicate minimal impact from the ablation at the metal interface.

**Fig. 43:** SEM image of 245 mJ ablation spot (Index #12) - 1000x

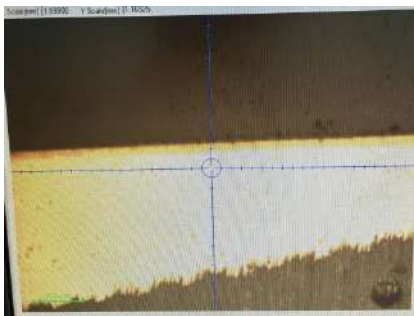
**Fig. 45:** Location of indent in bulk Al alloy layer

In order to characterize baseline results, the Aluminum control sample was tested first. Due to the cladding layer that sits below the primer coating, the nanoindentation was done on the inner bulk layer. This is meant to ensure that all values reported are from the deeper Aluminum alloy. For the initial indent, the approximate peak load forces are not known to achieve a proper indent. For this reason, a range of force values from 5000  $\mu\text{N}$  to 500  $\mu\text{N}$  were tested. Figure 45 displays the location of the indent in the Aluminum substrate. Figure 46 represents the location of the six nanoindents made in the specified region. Figure 47 shows the table that corresponds to each indent index.

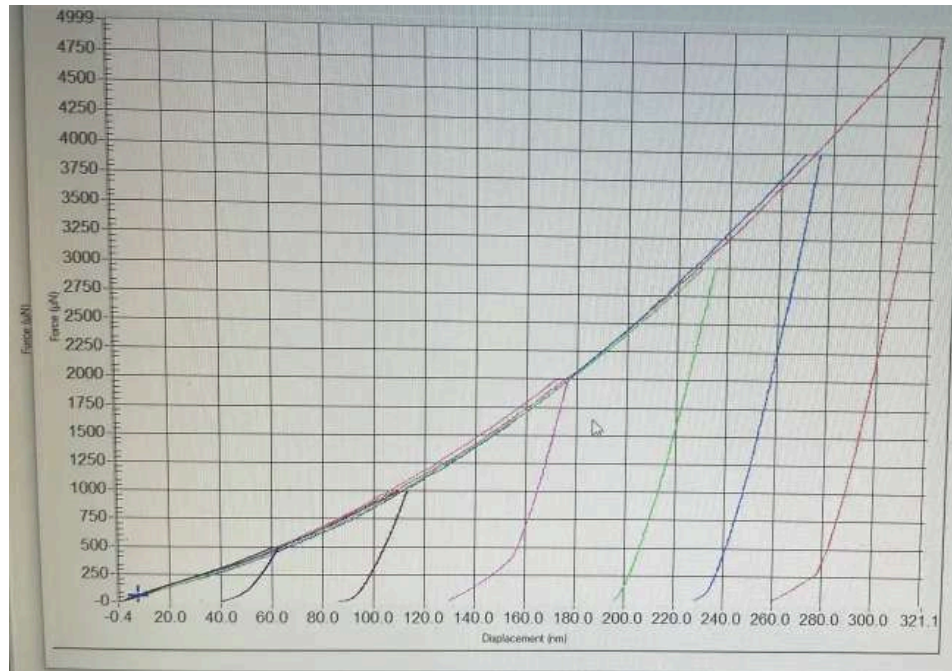
**Fig. 48:** Force (uN) vs. Displacement (nm) for indents ranging from 5000 to 500 uN

Figure 48 shows the force versus deformation curves which approximates the indent depth for each test. The indent depth ranges from 40 to 280 nanometers. The results across the range of forces should be consistent and the deformation curves should be well-aligned. Figure 48 displays consistent results across all the indents.

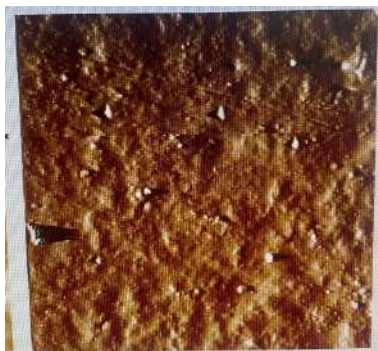
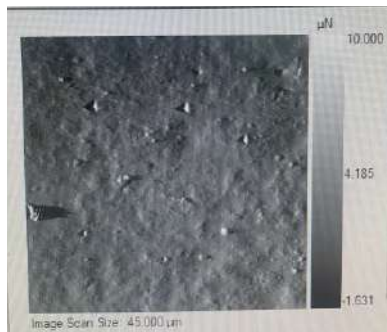
Figure 49 and 50 display the image scans after the six nanoindents were completed. The image scan size is 45  $\mu\text{m}$  by 45  $\mu\text{m}$ . The indents do not show any non-ideal characteristics such as pile-up or sink-in. Additionally, the indents are well-spaced apart from each other.

**Fig. 49:** Scan of six nanoindents (*upper*)

**Fig. 50:** Gray-scale scan of six nanoindents (*lower*)

The results of the indentations can be seen in Figure 51. As seen from Figure 50 and the results table, the 500

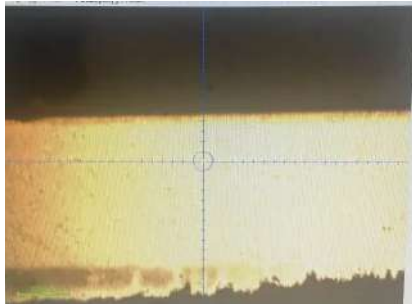
**Fig. 52:** Location of indent in bulk Al alloy layer

Further control testing was carried out to ensure repeatable results. A total of 9 indents were made on the bulk Aluminum alloy region of the sample; three different force values were tested. Figure 52 displays the location of the indent in the Aluminum substrate. Figure 53 represents the location of the nine nanoindents made in the specified region. Figure 54 shows the table that corresponds to each indent index.

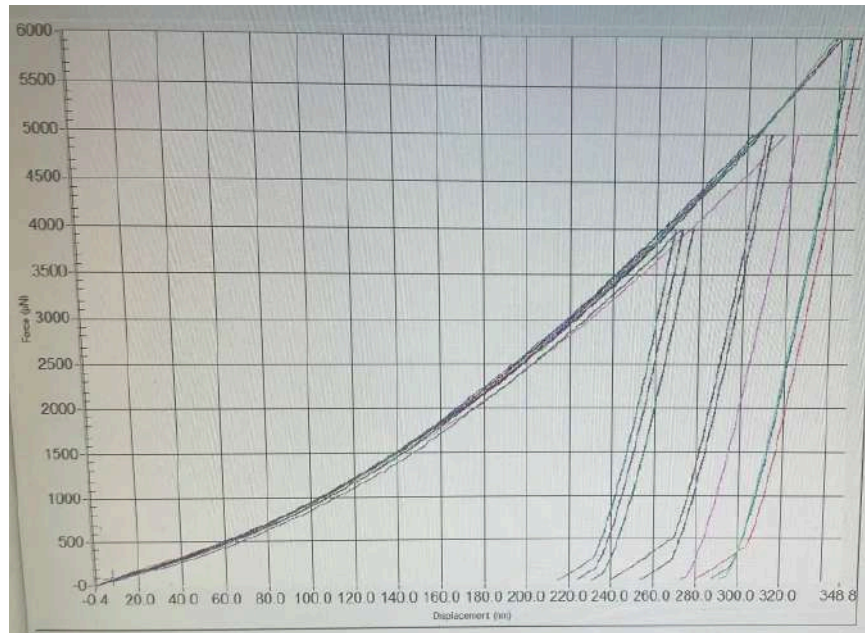
**Fig. 55:** Force (uN) vs. Displacement (nm) for indents ranging from 5000 to 500 uN

Figure 55 displays consistent results across all the indents. The approximate indent depth ranges from 220 to 300 nanometers.

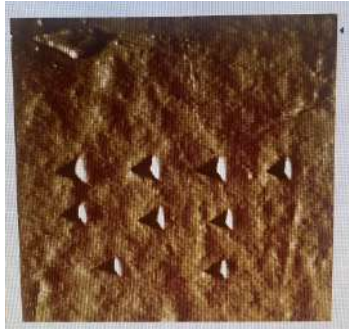
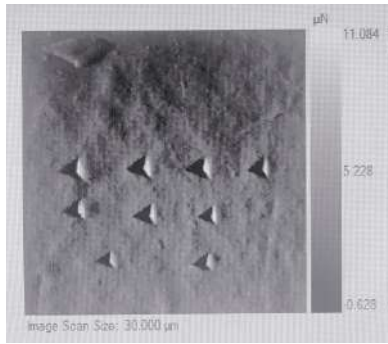
Figure 56 and 57 display the image scan after the nine nano indents were completed. The indents do not show any non-ideal characteristics. The sample surface is smooth and there are no noticeable defects that could skew the results.

**Fig. 56:** Scan of nine nanoindents (*upper*)

**Fig. 57:** Gray-scale scan of nine nanoindents (*lower*)

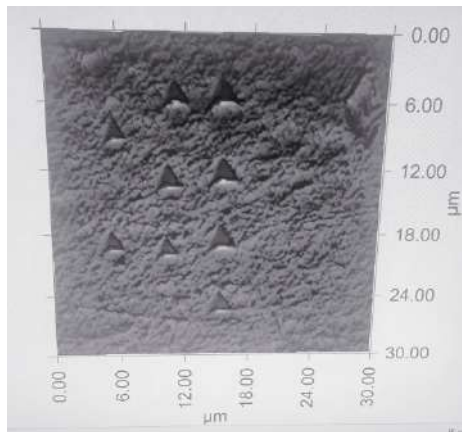
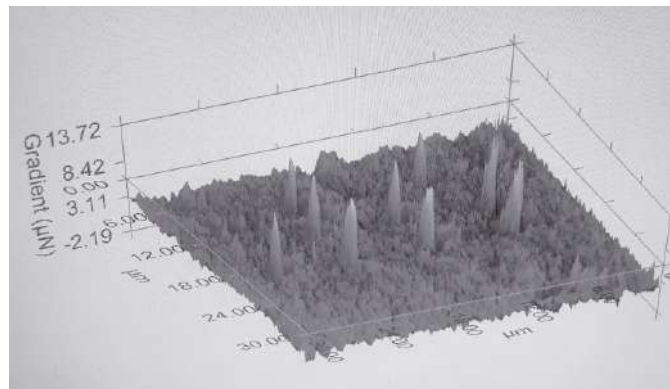
**Fig. 59:** 3D Image of Indentation (*Top View*)

**Fig. 60:** 3D Image of Indentation (*Isometric*)

The summary of output values from the second control test can be seen in Figure 58. Figure 59 and 60 represent 3D scans of the surface that was indented. The results from all control testing show an average reduced modulus of 74.95 GPa and a standard deviation of 3.99 GPa. Across all control tests, the average hardness value was 1.643 GPa with a standard deviation of 0.090 GPa.

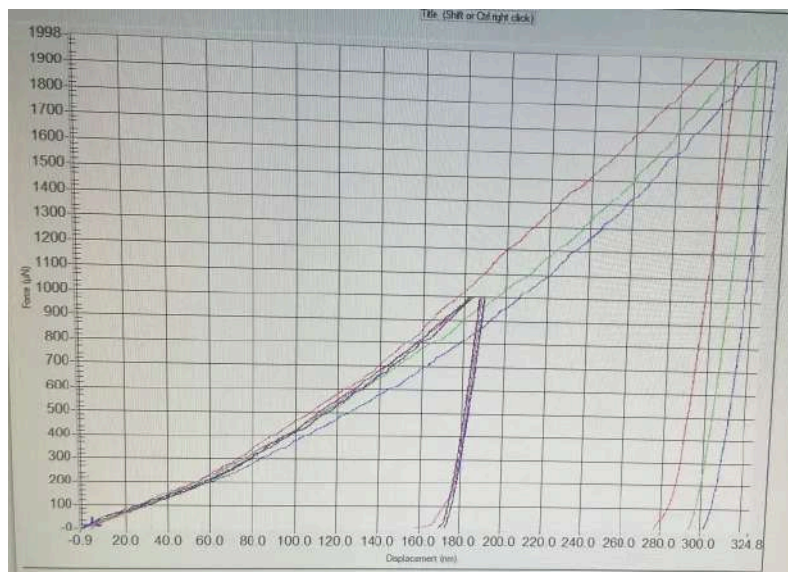
**Fig. 64:** Force (uN) vs. Displacement (nm) for indents ranging from 2000 to 1000 uN

Figure 64 shows that at 1000 uN, the approximate indent depth is 170 nm and at 2000 uN the approximate indent depth is 290 nm. The lines generated at 2000 uN are skewed and do not align.

An additional test (Test 2) was done at 1000 uN and the complete summary of all results can be seen in Figure 67. Due to the poor load-displacement curves at 2000 uN, the average and standard deviation values reported are for only the 1000 uN results\*\*.

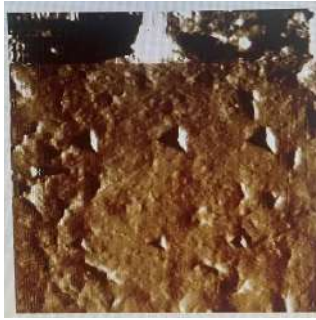
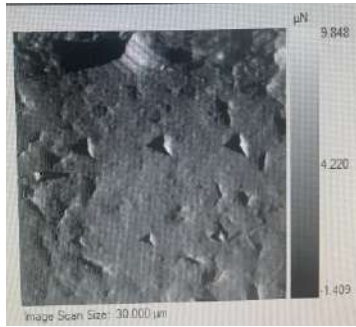
Figure 65 and 66 display the location of the six indents made on the surface. The 1000 uN indents seem very small however they do not indicate sink-in is occurring.

**Fig. 65:** Scan of six nanoindentations (*upper*)  
**Fig. 66:** Gray-scale scan of six nanoindentations (*lower*)

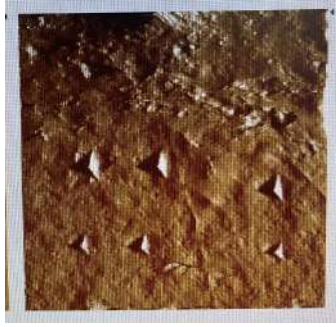
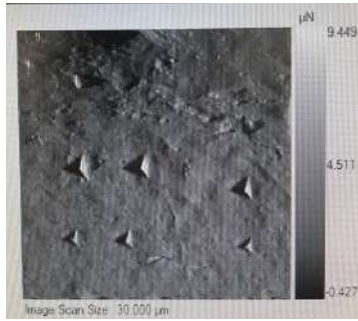
The nanoindenter image scans of the six indents can be seen in Figure 72 and 73.

**Fig. 72:** Scan of six nanoindentations (*upper*)  
**Fig. 73:** Gray-scale scan of six nanoindentations (*lower*)

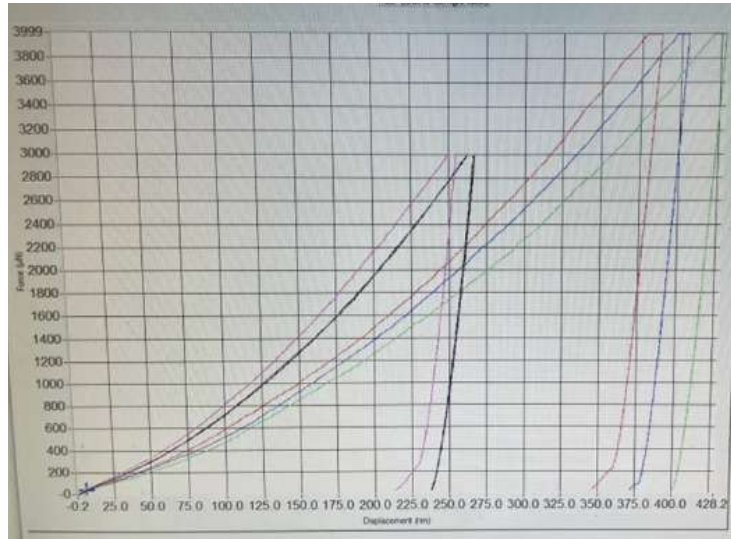
**Fig. 75:** Force (uN) vs. Displacement (nm) for indents ranging from 4000 to 3000 uN

Further nanoindentation was carried out on Tempest Sample 1, Row 5. Specifically, the mechanical properties of a 100 mJ (Index #14) shot was examined. At this energy, the spot size remains at approximately 3 mm and no significant morphological changes are observed. At this energy, it is possible to carry out laser ablation without damage to the substrate. The sample was tested just below the primer layer to determine the mechanical properties near the cladded region. The challenge of misaligned load-displacement curves was also seen; this can be seen in Figure 75. For this reason, it is recommended that further testing is carried out. Figure 76 shows the preliminary nanoindentation results.

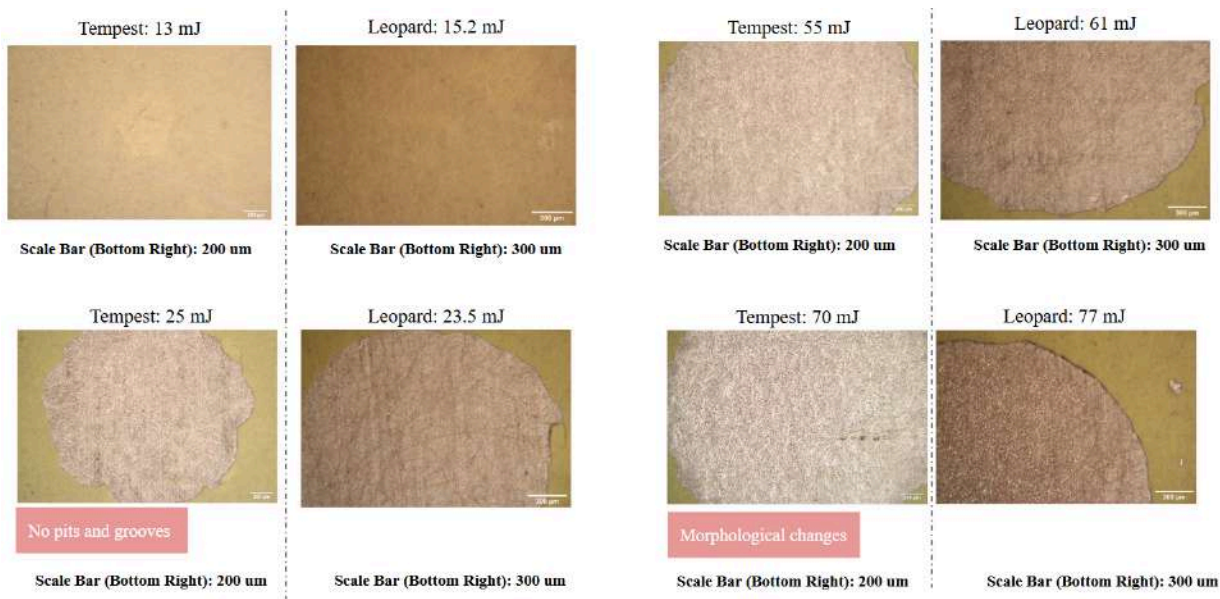
**Fig. 77:** Side-by-side: Tempest vs. Leopard Ablation Thresholds

The optical imaging of the Tempest sample and the Leopard sample showed similar damage mechanisms. Additionally, the ablation threshold for both lasers aligned very closely. A side by side comparison of the Tempest and Leopard ablation sites can be seen in Figure 77 and 78. As seen in Figure 77, at 13 to 15.2 mJ, the primer coating was not ablated. Due to the lower laser energy, the substrate remains largely intact. At 23.5 to 25 mJ the primer is fully ablated; no pits or grooves can be seen on the surface and the both spot sizes remain comparable. The spot size of the Tempest 25 mJ shot is 1.65 mm; the spot size of the Leopard 23.5 mJ shot is 1.98 mm. At 55-61 mJ, the surface profile is regular and no significant defects can be seen. However, at 70-77 mJ, substrate resolidification and remelting can be observed for both the Tempest and the Leopard.

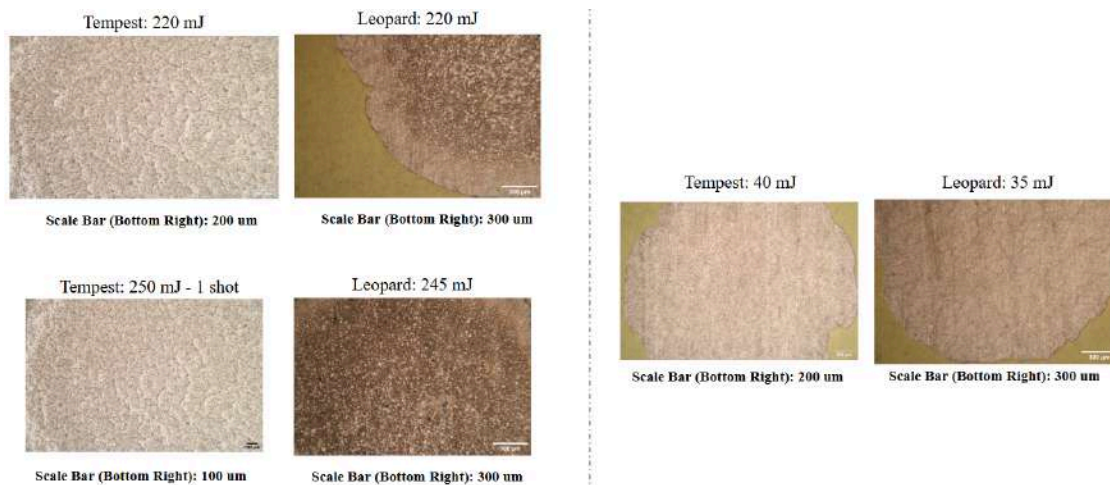
**Fig. 78:** Side-by-side: Tempest vs. Leopard Ablation Spots

In Figure 78, the higher energy laser shots can be seen. As the energy is raised above 220 mJ, for both lasers, significant burn marks and surface irregularities can be observed.

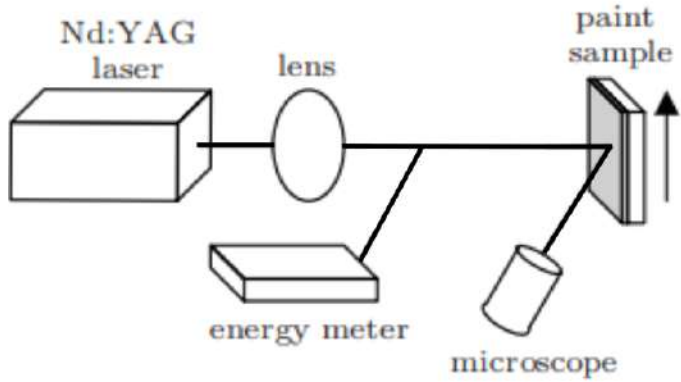
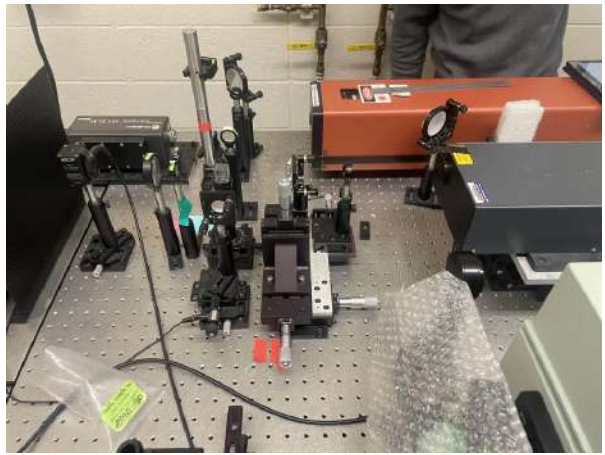
A simplified test setup diagram for the Tempest Laser can be seen in Figure 79. The actual test setup can be seen in Figure 80.

<p><b>Fig. 79:</b> Simplified experimental setup for paint removal, energy measurement</p>	<p><b>Fig. 80:</b> Actual setup of Q-switched Nd:YAG nanosecond laser system known as Tempest</p>

The Tempest Laser holds an energy range from 0 to 250 mJ. The laser shows consistent energy behavior with its first shot in burst mode. At higher energy levels, the first shot is generally about 10 mJ higher than intended. However, if shots are fired consecutively, with a 10-second pause between each, the energy stabilizes to the desired level. When using the burst mode setting at higher energies, the general uncertainty is  $\pm 5$  mJ. At lower energy levels (below 20 mJ), the first shot is consistently  $\sim 3$  mJ lower than intended, with energy rising to the target level after consecutive shots. When using the burst mode setting at higher energies, the general uncertainty is  $\pm 2.5$  mJ. Overall, the uncertainty of the energy output meter is  $+2$  mJ and  $-1$  mJ.

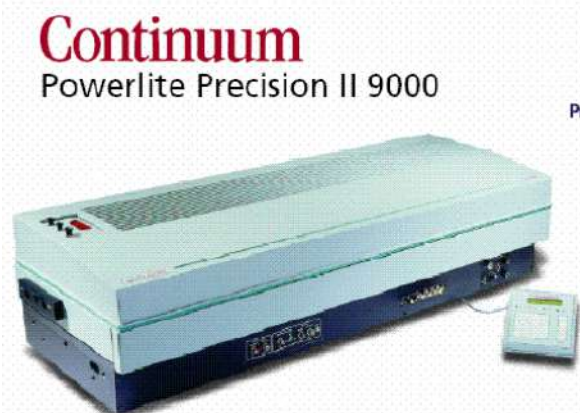
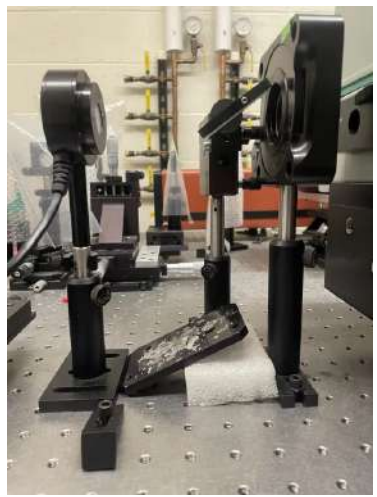
An image of the Leopard Laser used for testing can be seen in Figure 81. The test setup of the half-wave plate and power meter can be seen in Figure 82.

<p><b>Fig. 81:</b> Continuum Leopard SS-2 ps Nd:YAG picosecond laser system known as Leopard</p>	<p><b>Fig. 82:</b> Experimental setup of half-wave plate and power meter for energy control &amp; monitoring</p>

Prior to the experimental testing on Leopard, a calibration study was executed. The energy output was adjusted by rotating the half-wave plate from 0 to 360 degrees. An energy power meter was placed at the laser opening to display the output, each time the half-wave plate was rotated. The half-wave plate position used for testing was from 20 to 70 degrees. The energy output vs. half-wave plate position plot can be seen in Figure 83.
