Replace the defect TAC84 module

- **Explanation**
IN THE +AN1 CABINET:

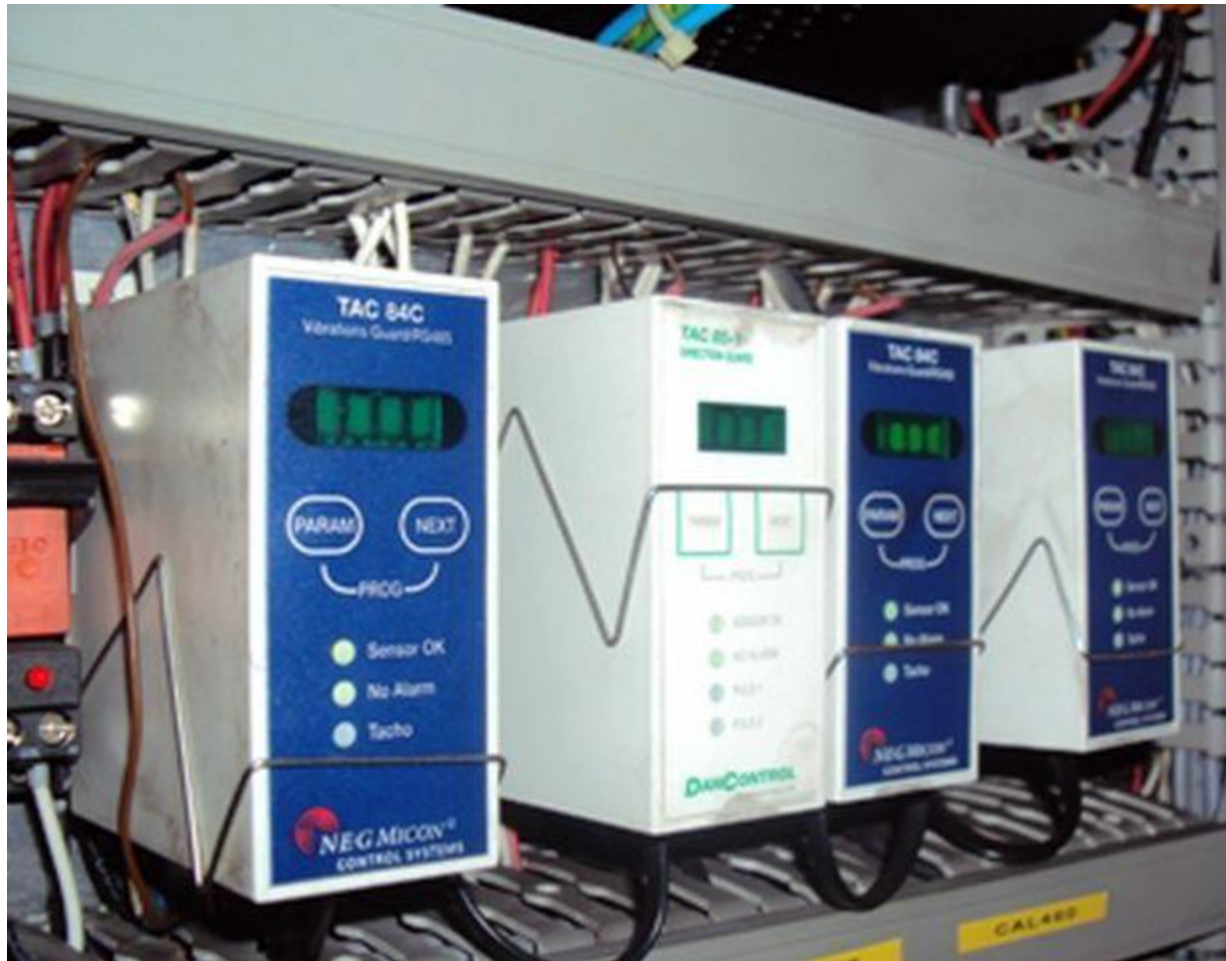
Vibration sensor and Speed Sensor signals Connected to TAC84

Check the TAC84 module parameters as per instruction

Settings for TAC 84 Edgewise blade vibrations & also refer TAC84 User manual.

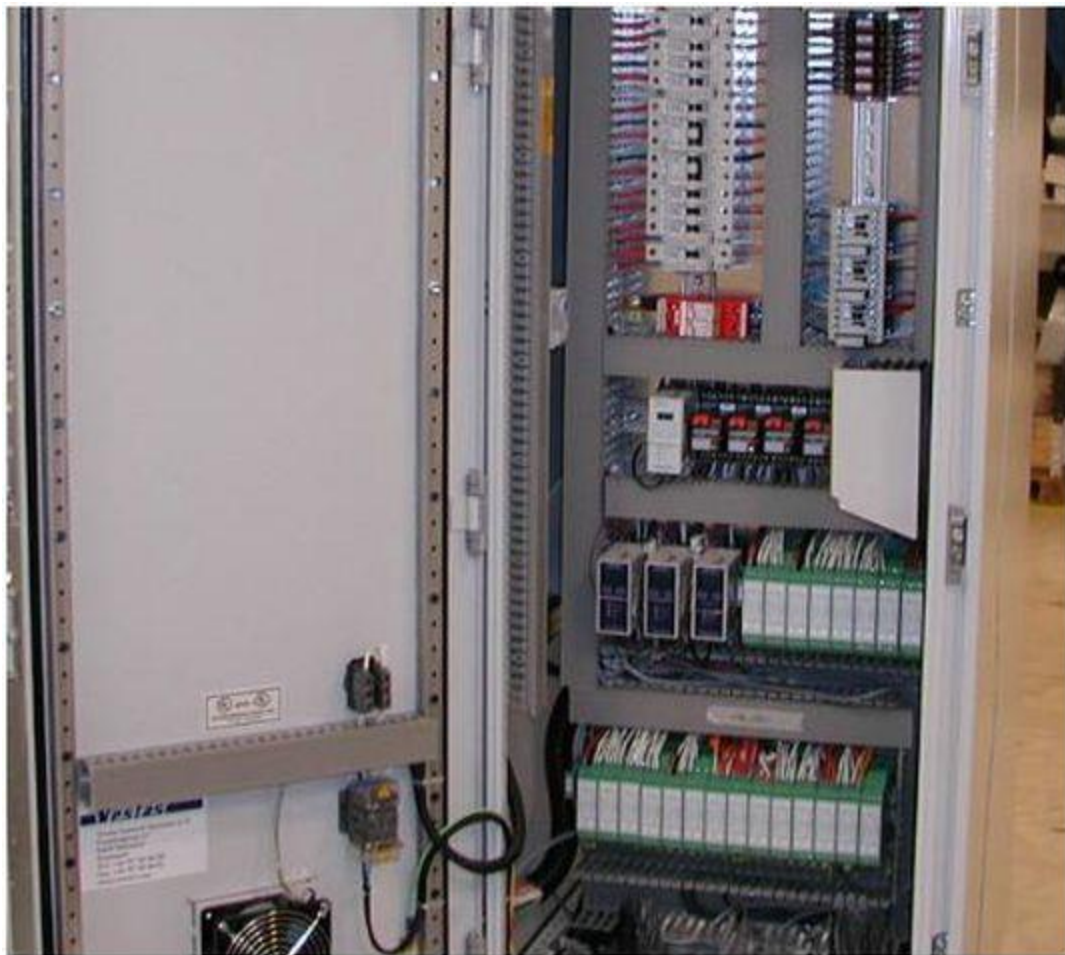
Check the TAC84 module for any loose connections:

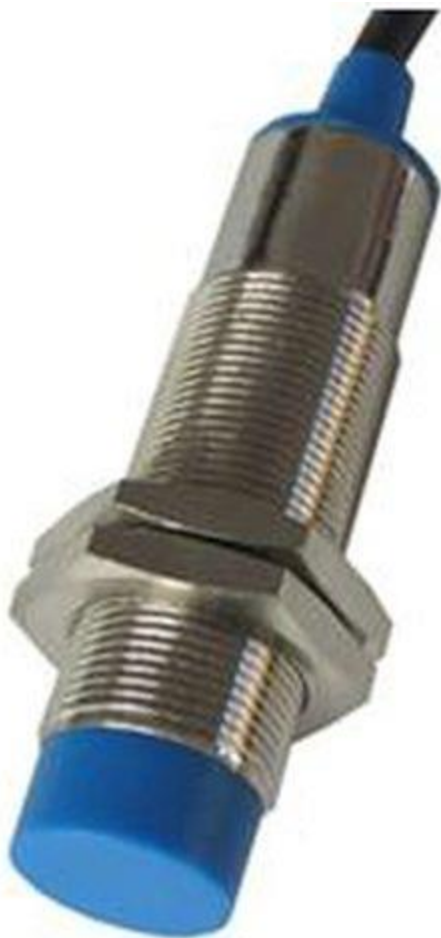
Using a screwdriver, pass the metal portion past the inductive sensors. The sensors should light up at the moment the screwdriver is passed over them.

If they do not, ensure that the sensors are free of dirt and oil/grease. Retry passing the screwdriver over the sensors at varying distances.

If only one of the sensors emits a light, the other is likely faulty or has a faulty cable.
