TF HOME INSPECTION

## TFHI RESIDENTIAL REPORT

1234 Main St. Union NJ 07083

07/21/2020 9:00AM

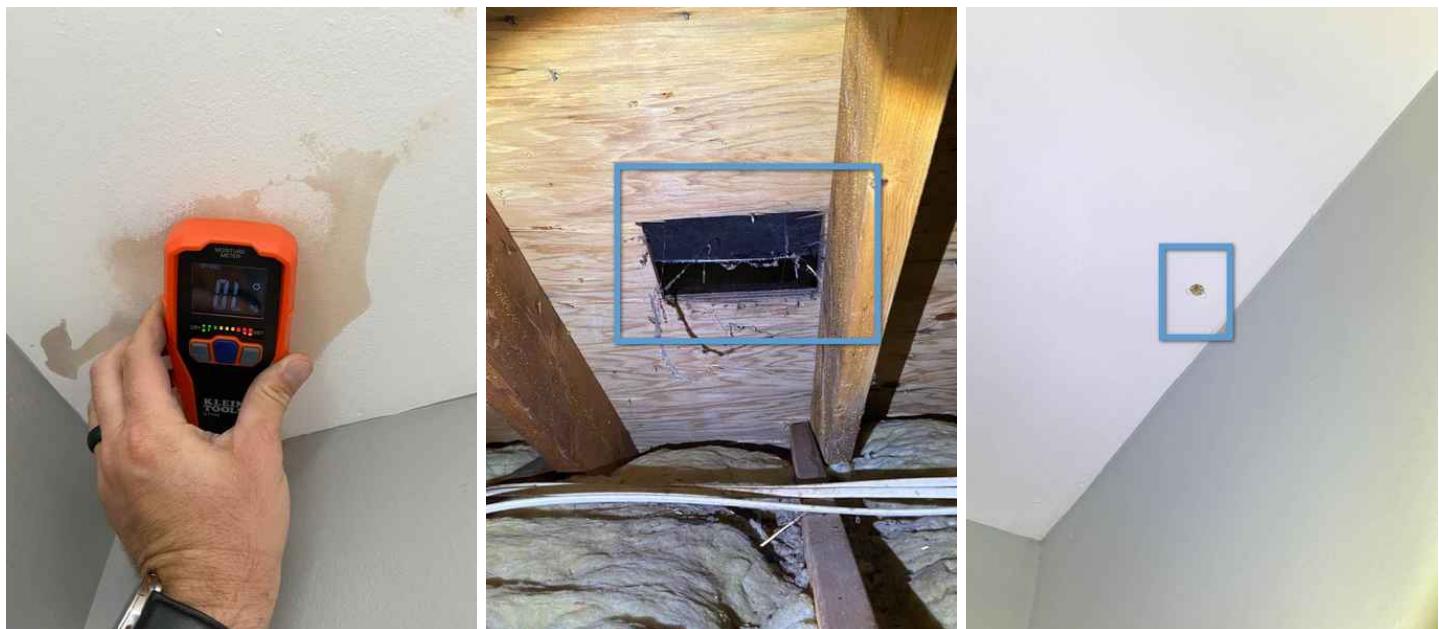
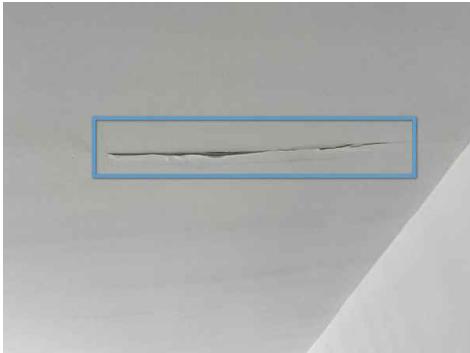
### 2.1.1 Coverings

#### LEAKING

The master bathroom and garage showed signs of moisture damage in the ceilings. The attic above the garage was inaccessible, however the attic space above the master bathroom was accessible. An area of roof sheathing was noted to be missing, and nails were driven through the roofing in these areas, likely causing leaks. A qualified licensed roofer should evaluate the roof above the master bathroom and garage and repair and replace all areas allowing moisture to penetrate the home.

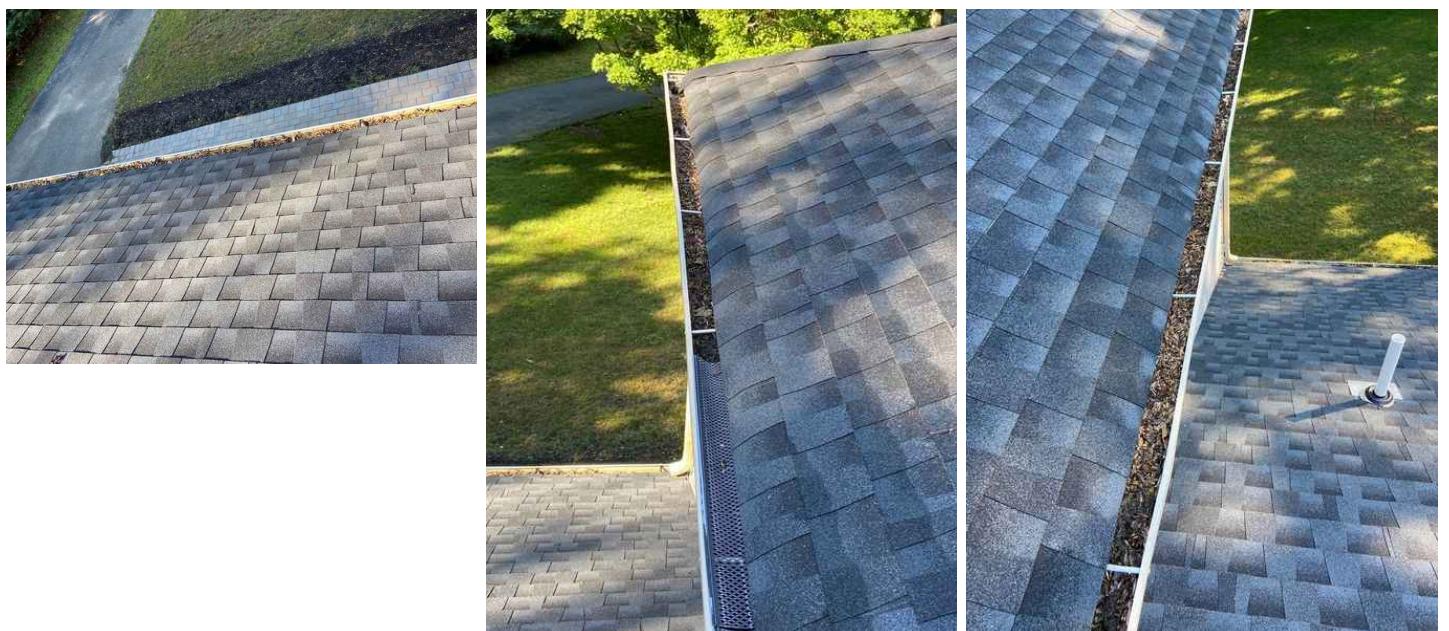
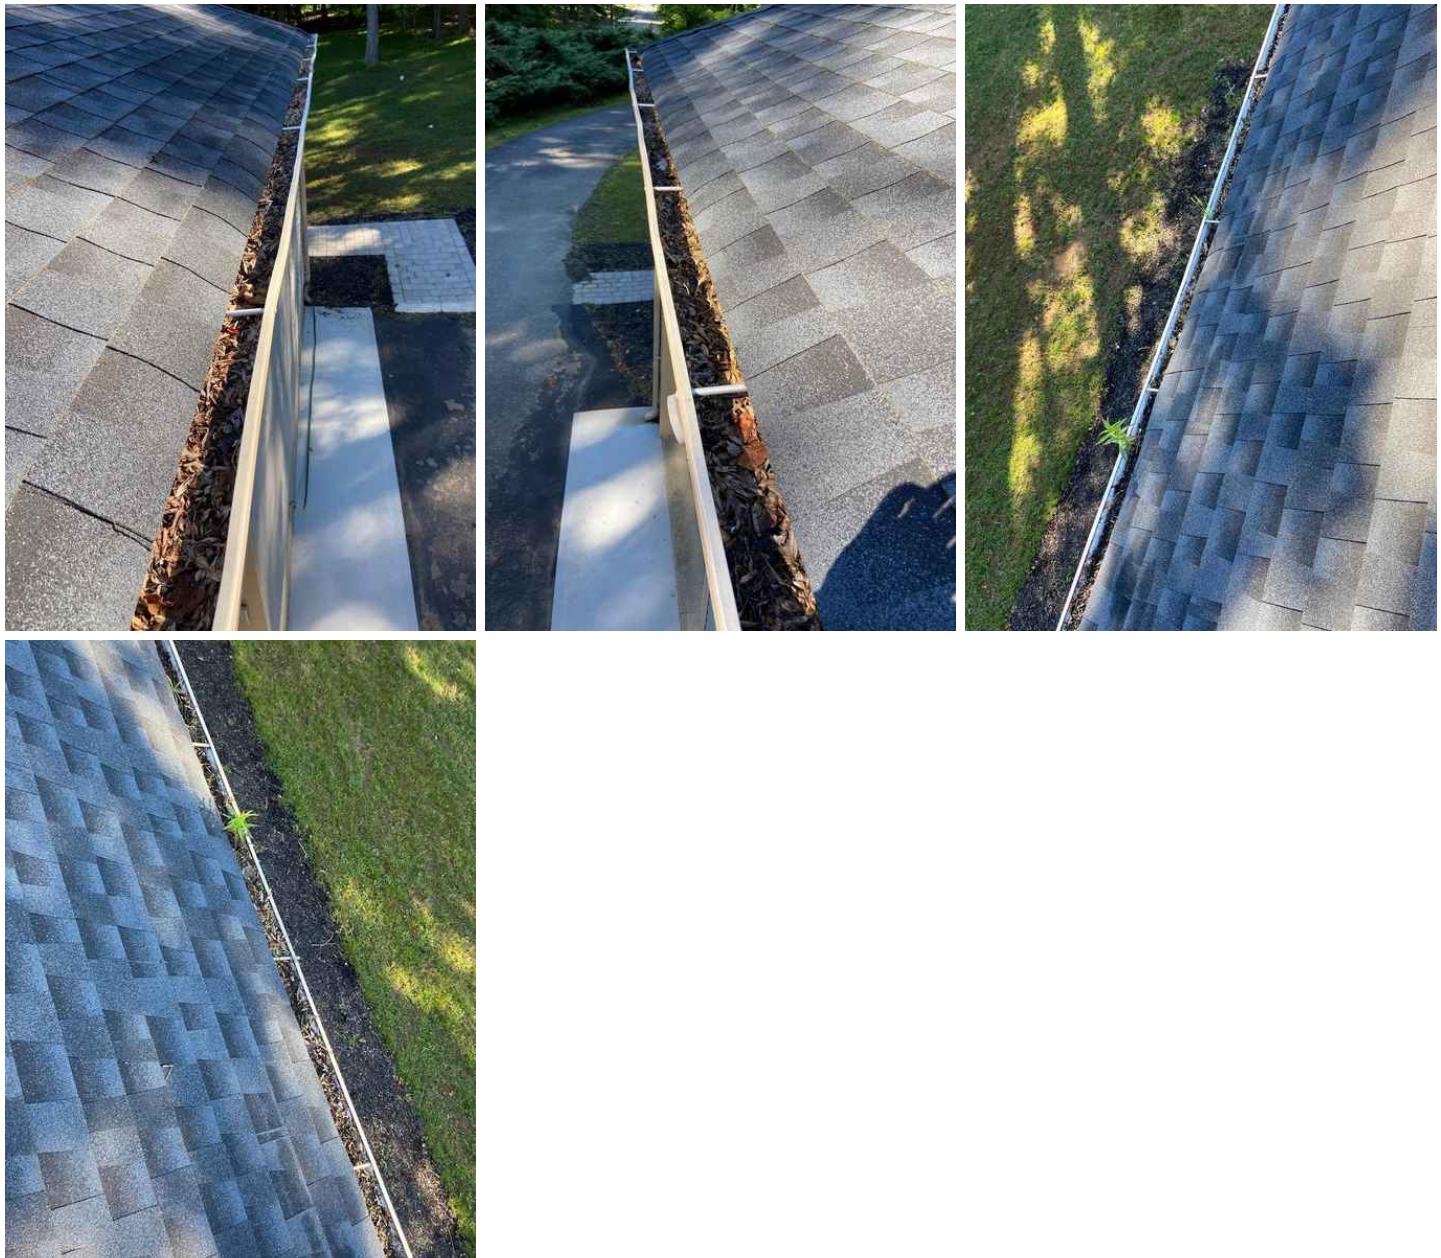
The gutters are full of debris in areas and need to be cleaned. The debris in gutters can also conceal rust, deterioration or leaks that are not visible until cleaned, and I am unable to determine if such conditions exist. A qualified licensed contractor should repair and replace as needed.

Contact a qualified professional.

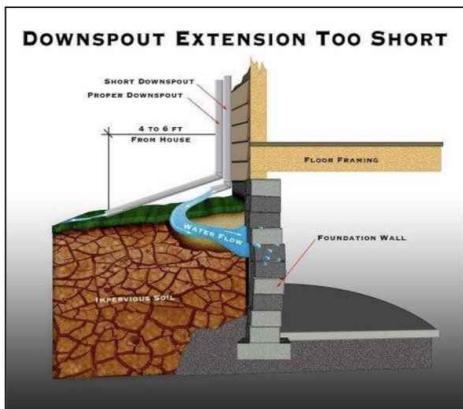
## 2.2.2 Roof Drainage Systems

### **DOWNSPOUTS DRAIN NEAR HOUSE**

The downspouts need an extension and or a buried drain line to carry water away from the home at the front, rear and sides of home. Having the downspouts terminate at such a short distance can allow for water to penetrate the basement during heavy rain. This can cause damage to the interior finishes of the basement and the foundation. I recommend a qualified licensed contractor repair or replace as needed.

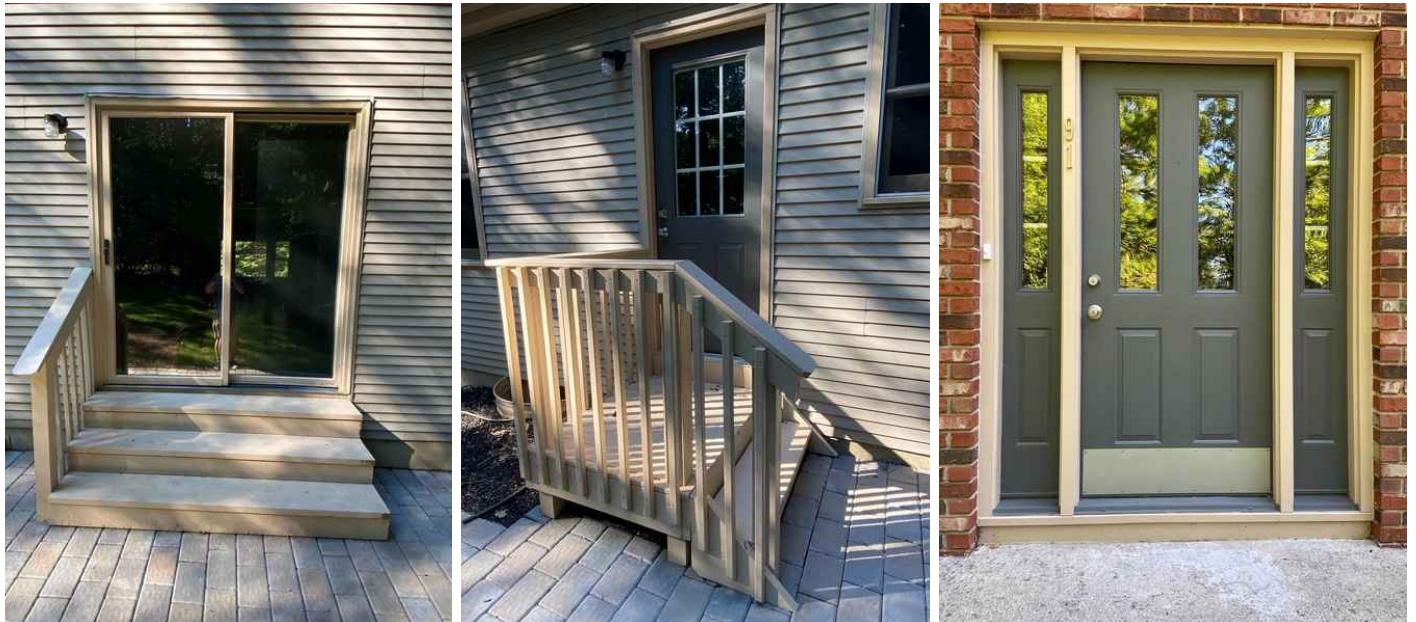
Check the condition of all exterior wall-covering materials and look for developing patterns of damage or deterioration.

Please be sure to keep all openings and cracks in the exterior surfacing material well sealed to prevent moisture entry to substrate materials.

Keep all holes and penetrations at siding sealed to prevent moisture entry to substrate.

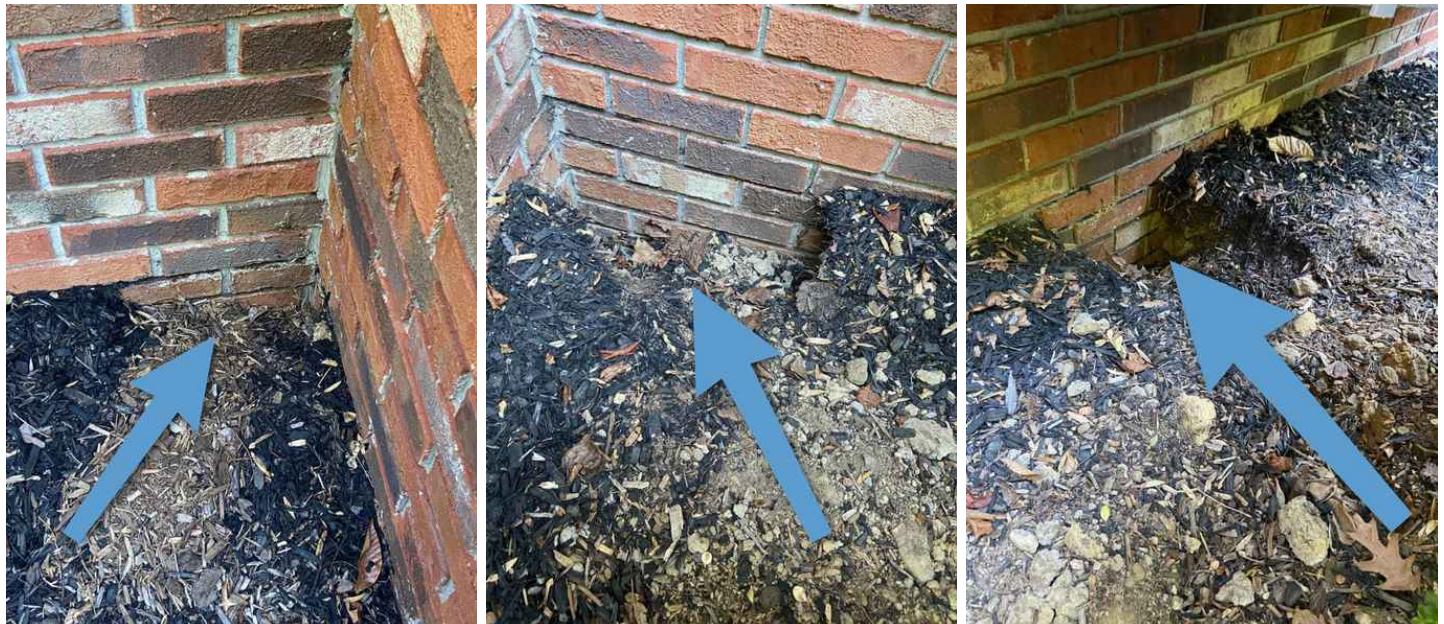
3.7.1 Vegetation, Grading, Drainage & Retaining Walls

### NEGATIVE GRADING

Grading is sloping towards the home in some areas. This could lead to water intrusion and foundation issues. The dirt below the mulch must be graded on a pitch away from the home. A qualified licensed contractor should repair as necessary.

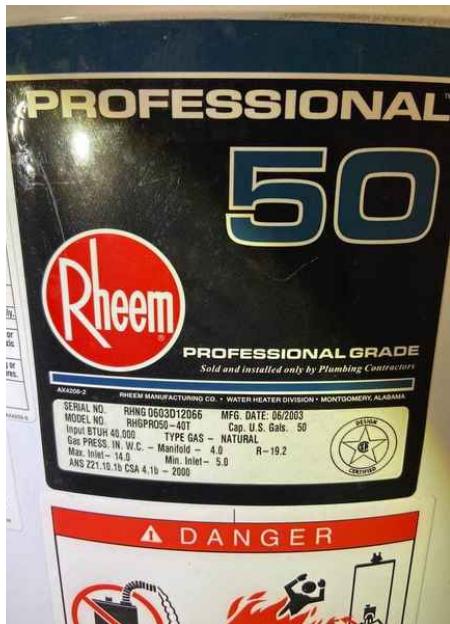
Rheem

I recommend flushing & servicing your water heater tank annually for optimal performance. Water temperature should be set to at least 120 degrees F to kill microbes and no higher than 130 degrees F to prevent scalding.

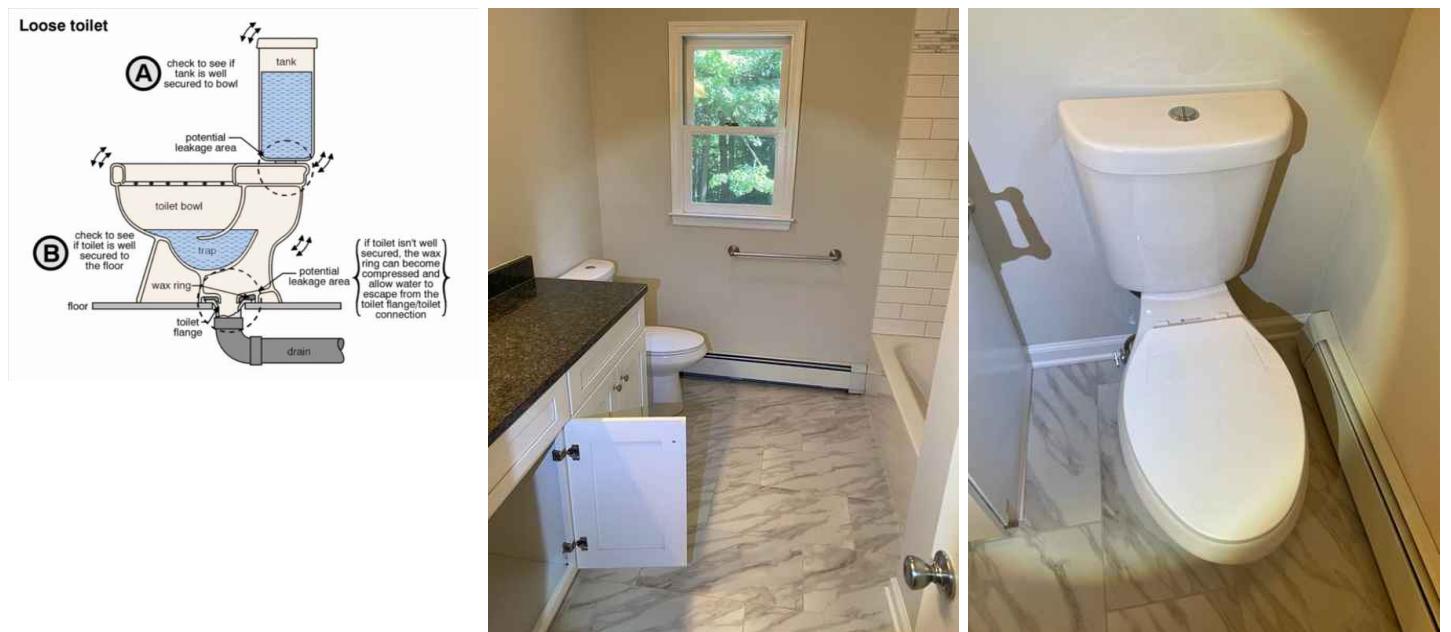
## 5.5.1 Bathroom Toilets

**TOILET NOT TIGHTLY SECURED**

## 2ND FLOOR BATHROOM

The toilet was not tightly secured. This can cause leaks which can damage the home. A qualified licensed plumber should evaluate, and repair and replace as necessary.

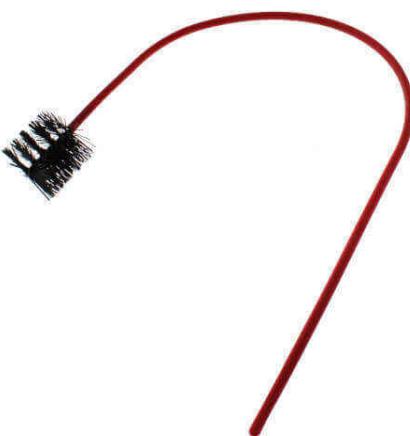
As a reminder, please be sure to monitor and repair/replace refrigerant line insulation as deemed as necessary to maintain efficiency.

I recommend cleaning A/C P-Trap with a 18" EZT-406 Standard Flexible Rod Cleaning Brush every time the filter is changed.

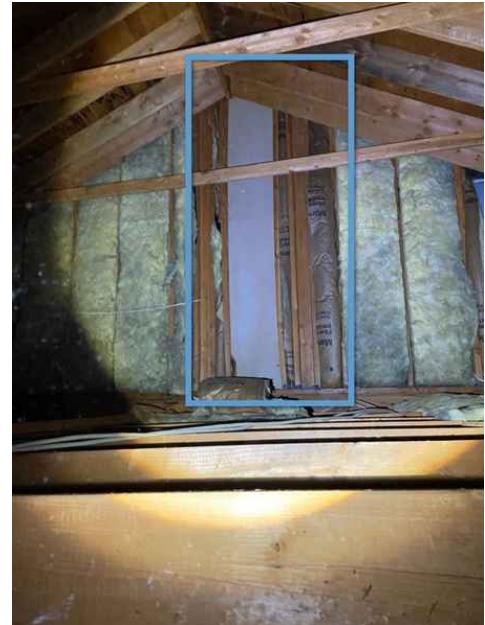
### 10.3.1 Attic Insulation

#### AREAS MISSING INSULATION

##### OVER GARAGE

Fiberglass (Batts) insulation has been removed in areas of the attic. Heat loss can occur more on this home than one that is properly insulated. When installed, the insulation paper should face the interior of the house. A qualified licensed contractor should repair and replace as needed.

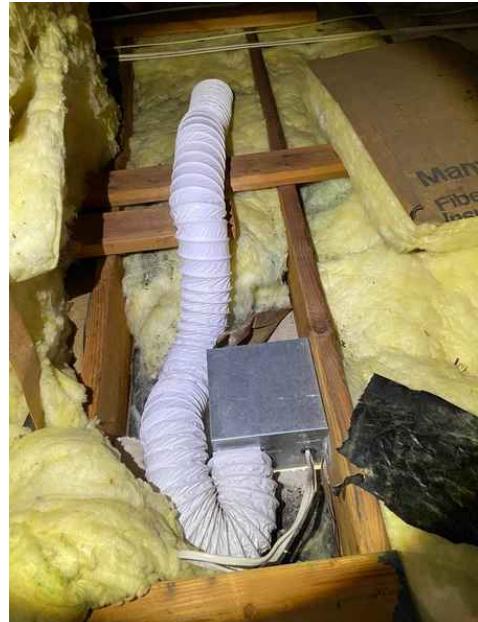
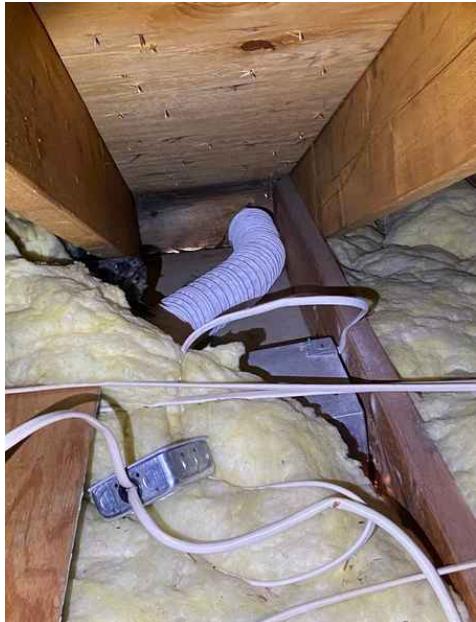
Exhaust air from bathrooms, toilet rooms, water closet compartments, and other similar rooms shall not be:

- exhausted into an attic, soffit, ridge vent, crawlspace, or other areas inside the building; or
- recirculated within a residence or to another dwelling unit.

A qualified licensed contractor should repair and replace as necessary.

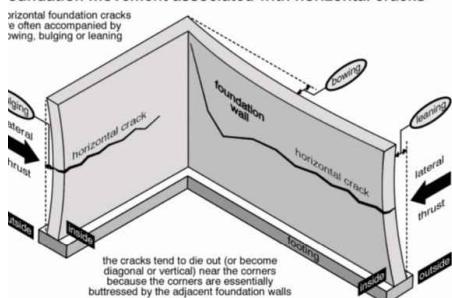
A large majority of the home has finished construction on the walls, floors, ceilings, band boards, and sill plates. Suggest inquiring with current owners and/or local authorities of obtaining all documentation and permits that may exist. Most of the walls and ceilings in the finished basement are covered and structural members are not visible. No obvious problems discovered. I could not see behind these coverings.

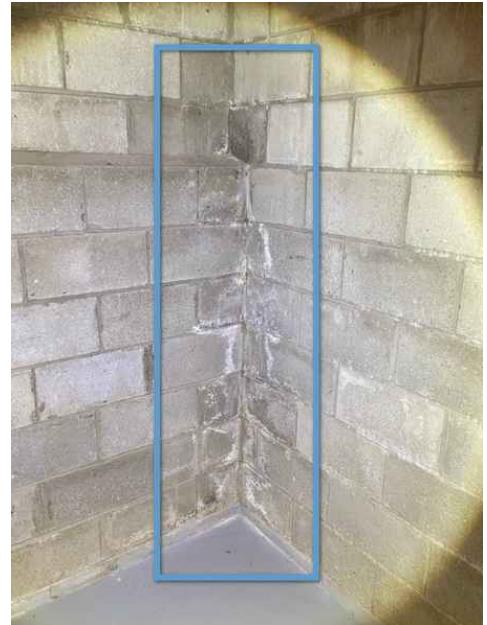
### 11.2.1 Basements & Crawlspaces

#### EFFLORESCENCE IN BASEMENT

I observed efflorescence on all walls of unfinished basement. Efflorescence is the white chalky powder that you might find on the surface of a concrete or brick wall. It can be a cosmetic issue, or it can be an indication of moisture intrusion that could lead to major structural and indoor air quality issues. I noted the presence of efflorescence in the inspection report because it generally occurs where there is excess moisture, a condition that also encourages the growth of mold. These areas should be monitored for signs of mold growth and/or water infiltration. A qualified licensed professional should locate the source of moisture, then correct so moisture is not penetrating the basement.

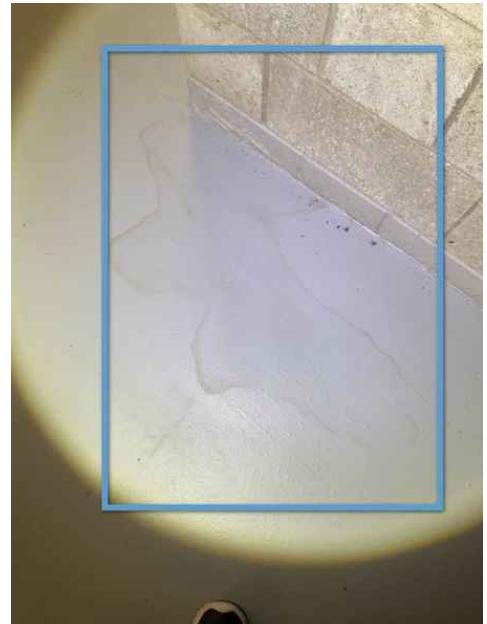
There was evidence of moisture intrusion in the basement. A qualified licensed professional should repair and replace as necessary.

Contact a qualified professional.

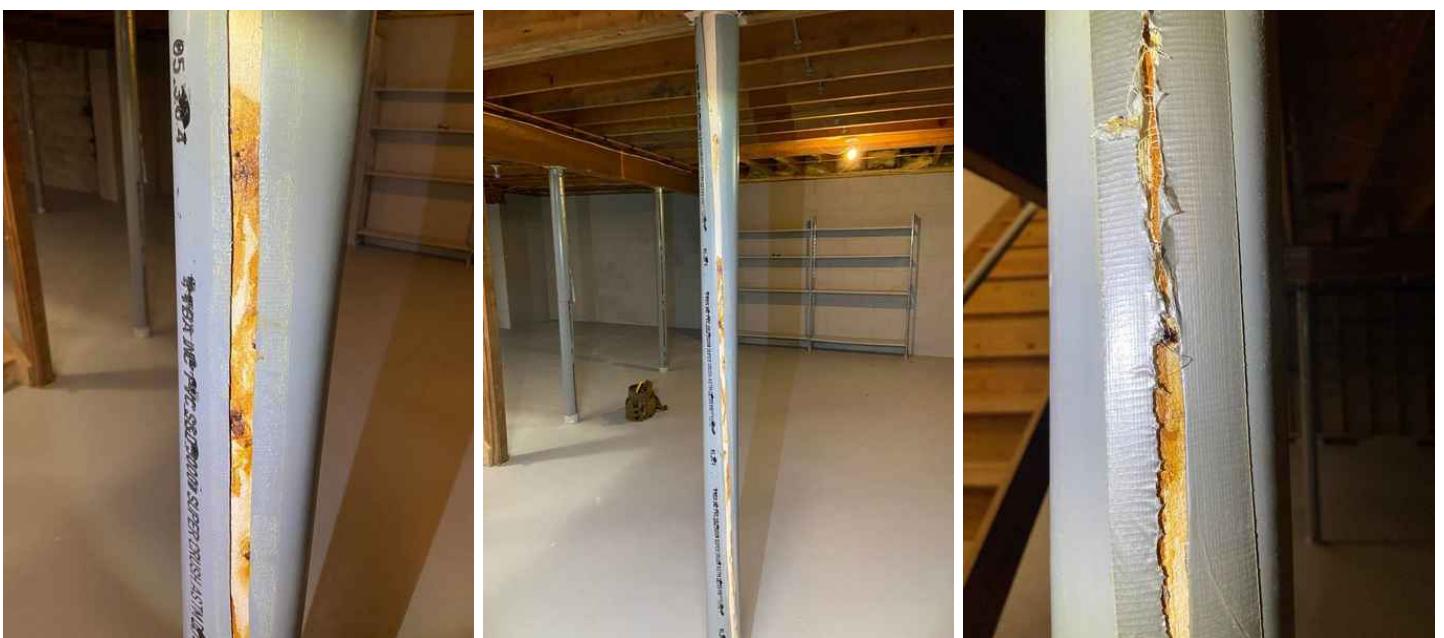
## 11.6.1 Columns or Piers

**STEEL LALLY COLUMN WRAP LOOSE**

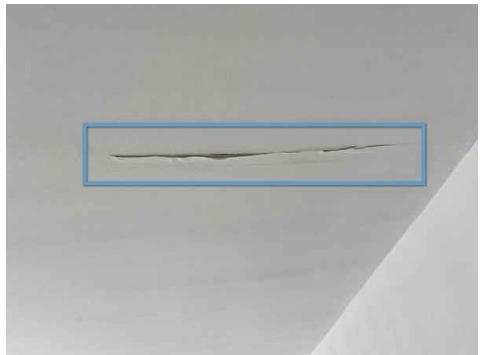
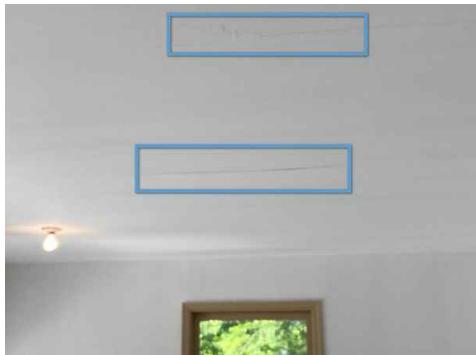
#### 12.6.1 Moisture Intrusion in Garage

### MOISTURE INTRUSION

Garage ceilings showed signs of moisture intrusion. Recommend a qualified contractor evaluate and find source of moisture to prevent further damage.
