Check the Balluff sensor cable

Check the blade position sensor

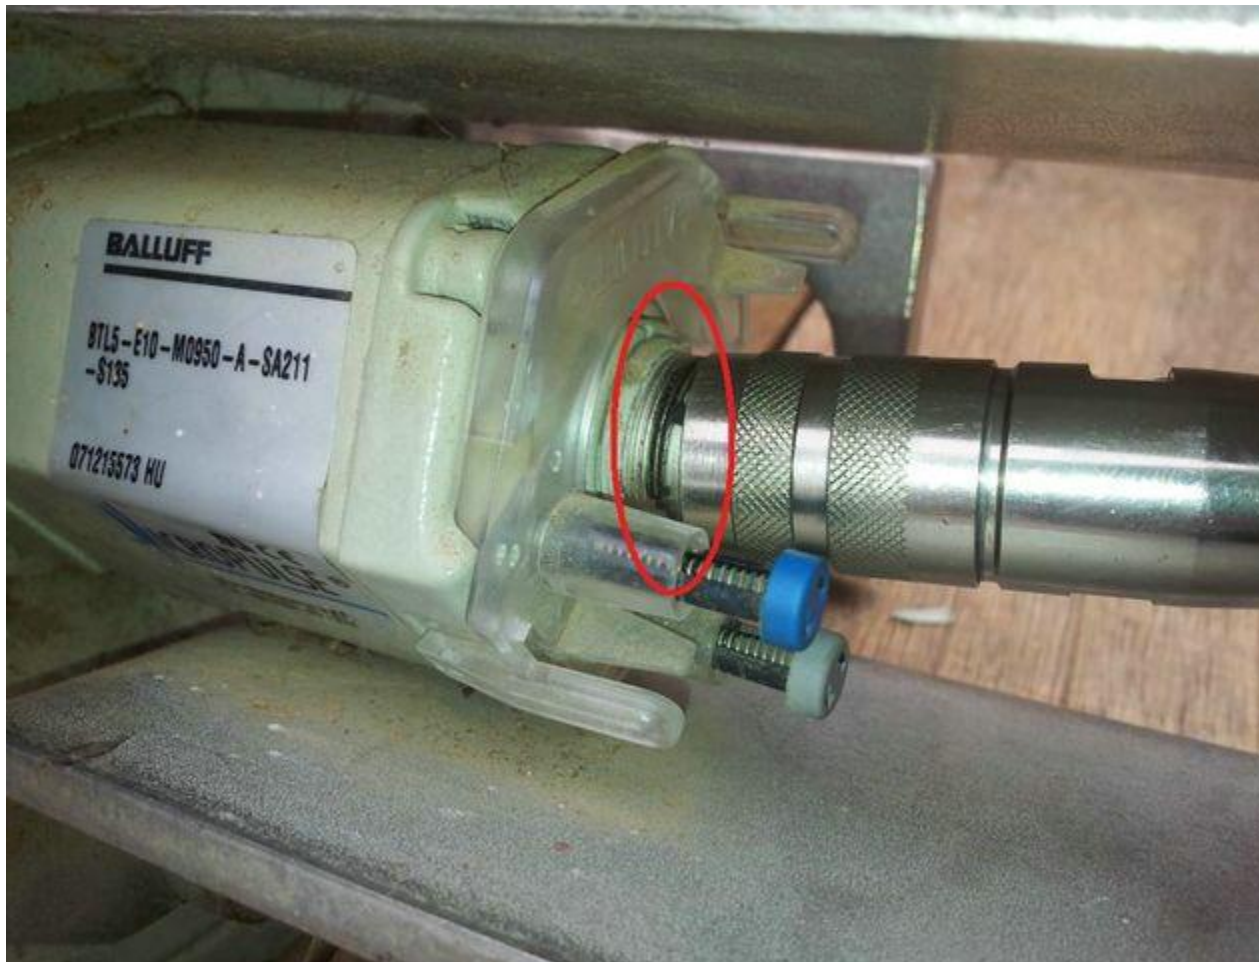
Check the transducer cable on the affected blade. Make sure the connector is not loose. Check to see if the pins are pushed in or corroded. If you suspect and open, check the cables for continuity.

Cable W923 Part number [60101018](#)

Cable W924 Part number [60101148](#)

Cable W925 Part number [60101149](#)

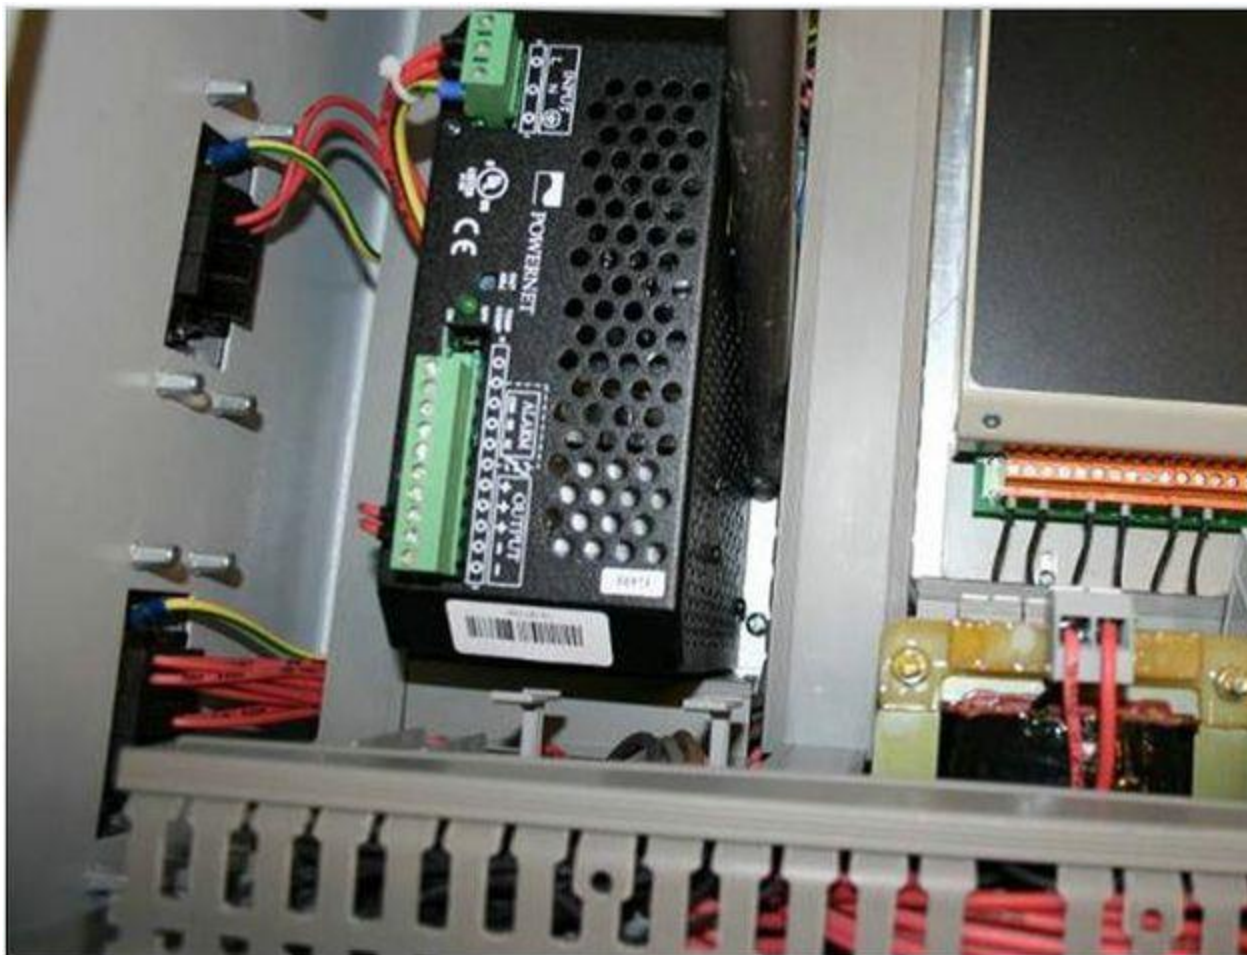
Check the power net for correct input and output voltage, 240VAC and 24VDC respectively.

The G400 supplies the proportional valves and the G401 supplies power to the position transducers.

Also, make sure the wires have solid connection on both ends. Pull test the wires and inspect them closer as needed.

PS ADC 5483R-3 10A-27,4 NM PIN Part number: [188453](#)
