# Report on architectural decisions and assumptions in the LASCAD system

March 13, 2016

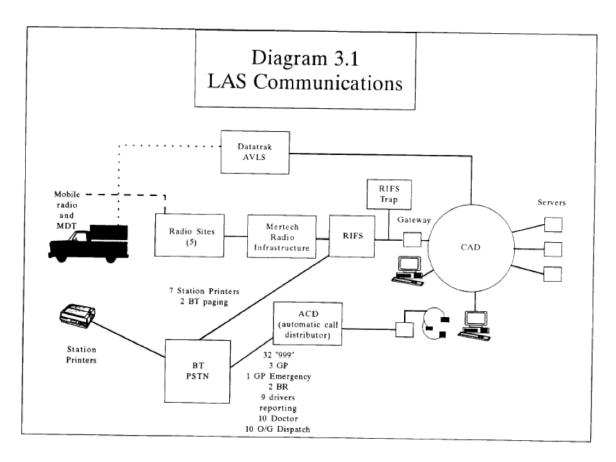
Figure 1: Diagram 3.1 from Report of the inquiry into the London Ambulance Service [6, p. 27]

We believe that the dominant decomposition of the architecture was component-based. The different components in the system (as shown in Figure 1, appendix A) were created by different companies:

As mentioned in the Architectural Decomposition, we concluded that the component-based architecture was dominant. This aspect strongly returns in Figure 1 located in appendix A, which shows the communication lines between the different entities in the system.
