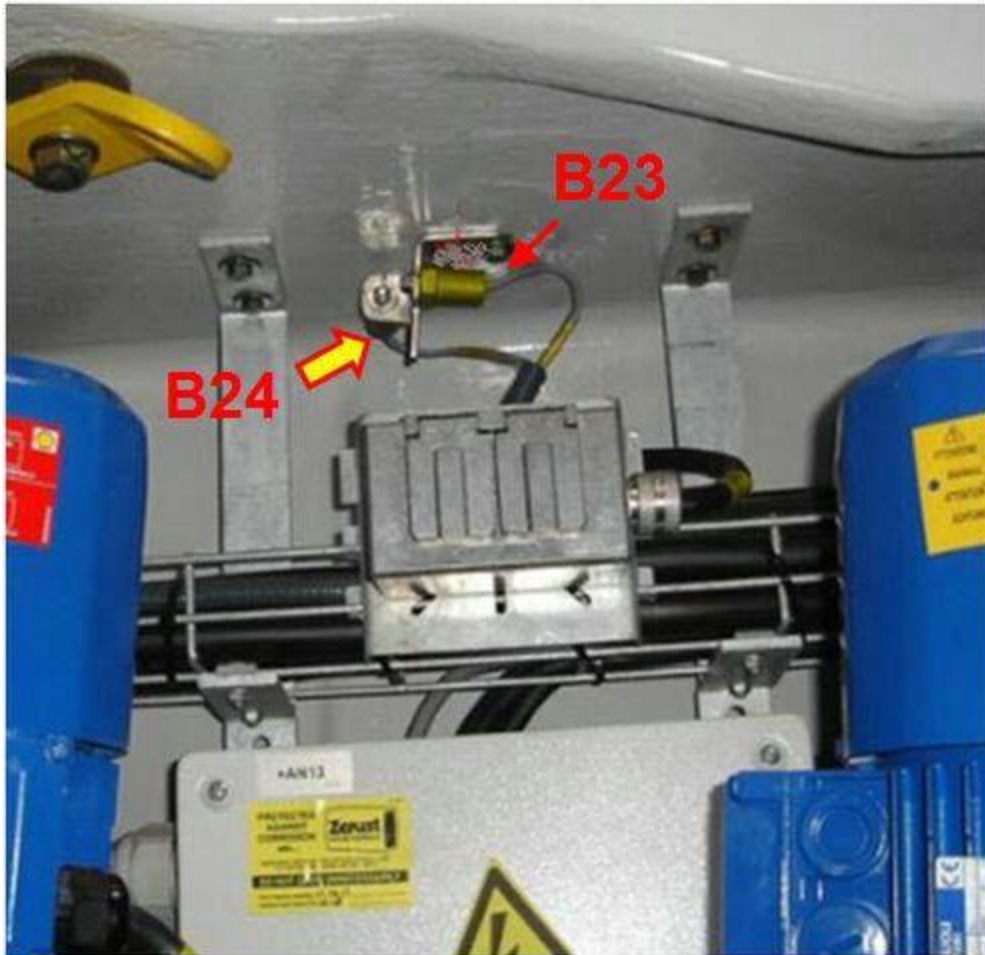
If the B24 and B23 sensor wires are switched, it will cause this alarm. Confirm that the lateral sensor wires runs to the U7 TAC84.

You can also validate the calibration number. It is a three digit number printed on the sensor wire and it should be stored as parameter 14 in the TAC module. This number should also be written on the Panduit cover under the TAC84 module.

To access the TAC84 parameters through the service panel, go to configuration → set top sensor parameters → TAC84 tower lateral parameters
