E39 Power Steering Reservoir Hose Replacement

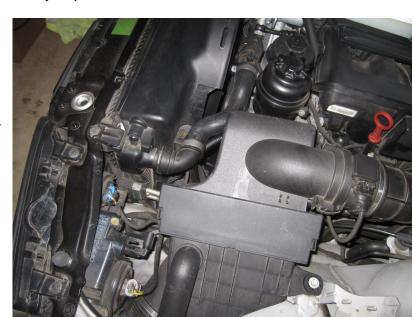
Required Consumables (from RealOEM.com):

- 1. 32411095526 Intake Manifold (Hose to P/S Pump)
- 2. 32411094306 Radiator Return Line (Hose to Cooling Coil)
- 3. 17211742636 O-ring for installation to cooling coil (2 required)
- 4. (2) 6 20 mm hose clamps for Intake Manifold Hose
- 5. (1) 9-24 mm hose clamp for Radiator Return Line
- 6. Lots of rags to mop up power steering fluid
- 7. Power Steering Fluid for sedan, use a high-quality ATF per the Bentley Manual. I used Mobil-1 Synthetic ATF. The Tourings, I believe, use Pentosin- DON'T MIX THE PENTOSIN FLUID W/ATF. Nothing good comes of that chemistry experiment.
