### Check wind sensor alignment by using laser boy

### Check varistor connections and circuit for faults

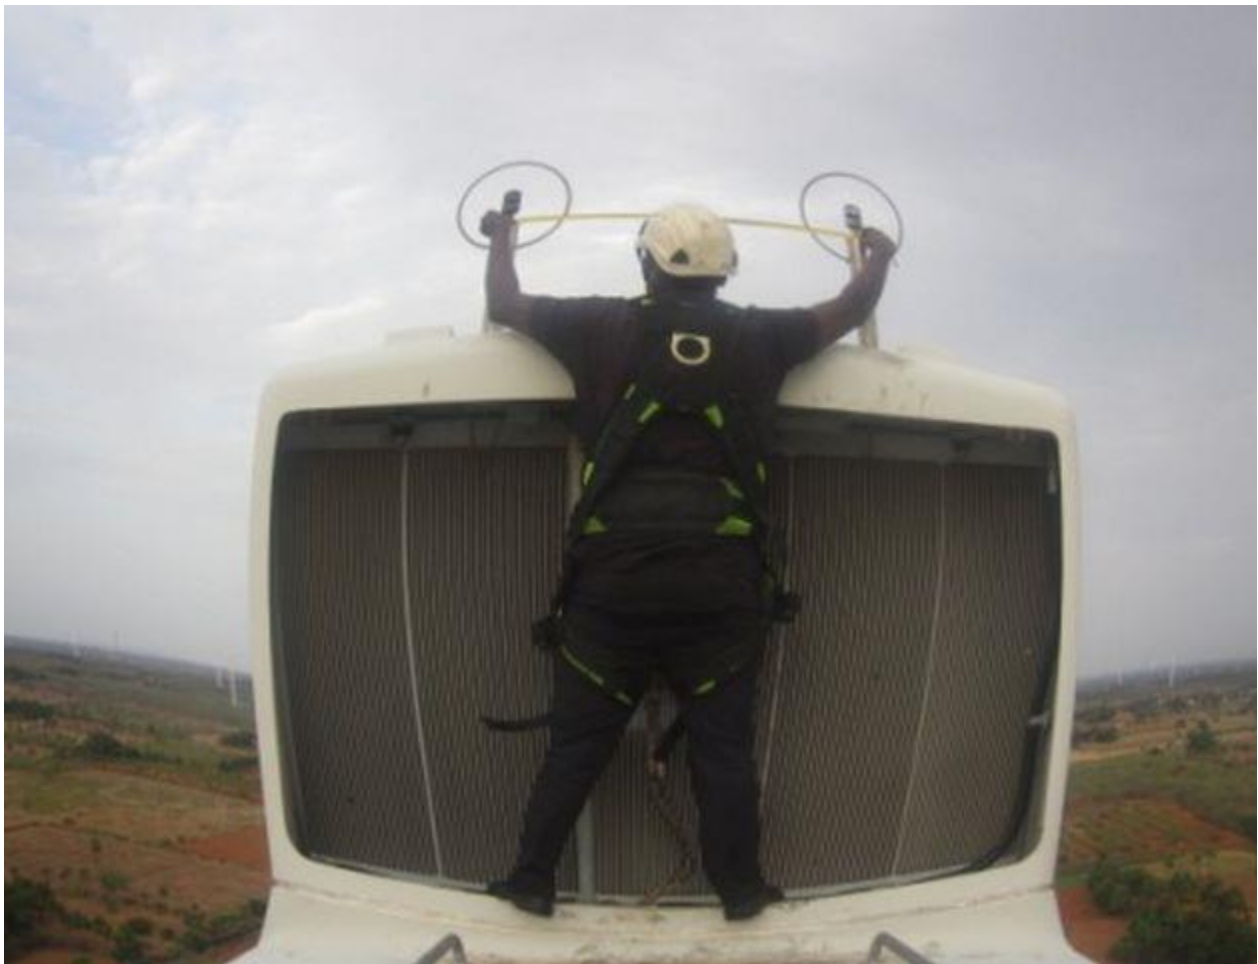
[0000-9925](#) Commissioning Instruction, V82-1.65 MW

Reference the below document for alignment procedures.

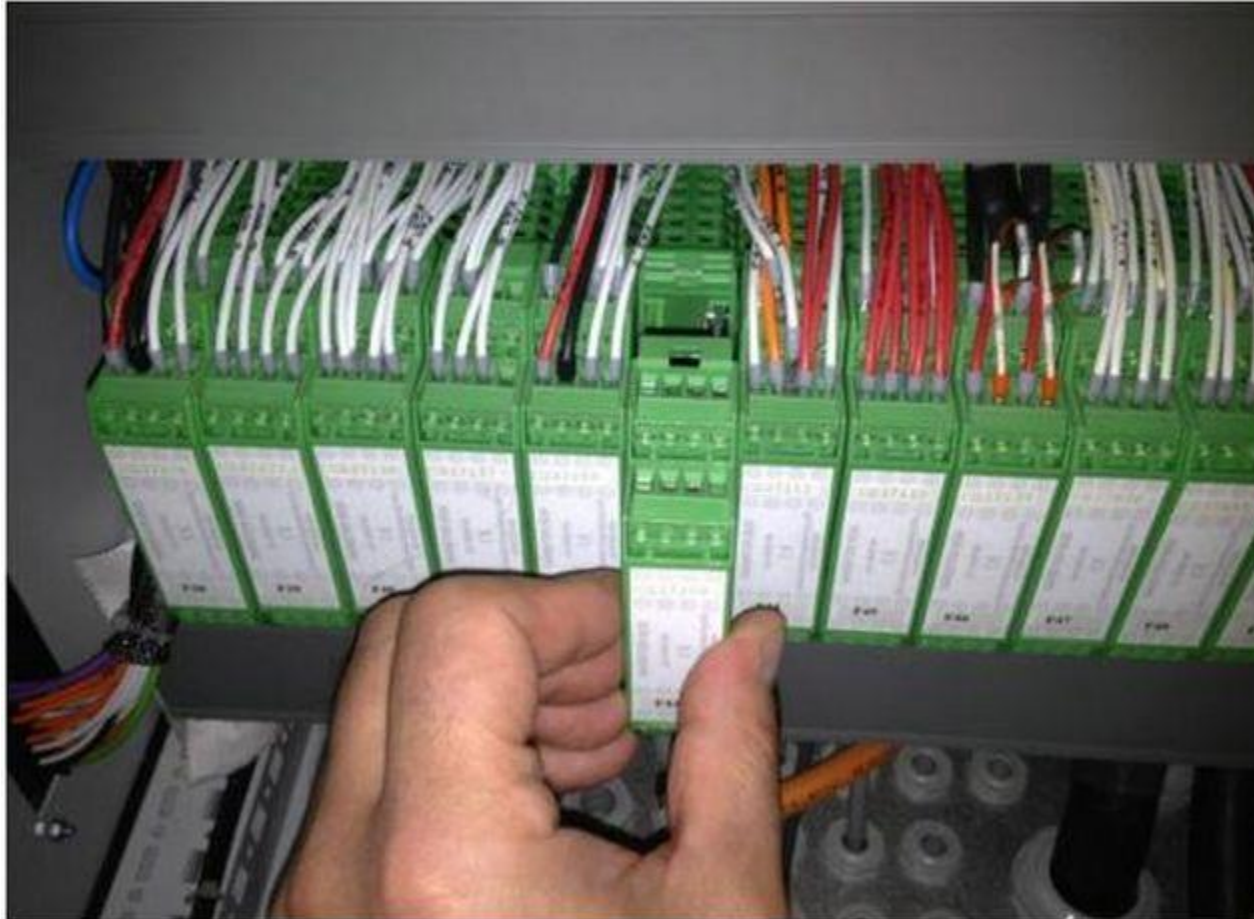
Ref: Drawing [934705](#) Sheet 214 Wind Sensors.

Check varistor connections and internal circuit for faults. Replace the varistor box if faulty.

51706201 VARISTOR BOX X8

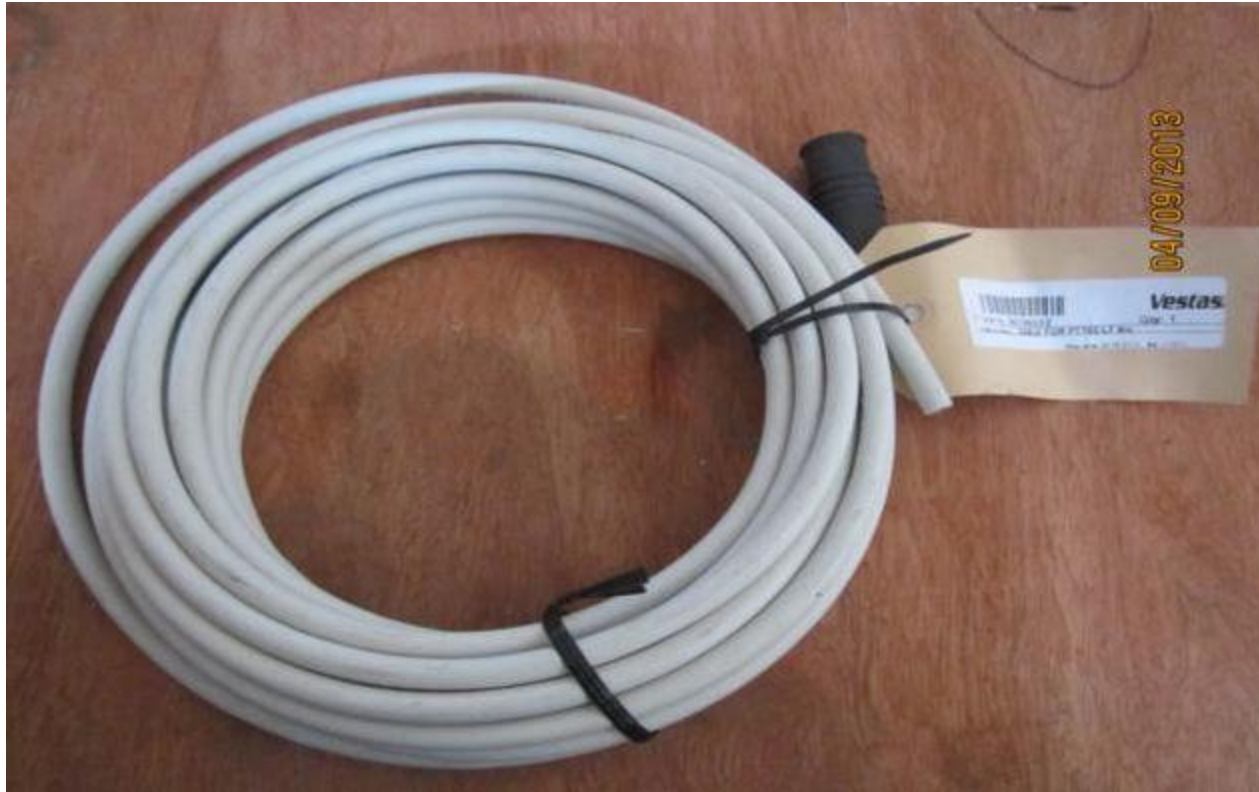
Ref: Drawing [934705](#) Sheet 049 External connections wind sensors.

**Check cable W 583 and W584 for any cable internal failures**

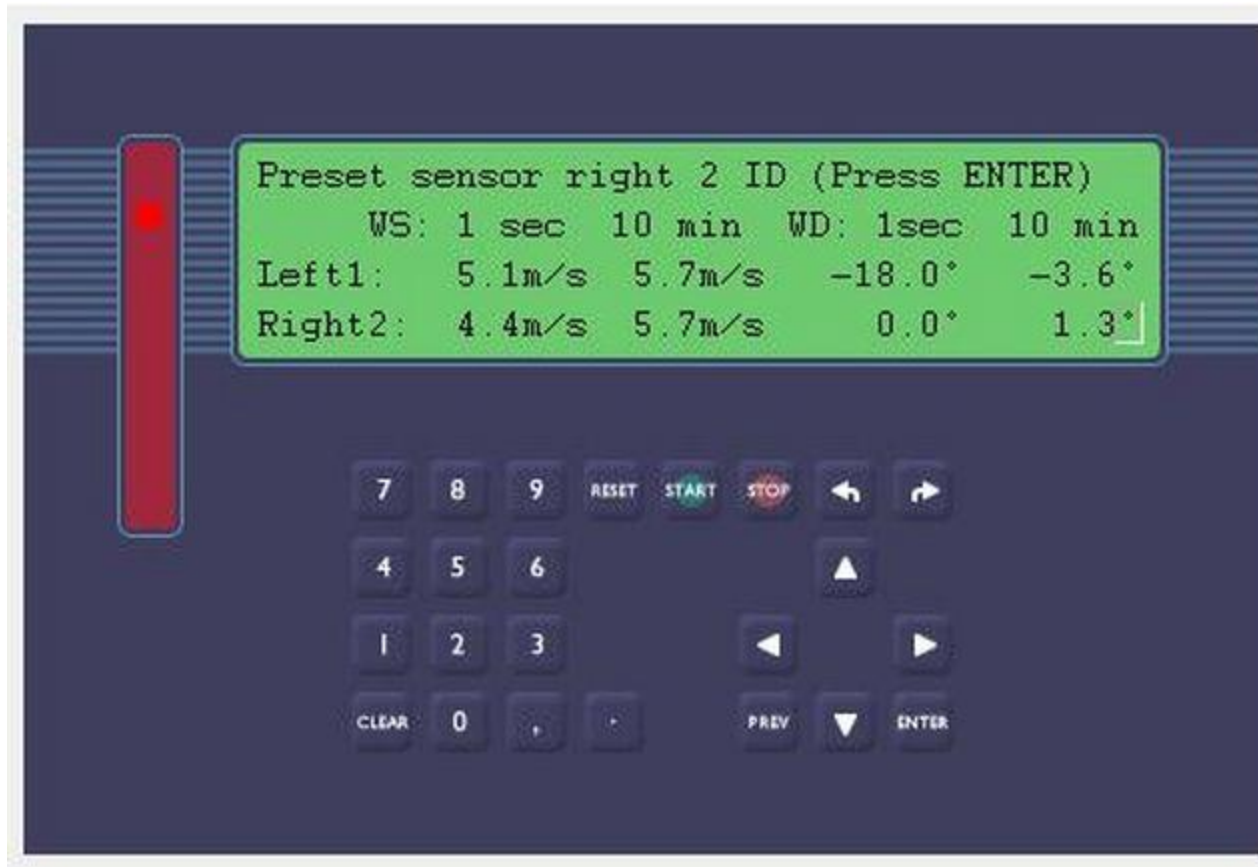
Navigate through the TAC II controller- Configuration=> Set wind sensor parameters. Monitor the 10 min average values.

Verify both the sensors are displaying the wind signals.

If not check the cable connection W583 and W584.

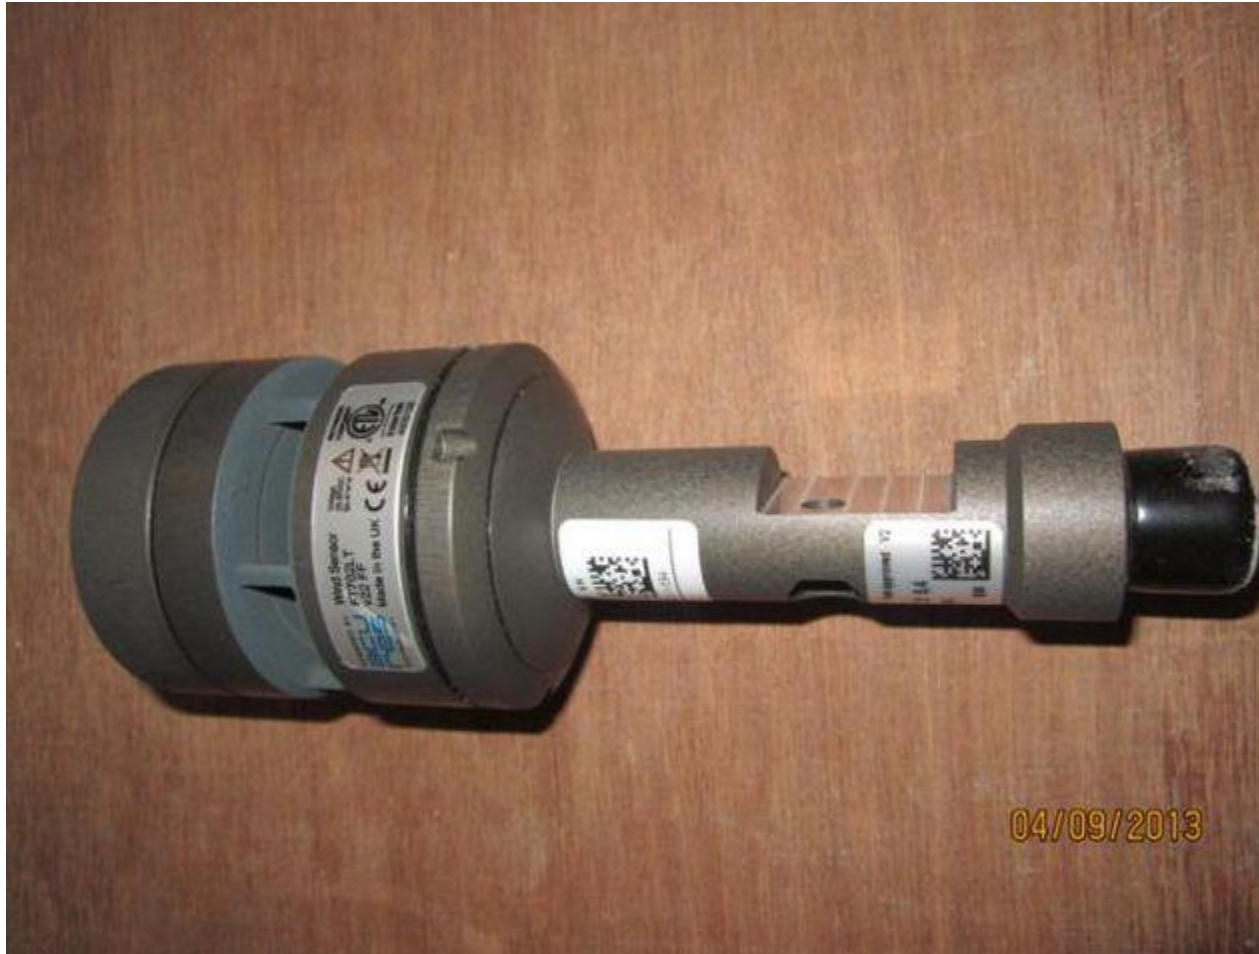
Ref: Drawing [934705](#) Sheet 049 External connections Wind sensors.

B31 and B32 wind sensors are located atop the nacelle radiator. The sensors are connected to the controller through cable no W583 and W584.

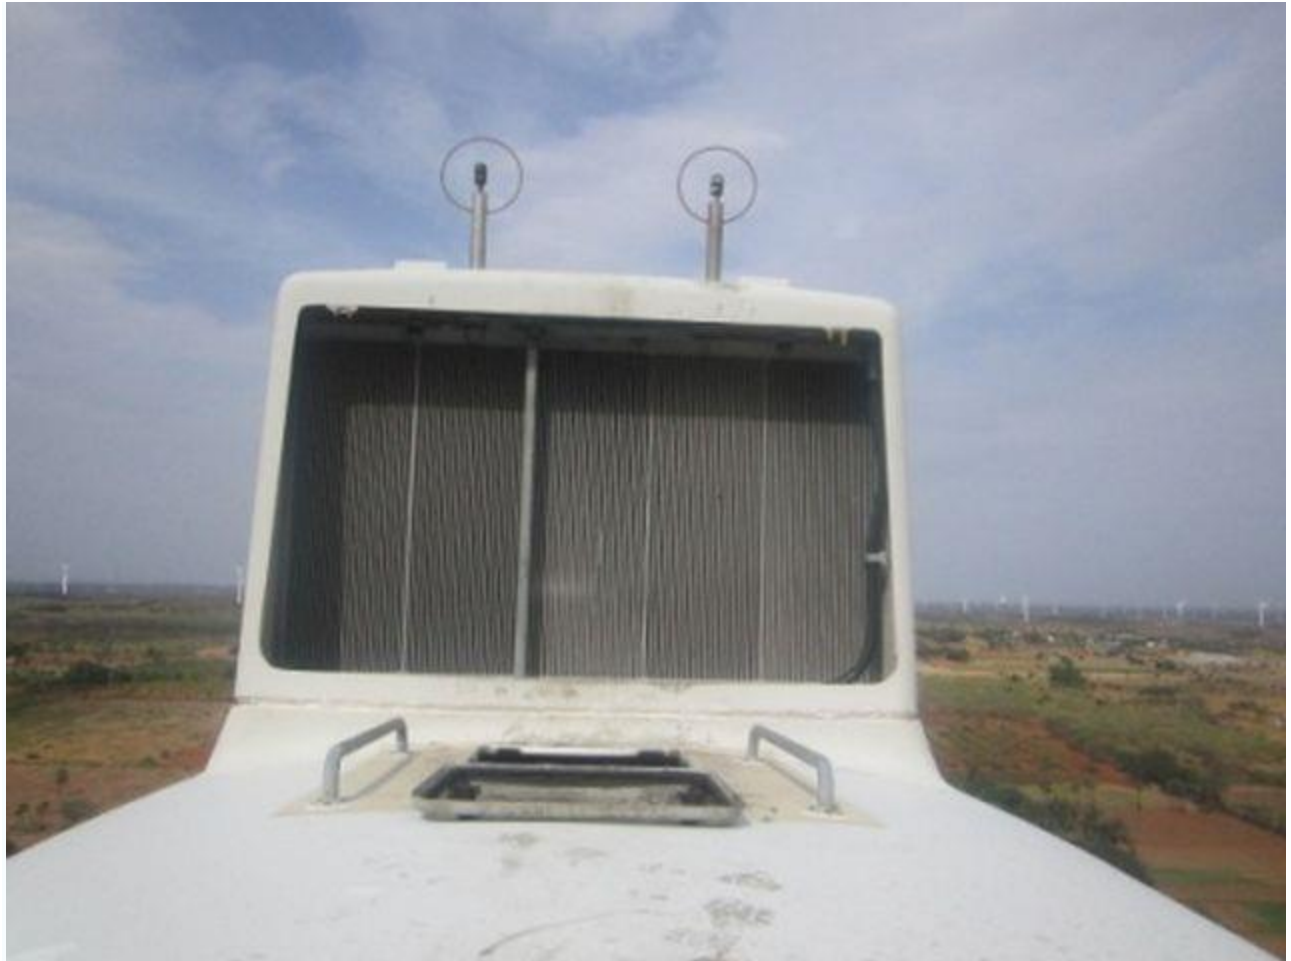
Navigate through the TAC II controller- Configuration=> Set wind sensor parameters. Confirm that the software version of the sensors is the same.

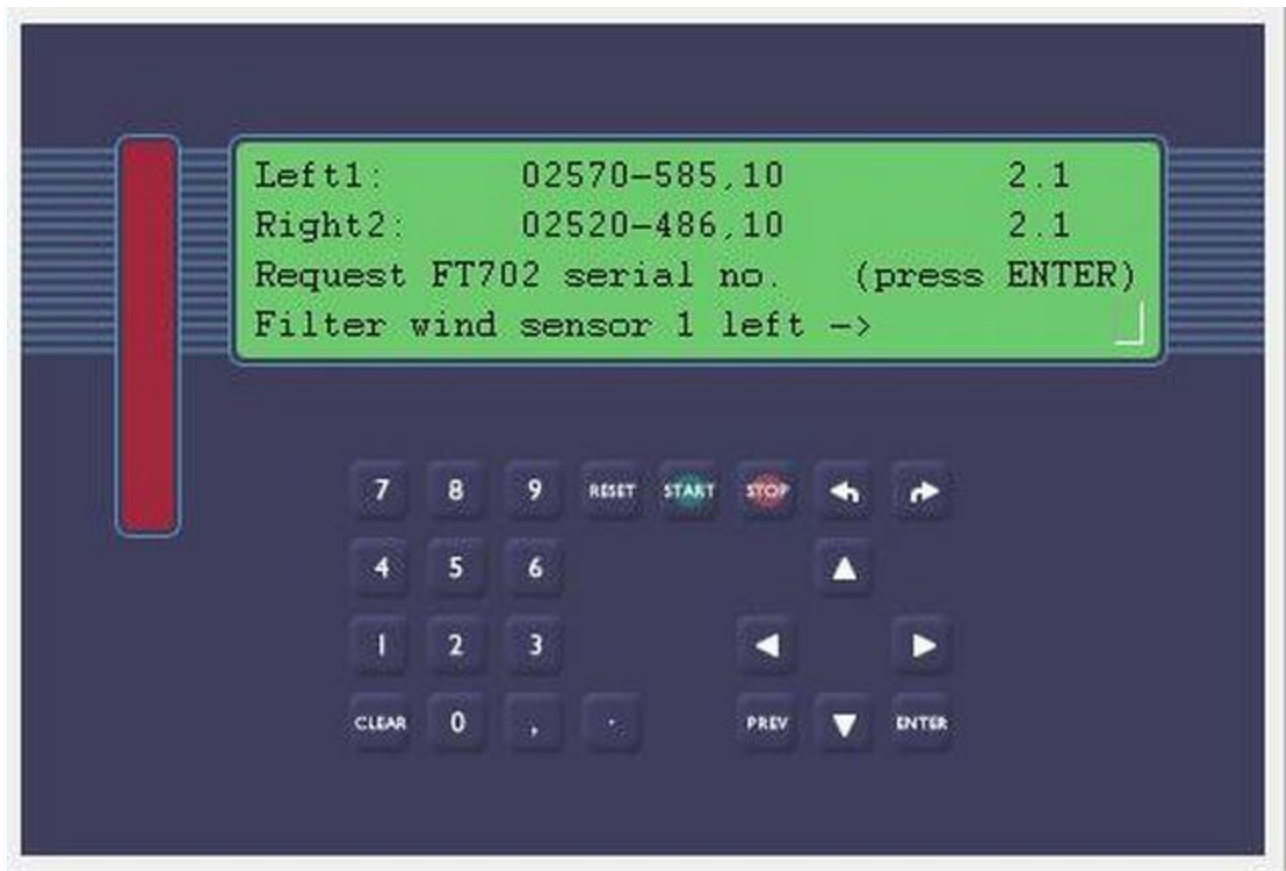
Navigate through the TAC II controller- Configuration=> Set wind sensor parameters. Monitor the 10 min average values.

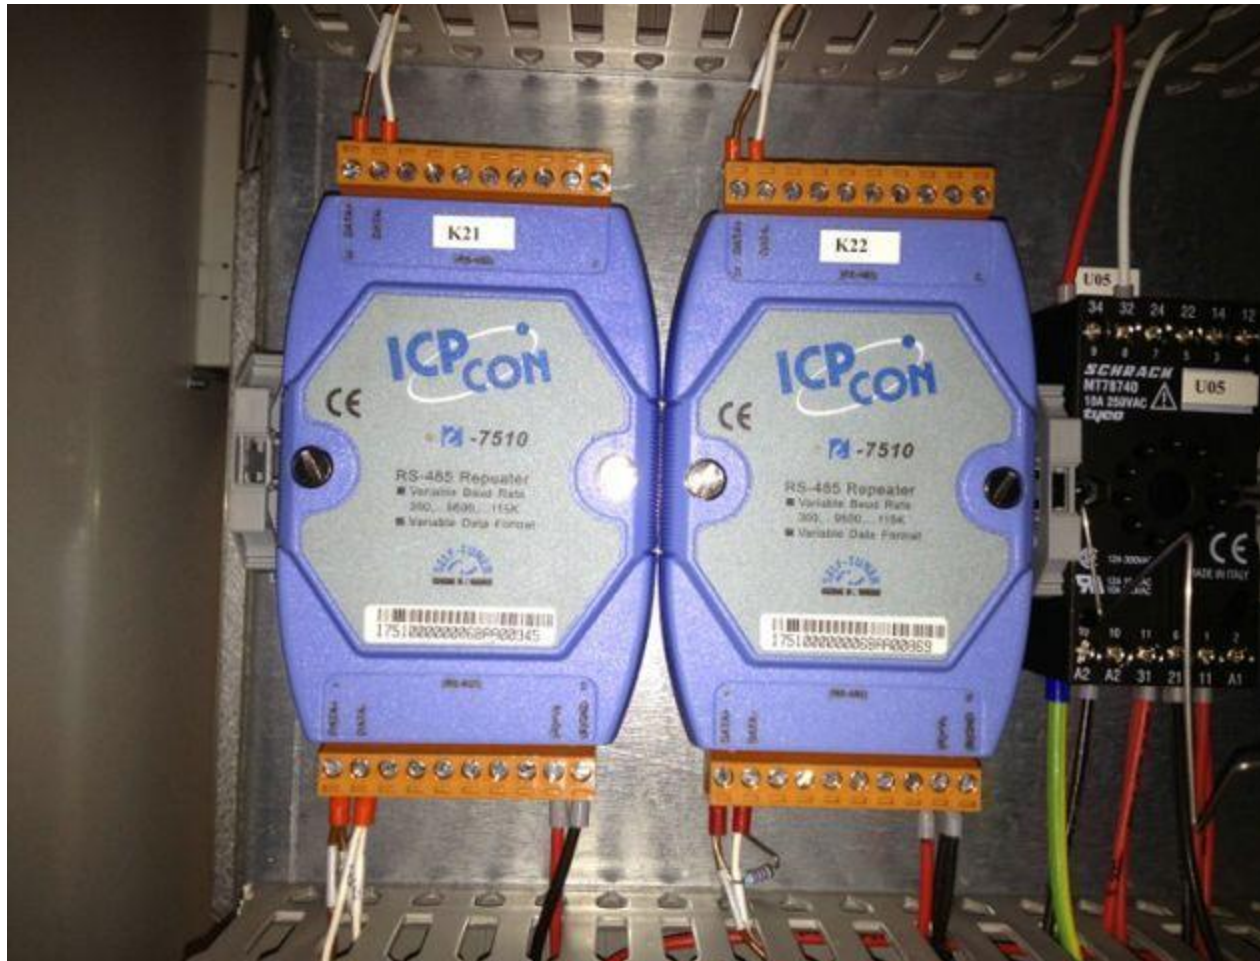
Ref: Drawing [934705](#) Sheet 214 Wind Sensors.

Test the function of the repeaters by swapping them with known functional repeaters and check to see if the signals are corrected.

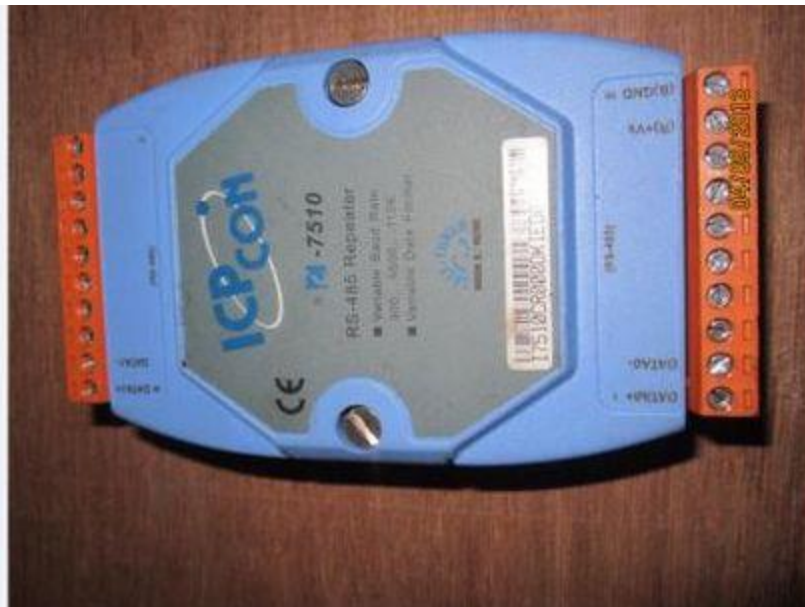
60004933 RS485/RS485 REPEATER I-75

Verify both that both of the sensors are displaying the wind parameters.

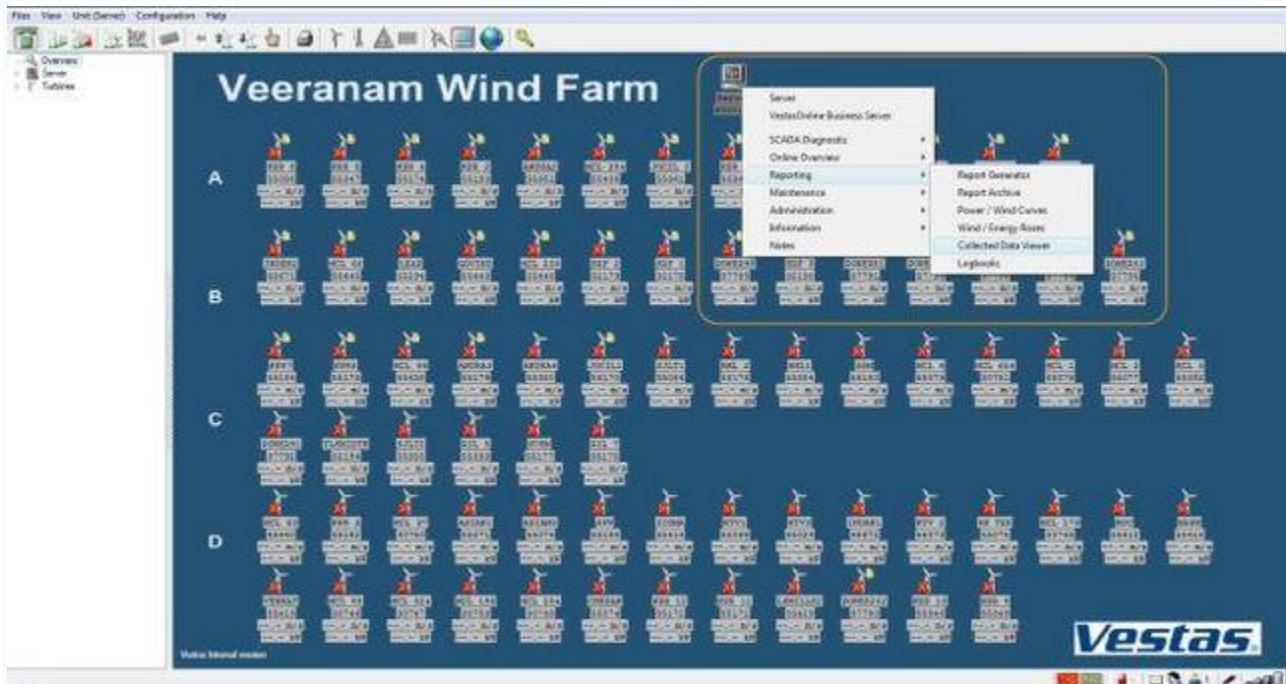
Through SCADA collected 10 min data verify the difference between two sensors.

If the difference exceeds more than a reasonable amount 10 Minute average, (12°/10 minutes is the alarm limit), the sensor may need to be replaced (replacing the ultrasonic sensor should be the last step in the troubleshooting process).

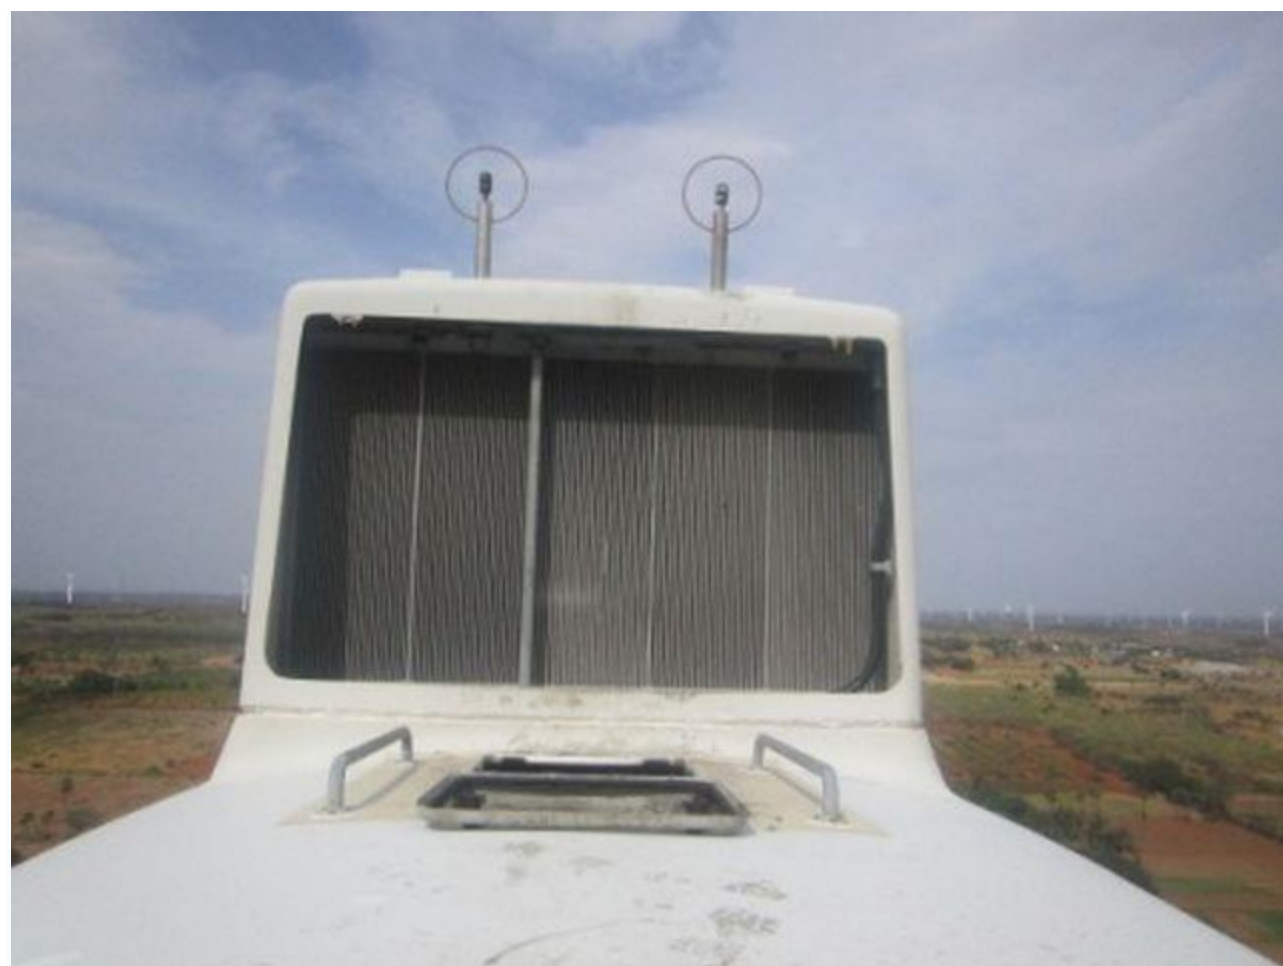
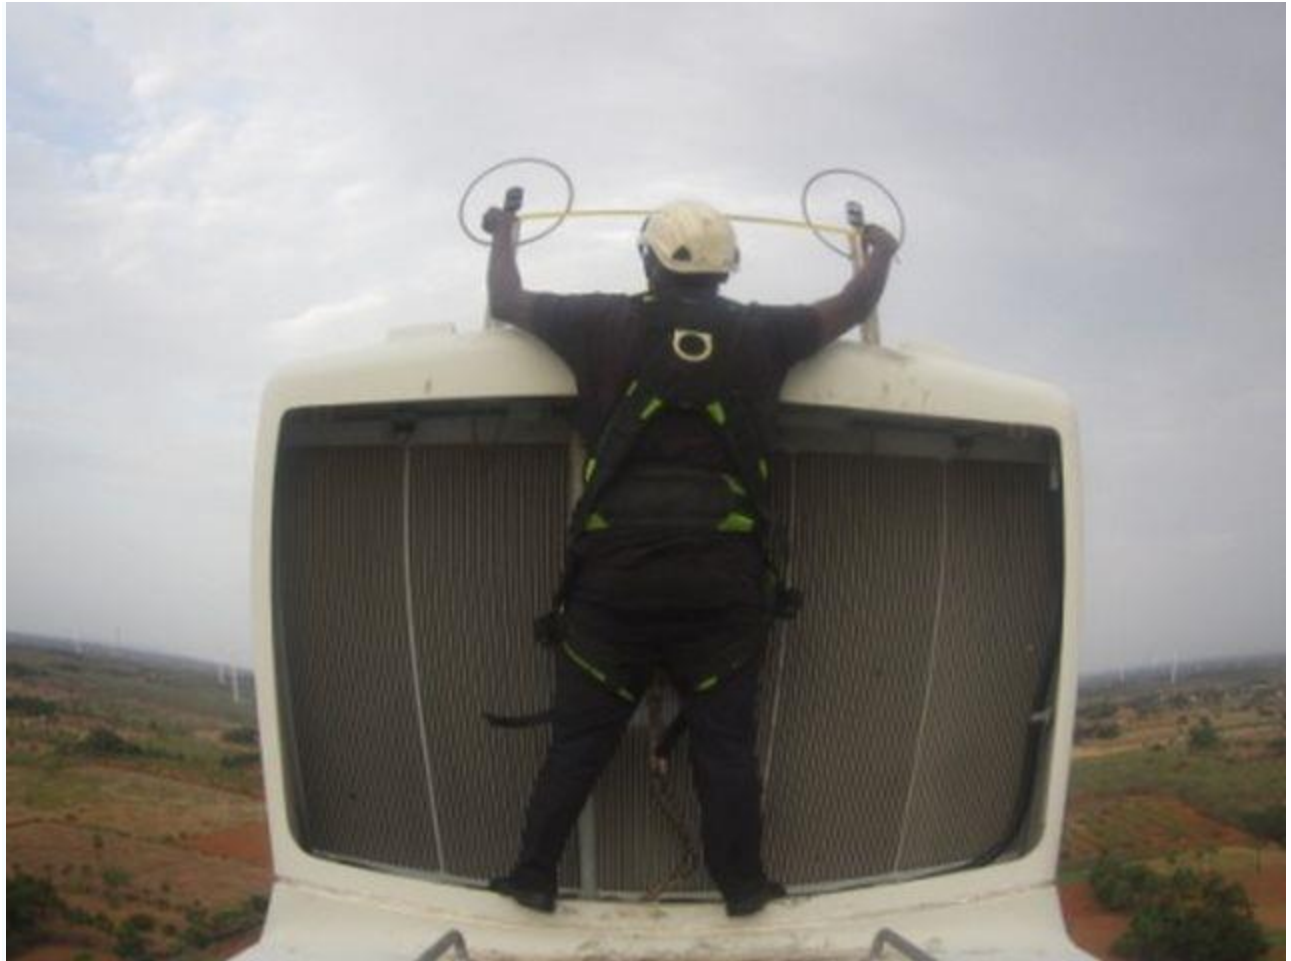
[0000-9925](#) Commissioning Instruction, V82-1.65 MW

Ref the below document for wind sensor alignment.
