BCDWristWatch

SulKith

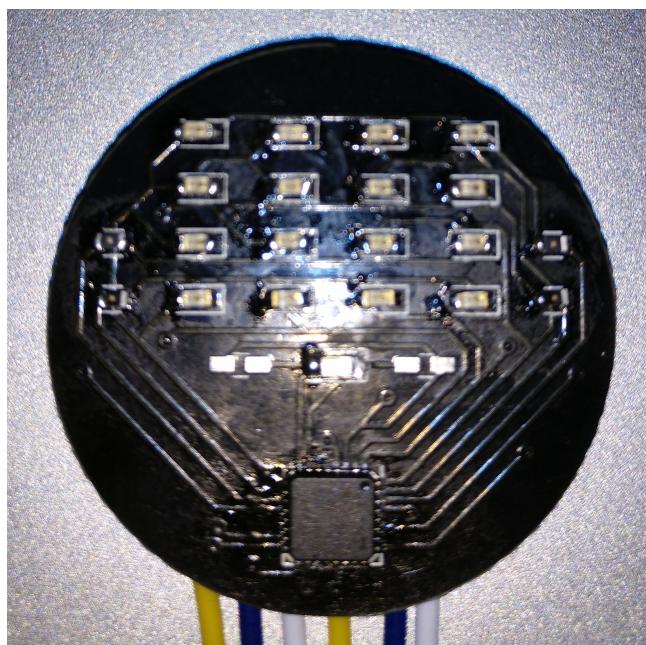
1.1 First PCB Version

The First PCB Version was a desaster. The PCBs arrived very fast, but the QFN Package had the wrong size. ATMEL only produces QFN32 in 7x7mm. Therefore the design of the PCB had to be changed to the smaller package, but that gave me the Chance to shrink the Design to a smaller form factor. The part which keeps the PCB from getting smaller is the Coin Cell Battery (CR2032). On the PCBs there was the order number printed on the Front side, which would be visble in the final assembly.

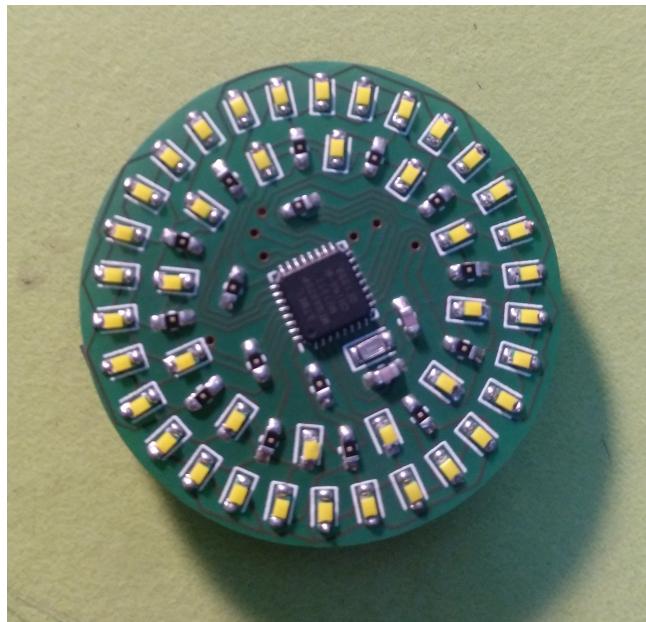
1.5 PCB3

The third PCB was ordered at [aisler.net](<https://aisler.net>). It only took around one and a half week to arrive(to Germany). The PCB was not completely milled out. It was in a carrier PCB with rectangular shape, but it was easy to remove. I had to sand the edges a bit, since it was a bit rough on the parts where i removed the connections to the carrier, since i had to sand the PCB anyway to fit in the Housing that was no big problem. The overall Quality of the PCBs is very good, but you can not choose the thickness or color of the PCB.

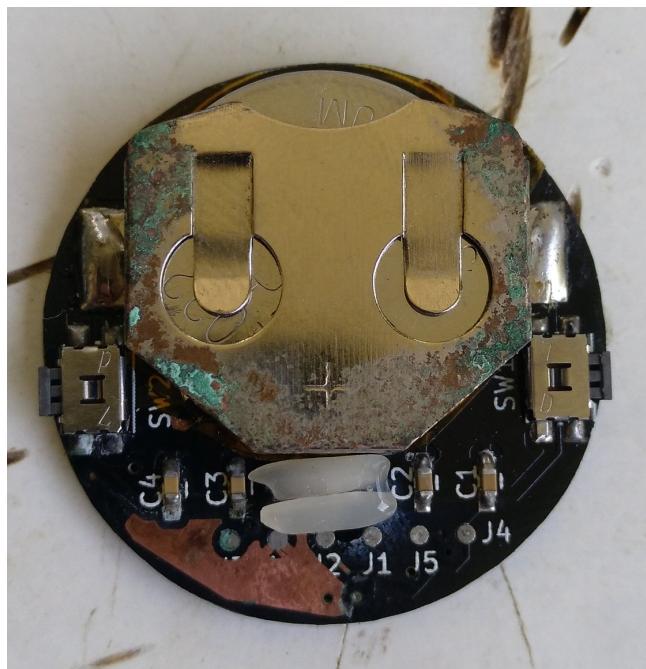
4.1 Sweat is entering the Housing

The first watch broke down after nearly 1 year. After opening the Housing the Problem was very obvious. Sweat was entering the Housing and corroded the PCB and the mounted parts.

After analyzing it again the PCB seemed to be ok. The PCB was only a little damaged from the first sweat attack. The Problem was that the time stopped to run, but another point was that the LEDs wont go off anymore. But it was possible to set the time. So the conclusion is that the clock which is run by the crystal stopped running.

As a solution i tried to clean the PCB with Isopropanol and glued some rice to the PCB to absorb the moisture, that helped only for about a week and the Watch stopped working again. So that is not the best solution, but is is an extraordinary try ;-)

The second solution was to add Tape, which is originally designed to be used to seal threads, between the housing and the lid. That worked out a little bit better, but the Watch also stopped working after a few weeks.

The next attempted solution was to add clear Nailpolish to the PCB, so the crystal is completely covered. This is an attempt to stop moisture from crawling below the crystal and stopping the clock.
