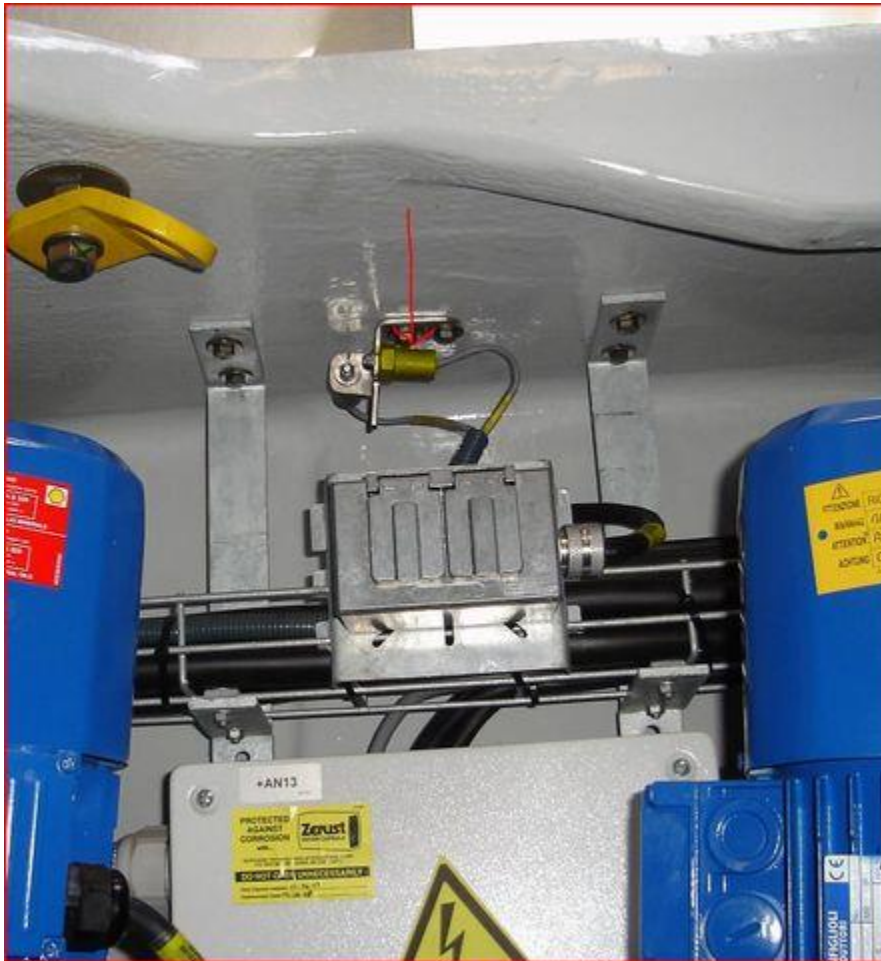
Accelerometer part number 51712401

Also, it is possible to change the position of the downwind and lateral vibration sensors. Change these sensor positions, adjust the calibration valve in the TAC module and start the turbine. If the lateral vibration starts to read

high and the downwind returns to normal, the problem was the accelerometer.
