Replace the vibration sensor

- **Explanation**
IN THE NACELLE:

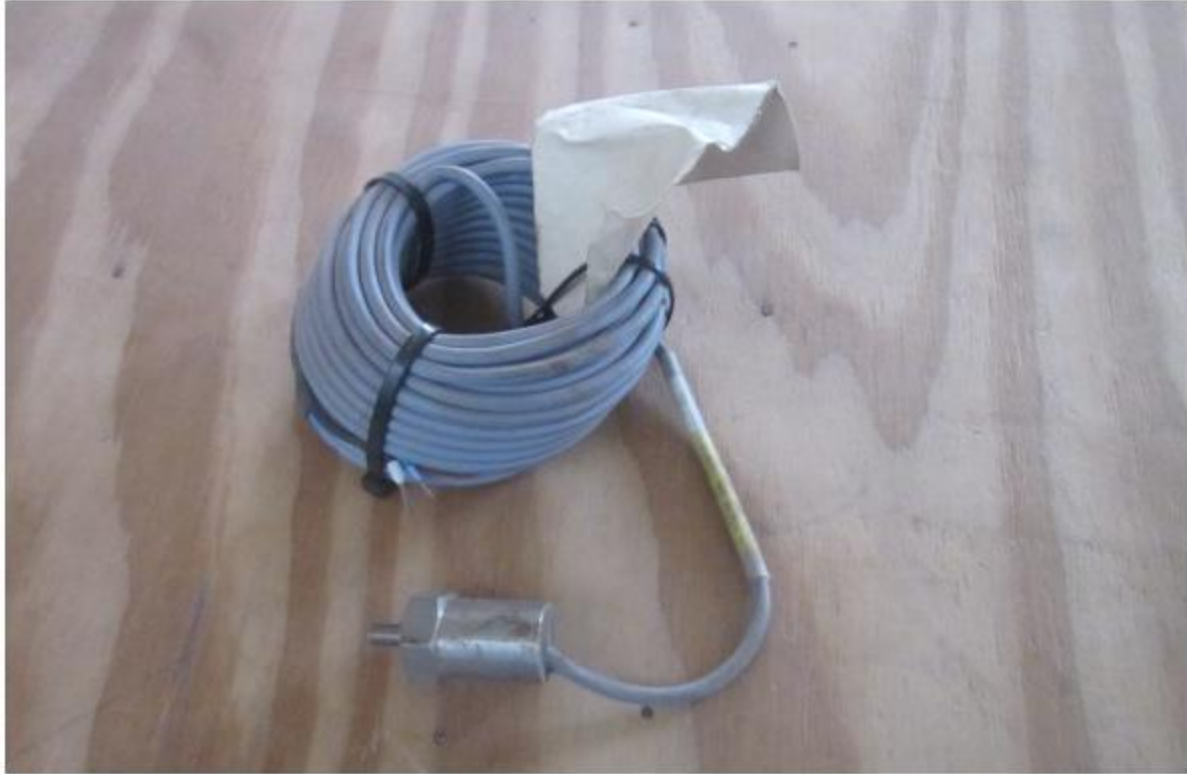
Part Number for Vibration sensor:

Blade Vibration sensor (B17):

51712401 VS05E ACCELEROMETER 6.5M

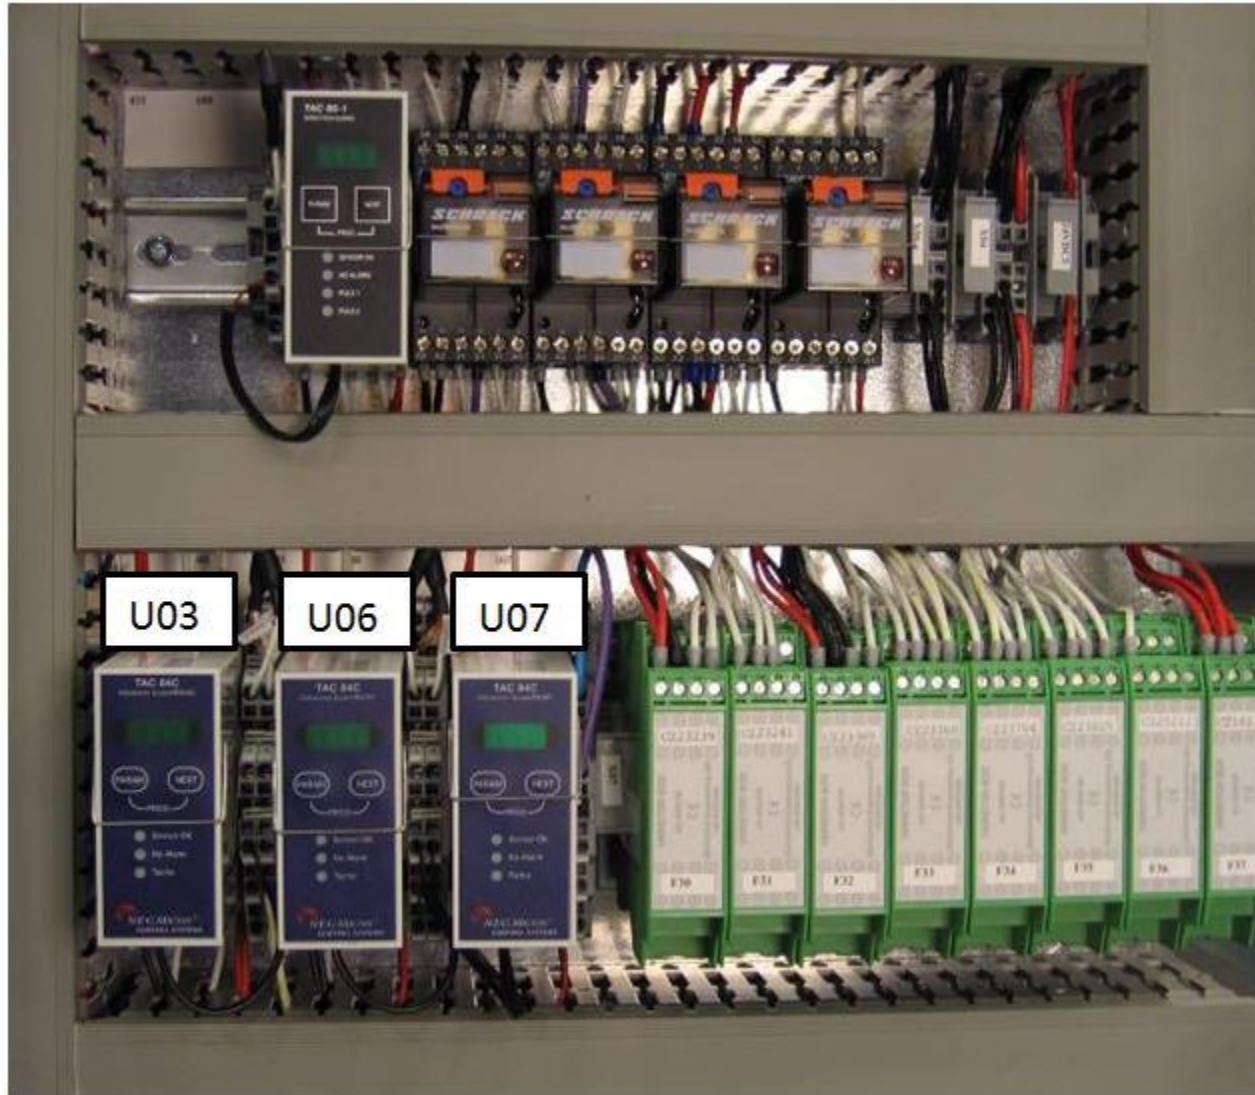
Vibration sensor and speed sensor signals are connected to the TAC84.

Check the TAC84 module parameters as per instruction.

Settings for TAC 84 Edgewise blade vibrations **DMS: [17000068](#)**
