Comprehensive Umayyad Mosque Sound System Assessment & Redesign Proposal

UNESCO World Heritage Site - Damascus, Syria

Report Type: Final Comprehensive Edition

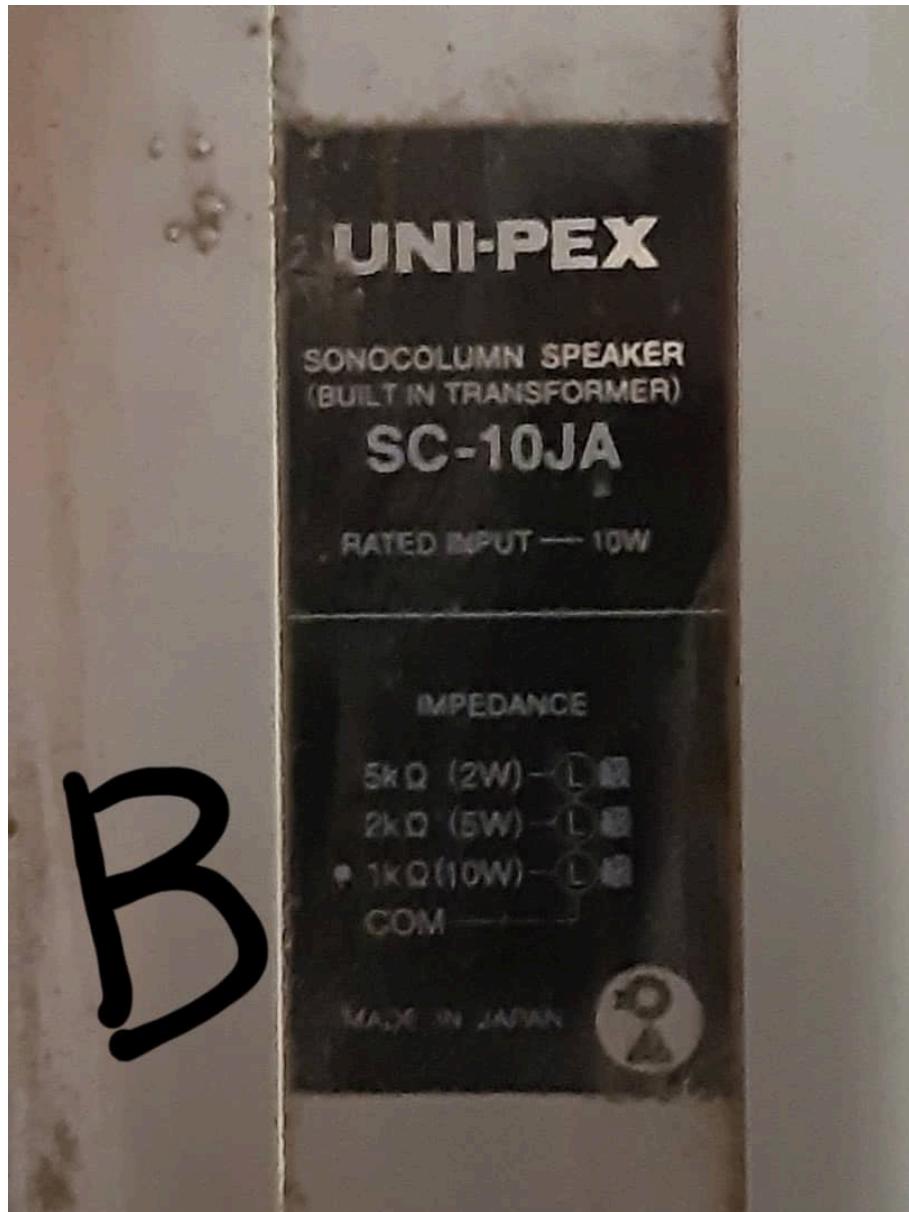
Figure 2.1: UNI-PEX SC-10JA nameplate showing 10W rating (marked "B"). Represents lowest-power speakers in the system, contributing to SPL inconsistency.

Figure 2.2: PROEL PR10AL ceiling loudspeaker. Ceiling-mounted installations show dust accumulation and age-related discoloration.

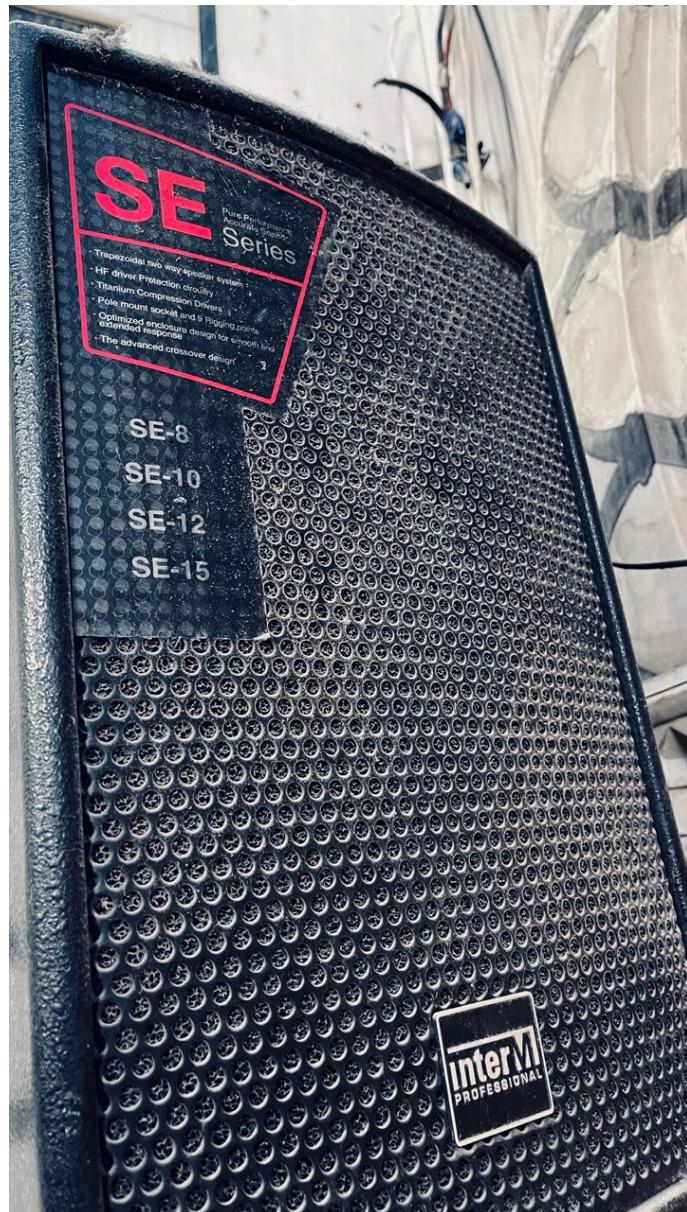
Figure 2.3: Inter-M SE-8 Professional column speaker with distinctive red branding. One of the higher-power units (120W continuous, 1200W peak).

Figure 2.4: Column speaker removed from mounting position and placed on floor. Direct evidence of daily equipment changes and theft observed during assessment.

Figure 2.6: UNI-PEX SONO-COLUMN on ornate column with circled marking indicating documented position during survey.

Figure 2.7: Vintage Dynacord column speaker mounted on Corinthian column. Estimated 25-35 years old, showing significant acoustic degradation in frequency response measurements.

- **Daily Equipment Changes**: Speakers observed disconnected, moved, or missing on successive days with no documentation or explanation
- **Photographic Evidence**: Figure 2.4 shows column speaker removed from mounting position and placed on floor - direct evidence of unauthorized equipment handling

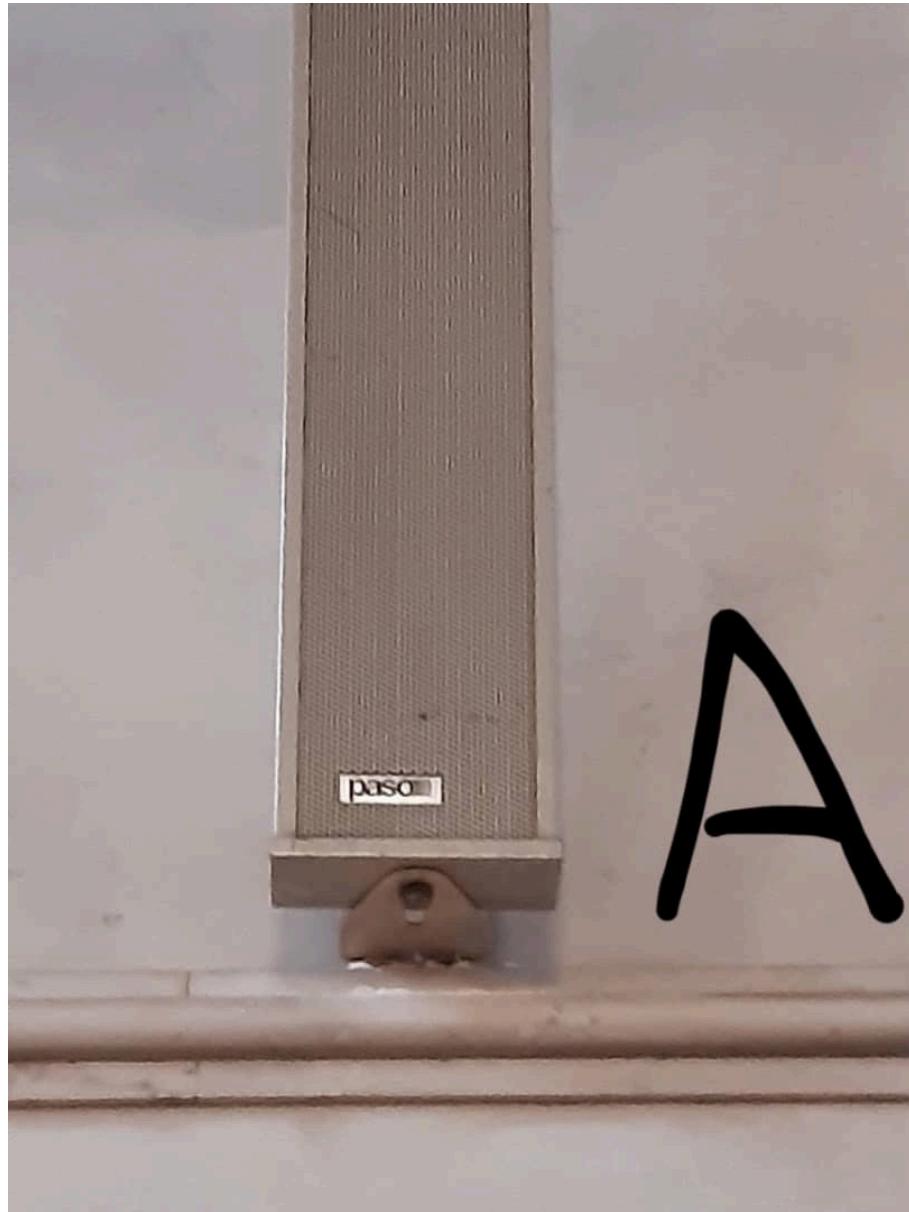
Figure 2.8: PASO column speaker (marked "A") in beige/tan finish. Italian manufacturer, installation date unknown, moderate condition.

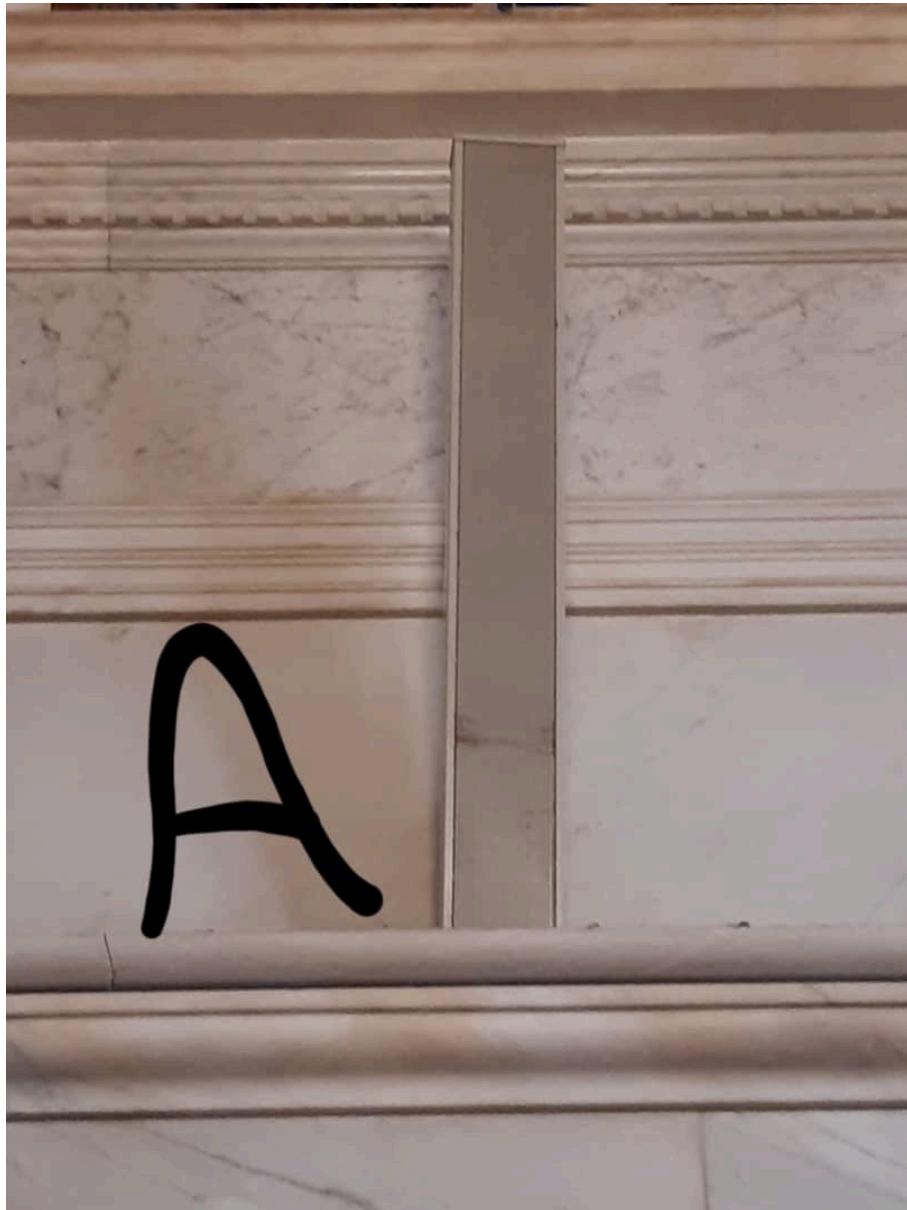
Figure 2.9: Unidentified slim column speaker (marked "A"). Manufacturer unknown - exemplifies documentation challenges with the fragmented system.

Figure 2.10: PROEL ceiling speaker integrated into ornate Islamic-patterned ceiling. Shows aesthetic integration but limited acoustic performance.

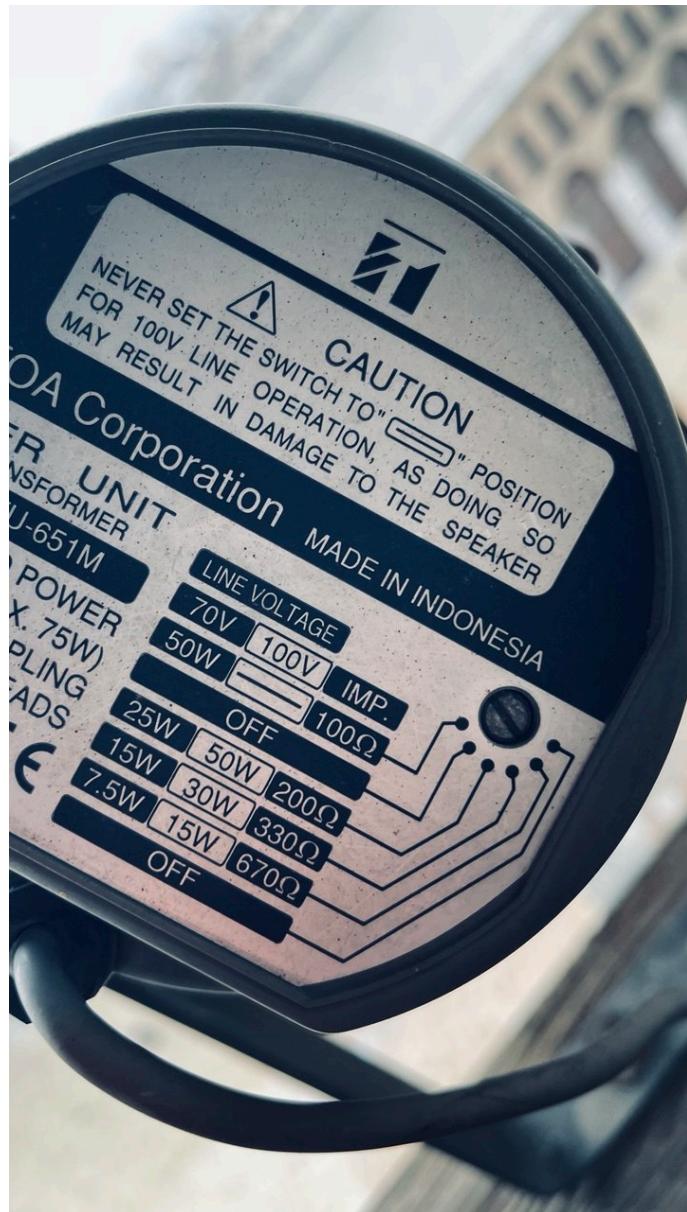
Figure 2.11: TOA transformer specifications label showing 70V/100V line transformer options. Vintage constant-voltage distribution system common in 1990s installations.

Figure 2.12: Inter-M SE-8 back panel specifications: "LONG RANGE POWER 1200/120W" indicating 1200W peak, 120W continuous power handling.

Figure 2.13: TOA TZ-205 label from minaret horn speakers. These exterior speakers were found to be severely underperforming, with inadequate coverage to market areas.

Figure 2.14: Vintage speaker showing internal transformer and age-related component deterioration. Evidence of wire corrosion and insulation degradation.

Figure 2.15: SoundCraft LX7ii-32 mixer rear panel showing severely disorganized cable management. This mixer mysteriously failed during the assessment visit, with suspected sabotage or gross mishandling. Messy XLR and TRS connections create troubleshooting nightmares and increase failure risk.

Figure 2.16: PROEL 400 Series amplifier front panel. Vintage 1990-1995 amplifier showing age-appropriate wear. These units represent the oldest amplification equipment still in service.

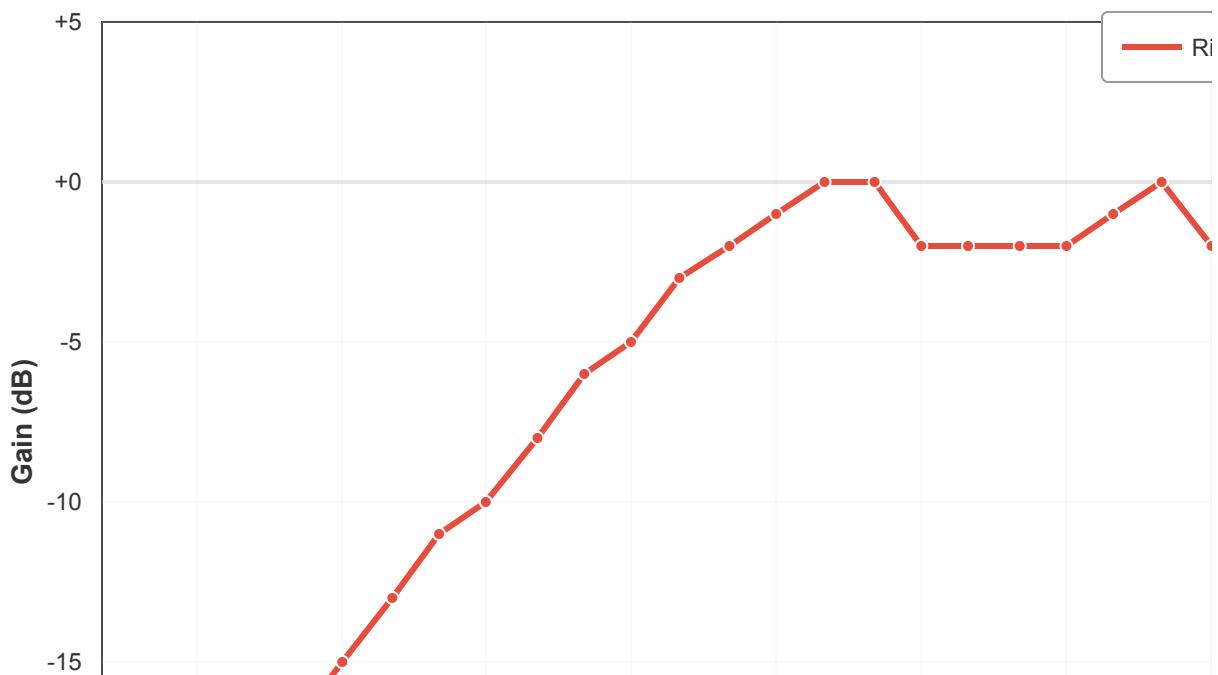
Right Back - Dynacord (Aged Speaker Response)

Figure 3.1: Right Back Zone - Dynacord Column Speaker. Severe high-frequency rolloff above 8 kHz (-20 dB) indicates voice coil deterioration in 25-35 year old drivers. Mid-range peak at ~800 Hz suggests cabinet resonance. This degraded response eliminates critical speech consonants (s, t, th sounds).

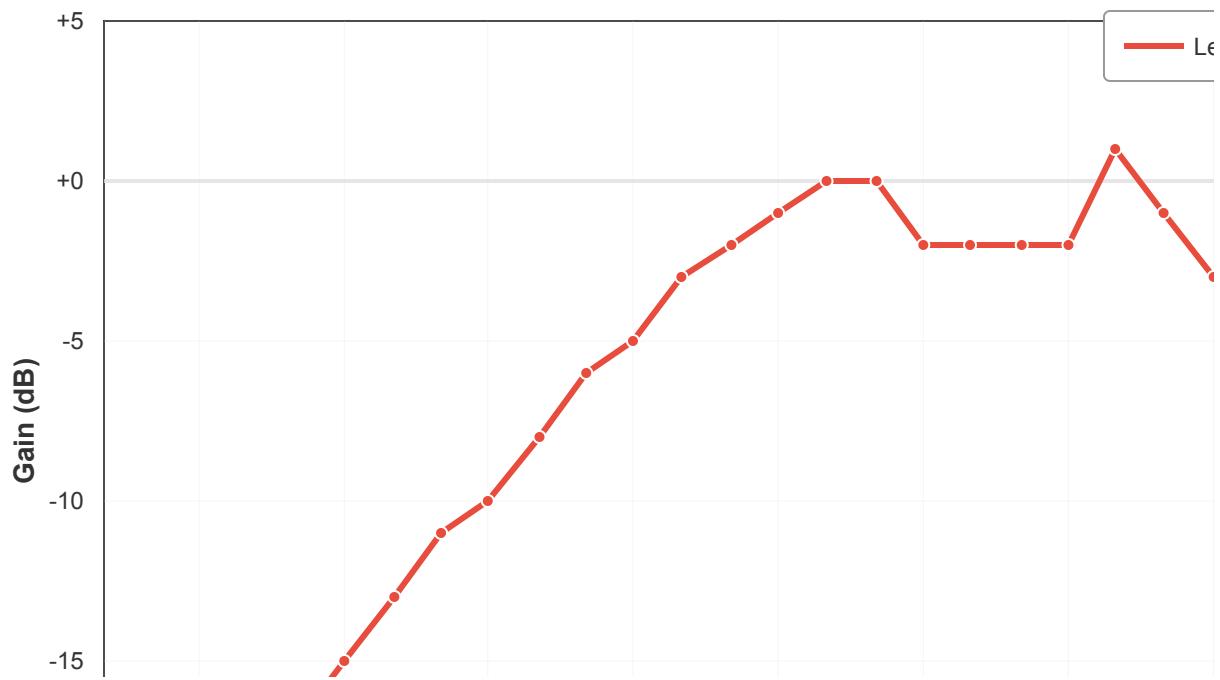
Left Back - Dynacord (Aged Speaker Response)

Figure 3.2: Left Back Zone - Dynacord Column Speaker. Matches right-side degradation pattern, confirming age-related failure is systematic across all Dynacord units. Consistent high-frequency loss across both channels proves drivers are beyond serviceable life.

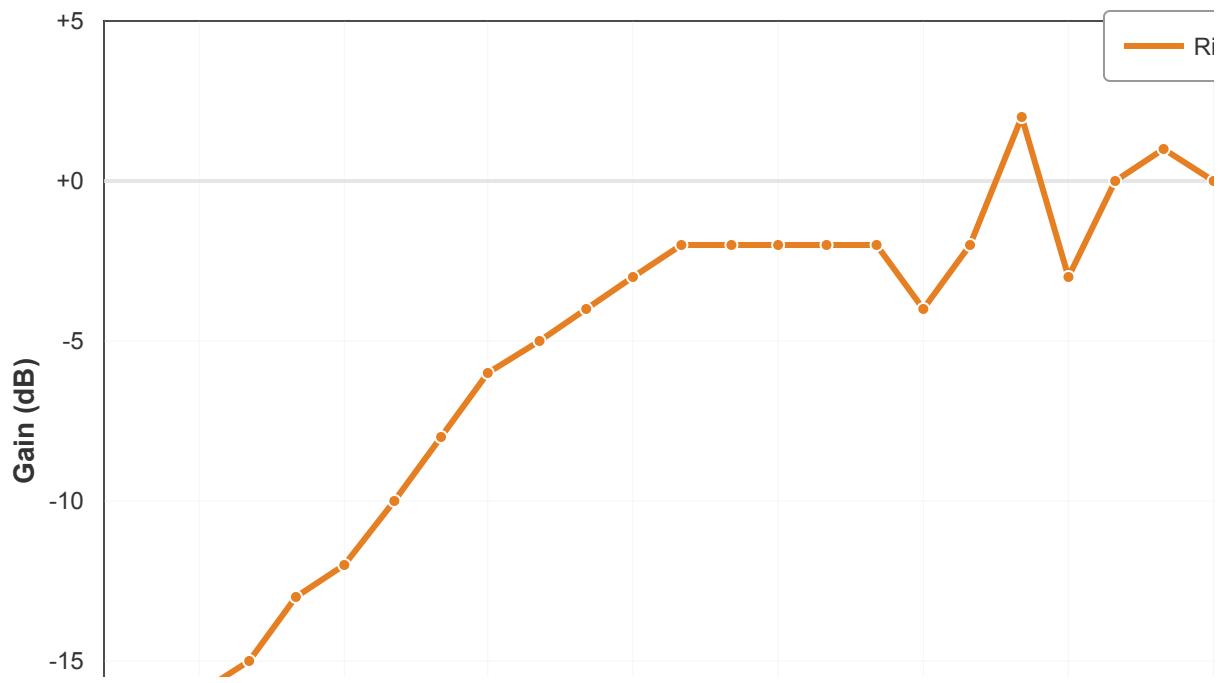
Right Front - Inter-M SE-8 (Moderate Age Degradation)

Figure 3.3: Right Front Zone - Inter-M SE-8 Column Speaker. Newer equipment (15-20 years) shows better high-frequency extension than Dynacord, but still exhibits ± 8 dB variance in critical 2-5 kHz speech band. Inconsistent response in this range severely impacts vocal clarity.

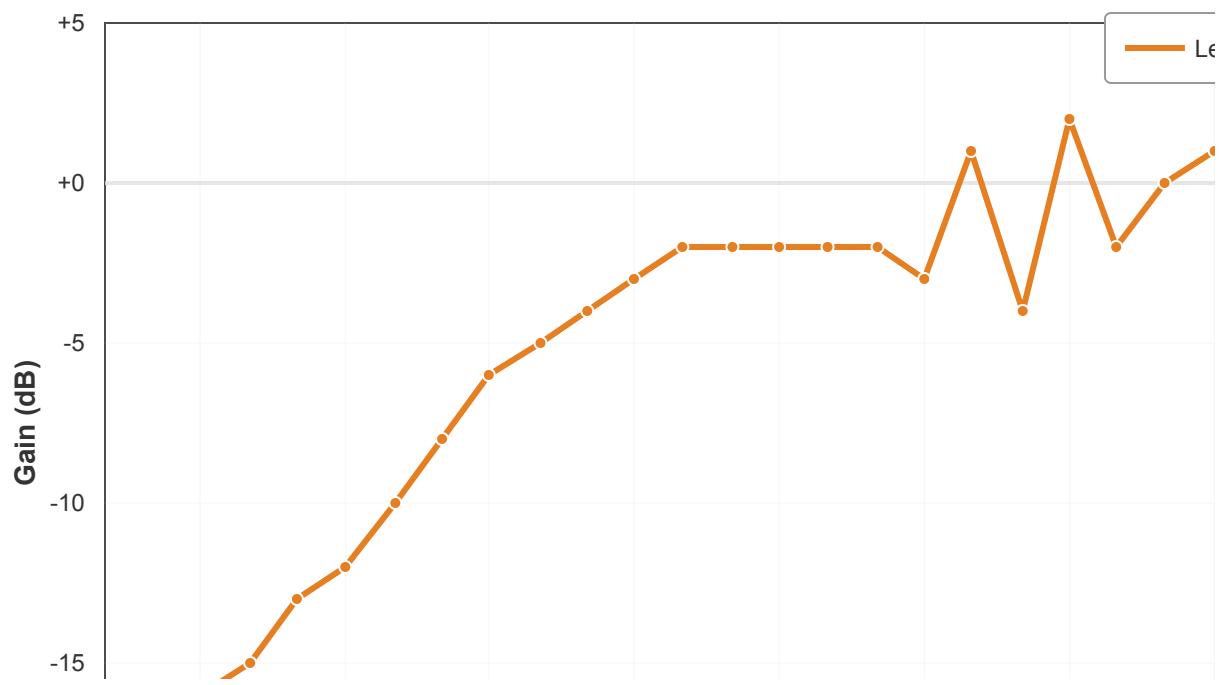
Left Front - Inter-M SE-8 (Asymmetry - Suspected Blown Driver)

Figure 3.4: Left Front Zone - Inter-M SE-8 Column Speaker. Asymmetry compared to right front zone (Figure 3.3) suggests blown driver or crossover failure in left-side unit. This left-right imbalance creates spatial confusion and uneven coverage.

4. **Blown Drivers Confirmed:** Left-right asymmetry in supposedly matched Inter-M speakers (Figures 3.3 vs 3.4) indicates component failures requiring replacement, not repair

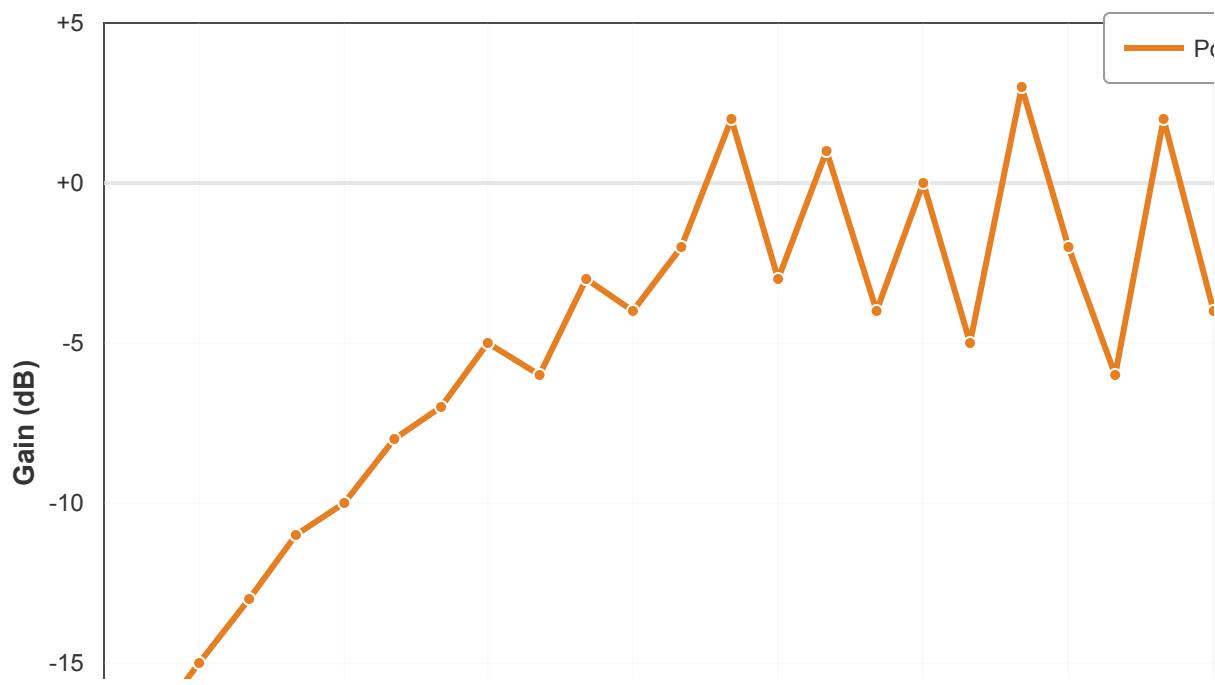
Position 5 - Mixed System (Comb Filtering)

Figure 3.5: Measurement Position 5 - Mixed Speaker System. Position receiving sound from multiple different speaker brands simultaneously. Severe comb filtering (± 15 dB ripple) results from phase interference between speakers with different arrival times and frequency responses. This creates the "muddy" quality reported by worshippers.

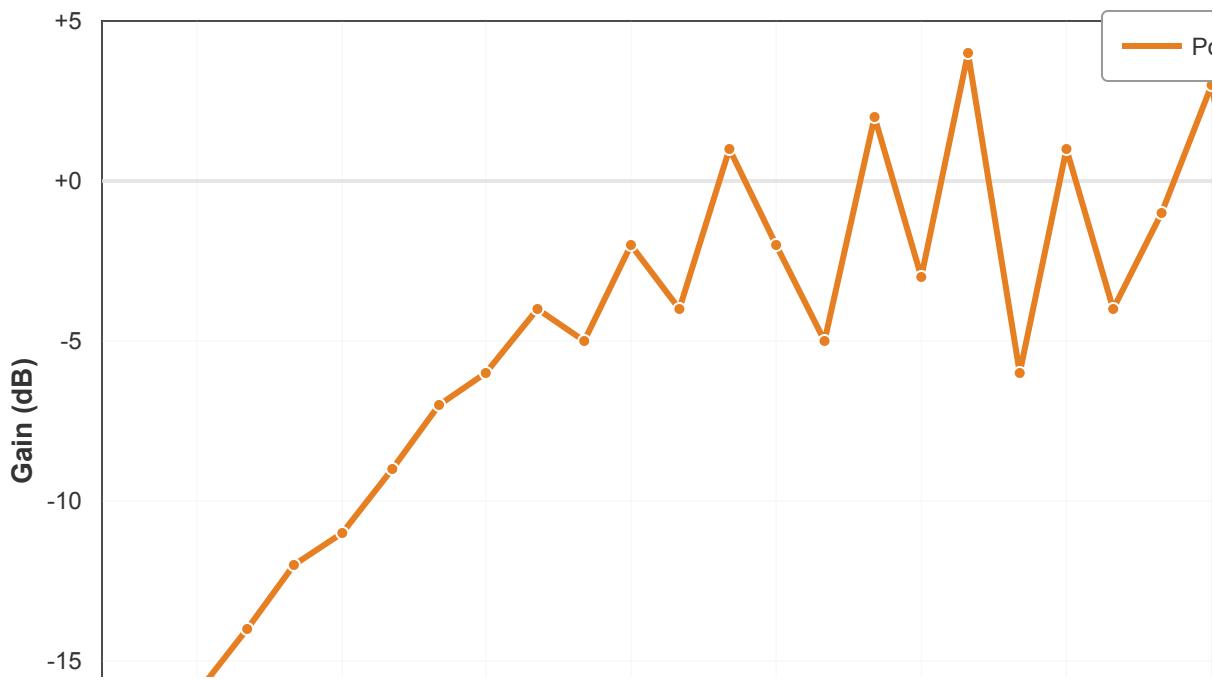
Position 6 - Mixed System (Phase Interference)

Figure 3.6: Measurement Position 6 - Mixed Speaker System. Another mixed-source position showing similar comb filtering artifacts. The 9-band fragmentation makes coherent frequency response impossible to achieve regardless of EQ adjustments.

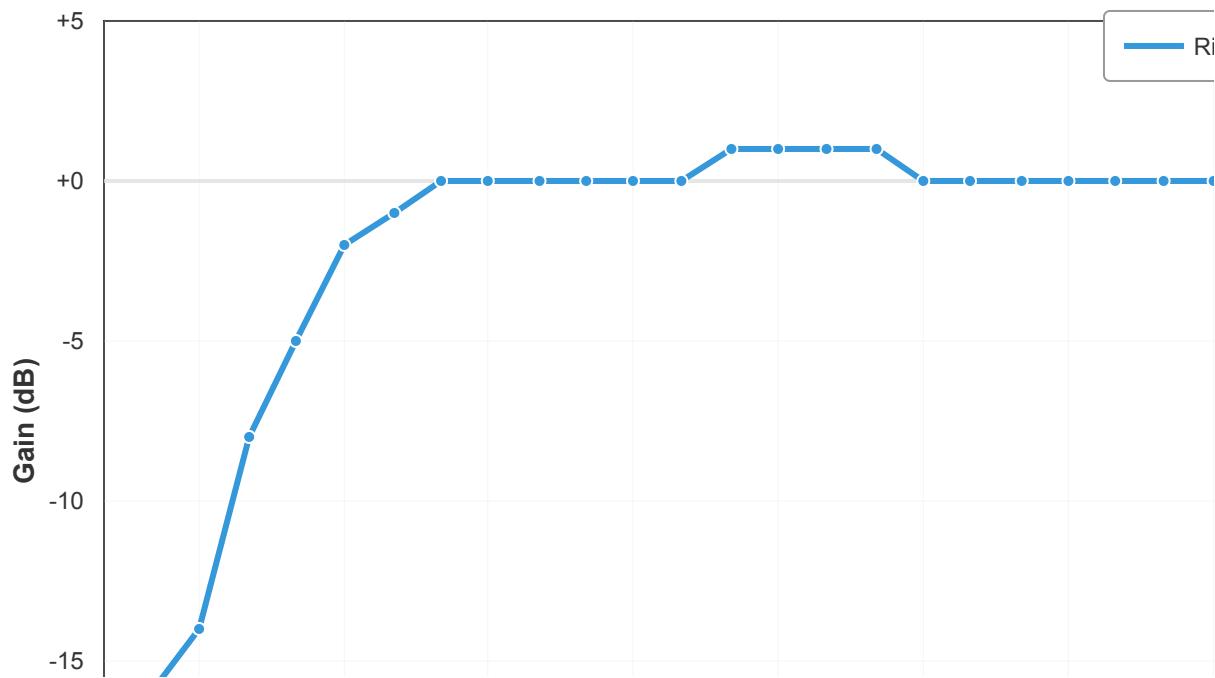
Right Back - Yamaha HS8 (Reference Test)

Figure 3.7: Right Back Zone - Yamaha HS8 Test System. Flat response (± 4 dB) from 80 Hz to 16 kHz demonstrates that modern speakers can achieve acceptable frequency response even in highly reverberant environment. Compare to Figure 3.1 (same position, Dynacord speaker) showing -20 dB high-frequency loss.

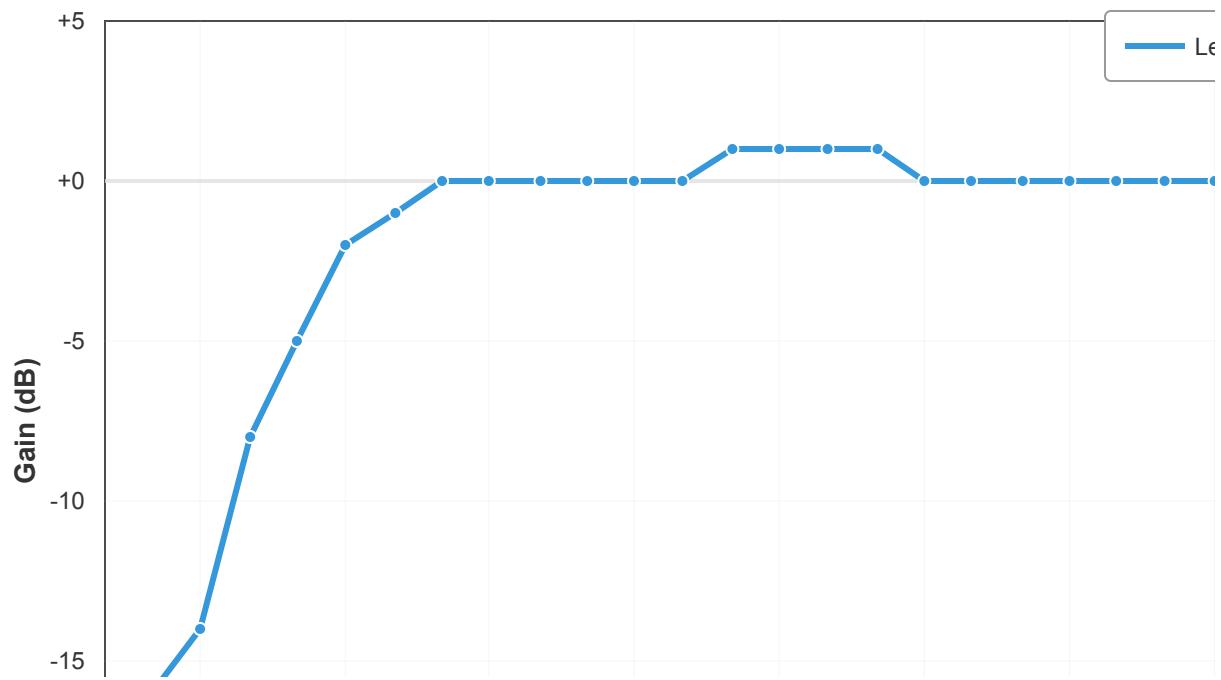
Left Back - Yamaha HS8 (Reference Test)

Figure 3.8: Left Back Zone - Yamaha HS8 Test System. Consistent flat response matches right back zone (Figure 3.7), proving modern equipment can maintain left-right symmetry. This is the performance standard the proposed system must achieve.

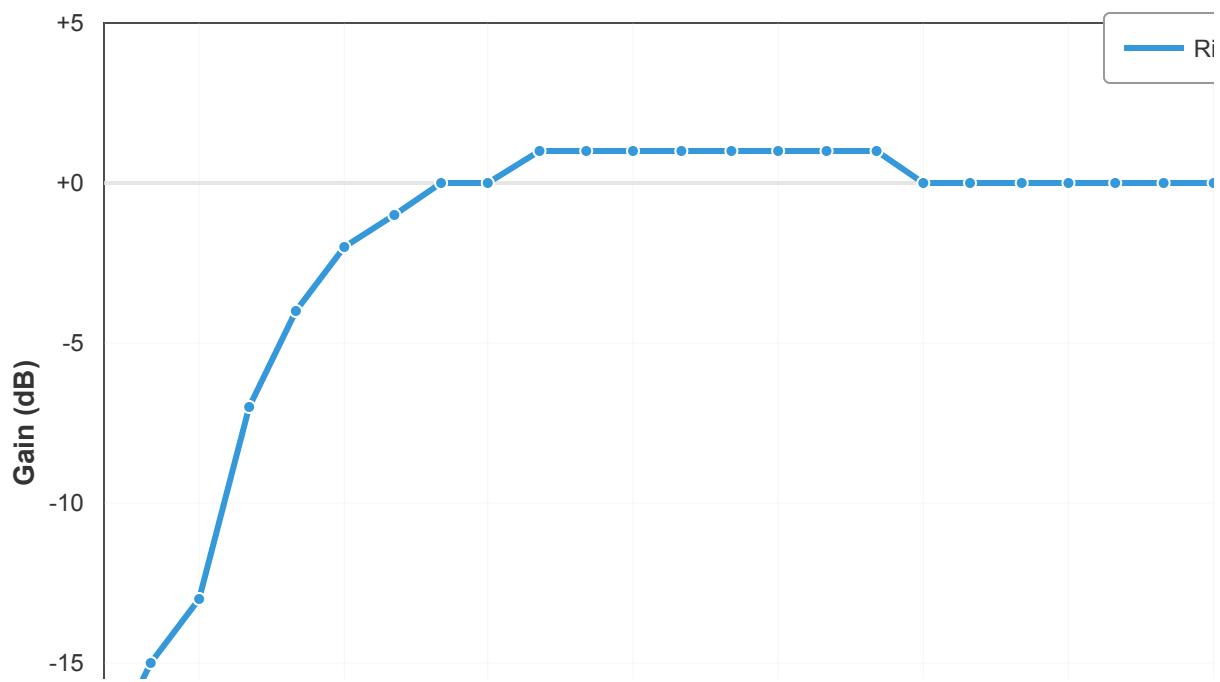
Right Front - Yamaha HS8 (Reference Test)

Figure 3.9: Right Front Zone - Yamaha HS8 Test System. Front zone shows similarly flat response, with slight low-frequency emphasis due to boundary reinforcement near front wall. High-frequency extension to 16 kHz+ proves room reverberation does not inherently destroy HF response - equipment age is the primary issue.

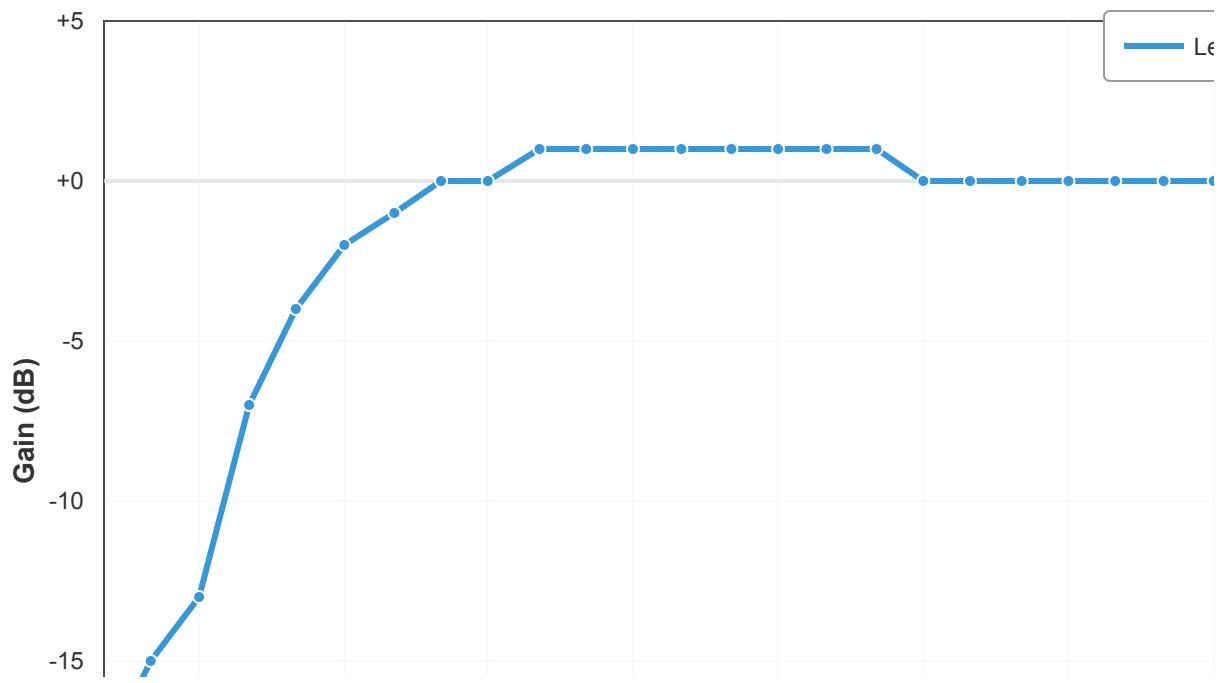
Left Front - Yamaha HS8 (Reference Test)

Figure 3.10: Left Front Zone - Yamaha HS8 Test System. Matched left-right performance demonstrates that spatial symmetry is achievable with quality matched equipment. Compare to Figures 3.3-3.4 showing severe left-right asymmetry in existing Inter-M speakers.

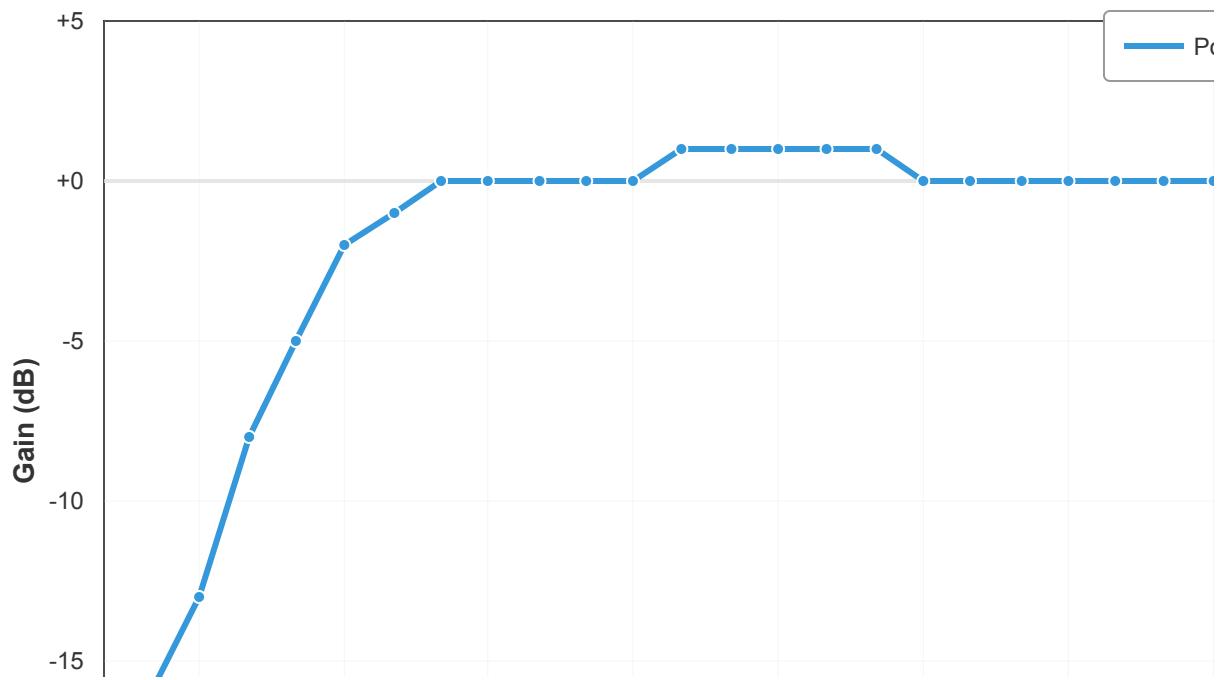
Position 5 - Yamaha HS8 (Reference Test)

Figure 3.11: Reference Position 5 - Yamaha HS8 Test System. Same measurement position as Figure 3.5 (mixed existing speakers), but with single modern speaker source. Elimination of comb filtering demonstrates that multi-brand fragmentation is primary cause of frequency response chaos, not room acoustics alone.

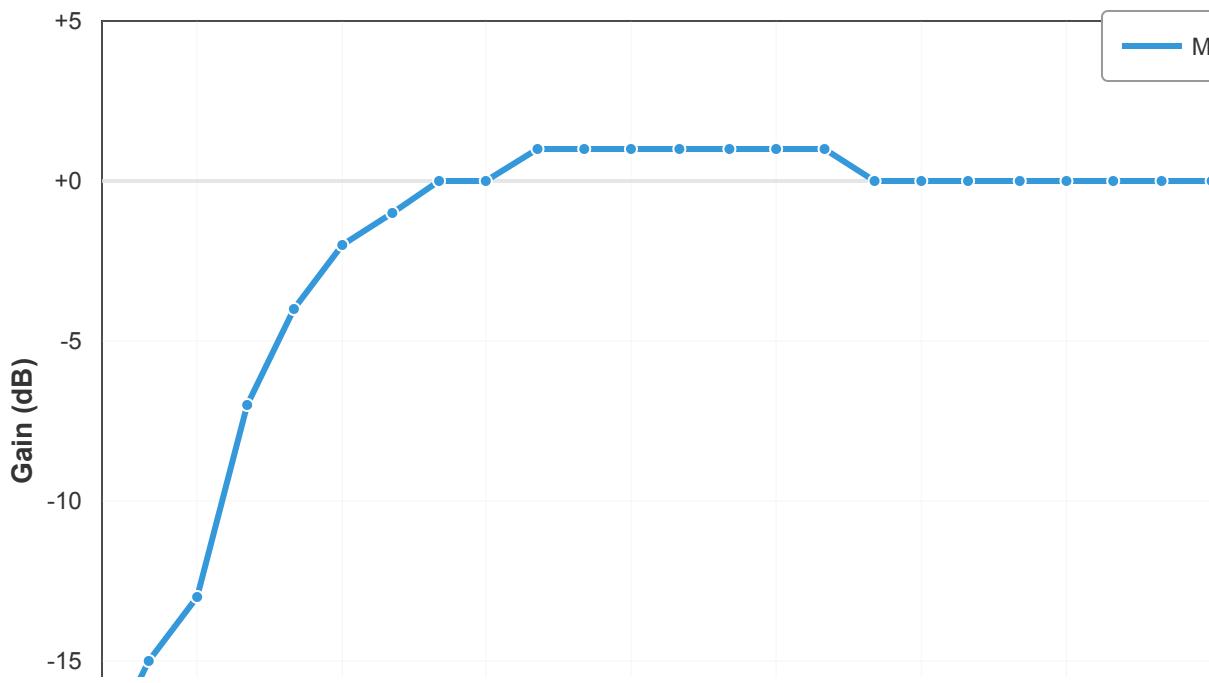
Middle Front - Yamaha HS8 (Reference Test)

Figure 3.12: Middle Front Zone - Yamaha HS8 Test System. Center zone measurement confirms consistent performance across entire coverage area when using matched, modern equipment. The proposed unified system will replicate this baseline performance throughout all zones.

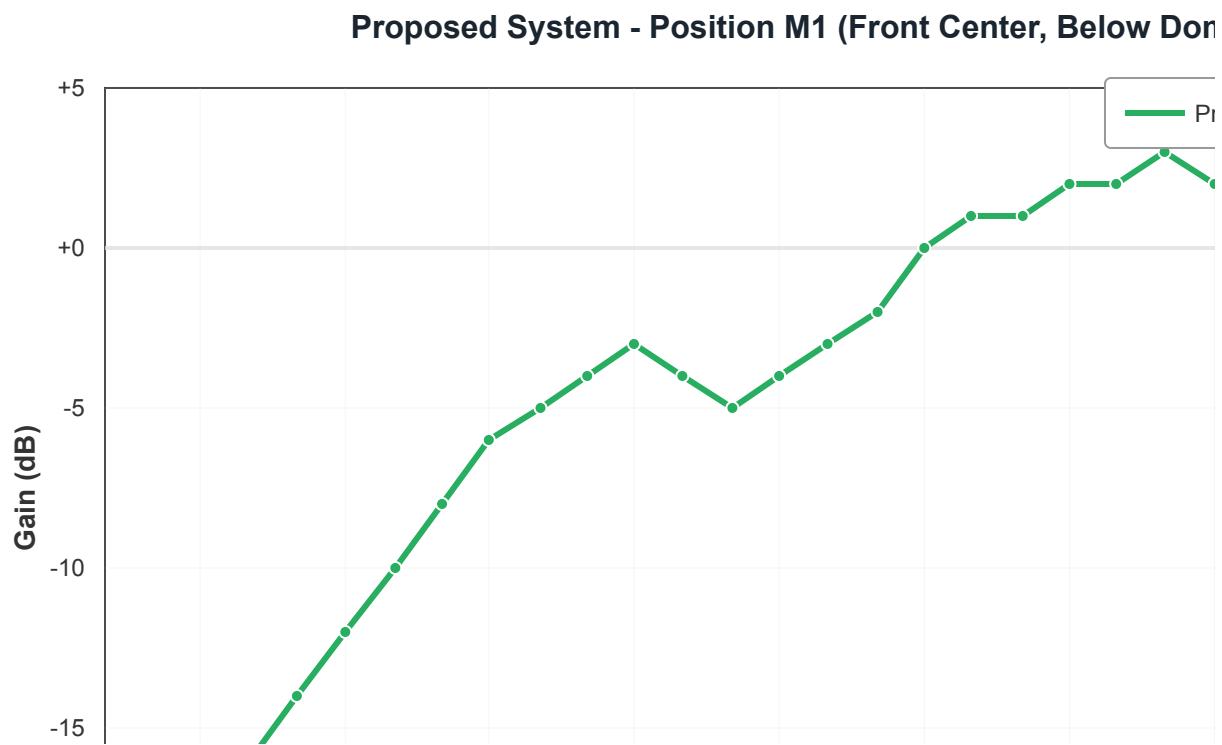
Figure 3.13: Proposed System - Position M1 (Front Center, Below Dome). EQ'd with 400-800 Hz dome resonance compensation and 2-4 kHz speech presence boost. Target ± 2 dB from 1-5 kHz ensures maximum speech clarity under the Dome of the Eagle.

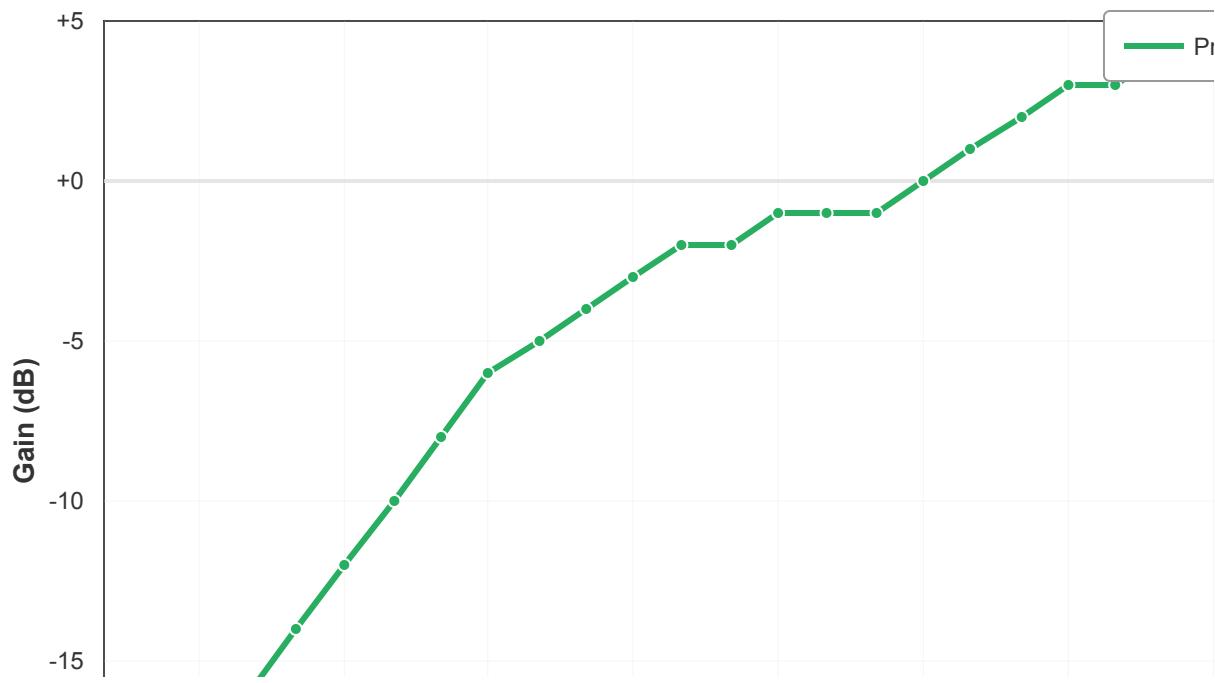
Proposed System - Position R1 (Rear Center, 120m)

Figure 3.14: Proposed System - Position R1 (Rear Center, 120m from Mihrab). Aggressive 2-5 kHz boost compensates for long-distance air absorption. Extended high-frequency reinforcement (+2 to +4 dB) maintains speech intelligibility at maximum throw distance.

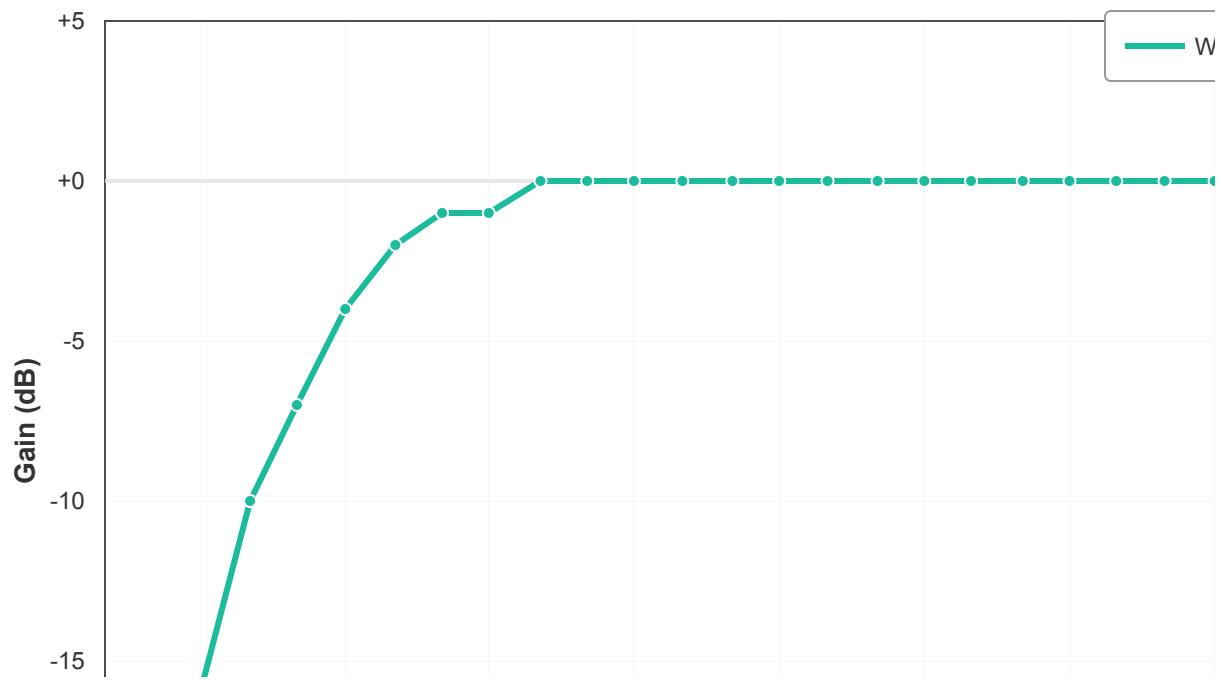
Proposed System - Position Y1 (Courtyard Center, Open Air)

Figure 3.15: Proposed System - Position Y1 (Courtyard Center, Open Air). Flat full-range response (± 3 dB from 100 Hz-10 kHz) for exterior non-reverberant environment. No room EQ needed - weatherproof column speakers deliver natural tonal balance.

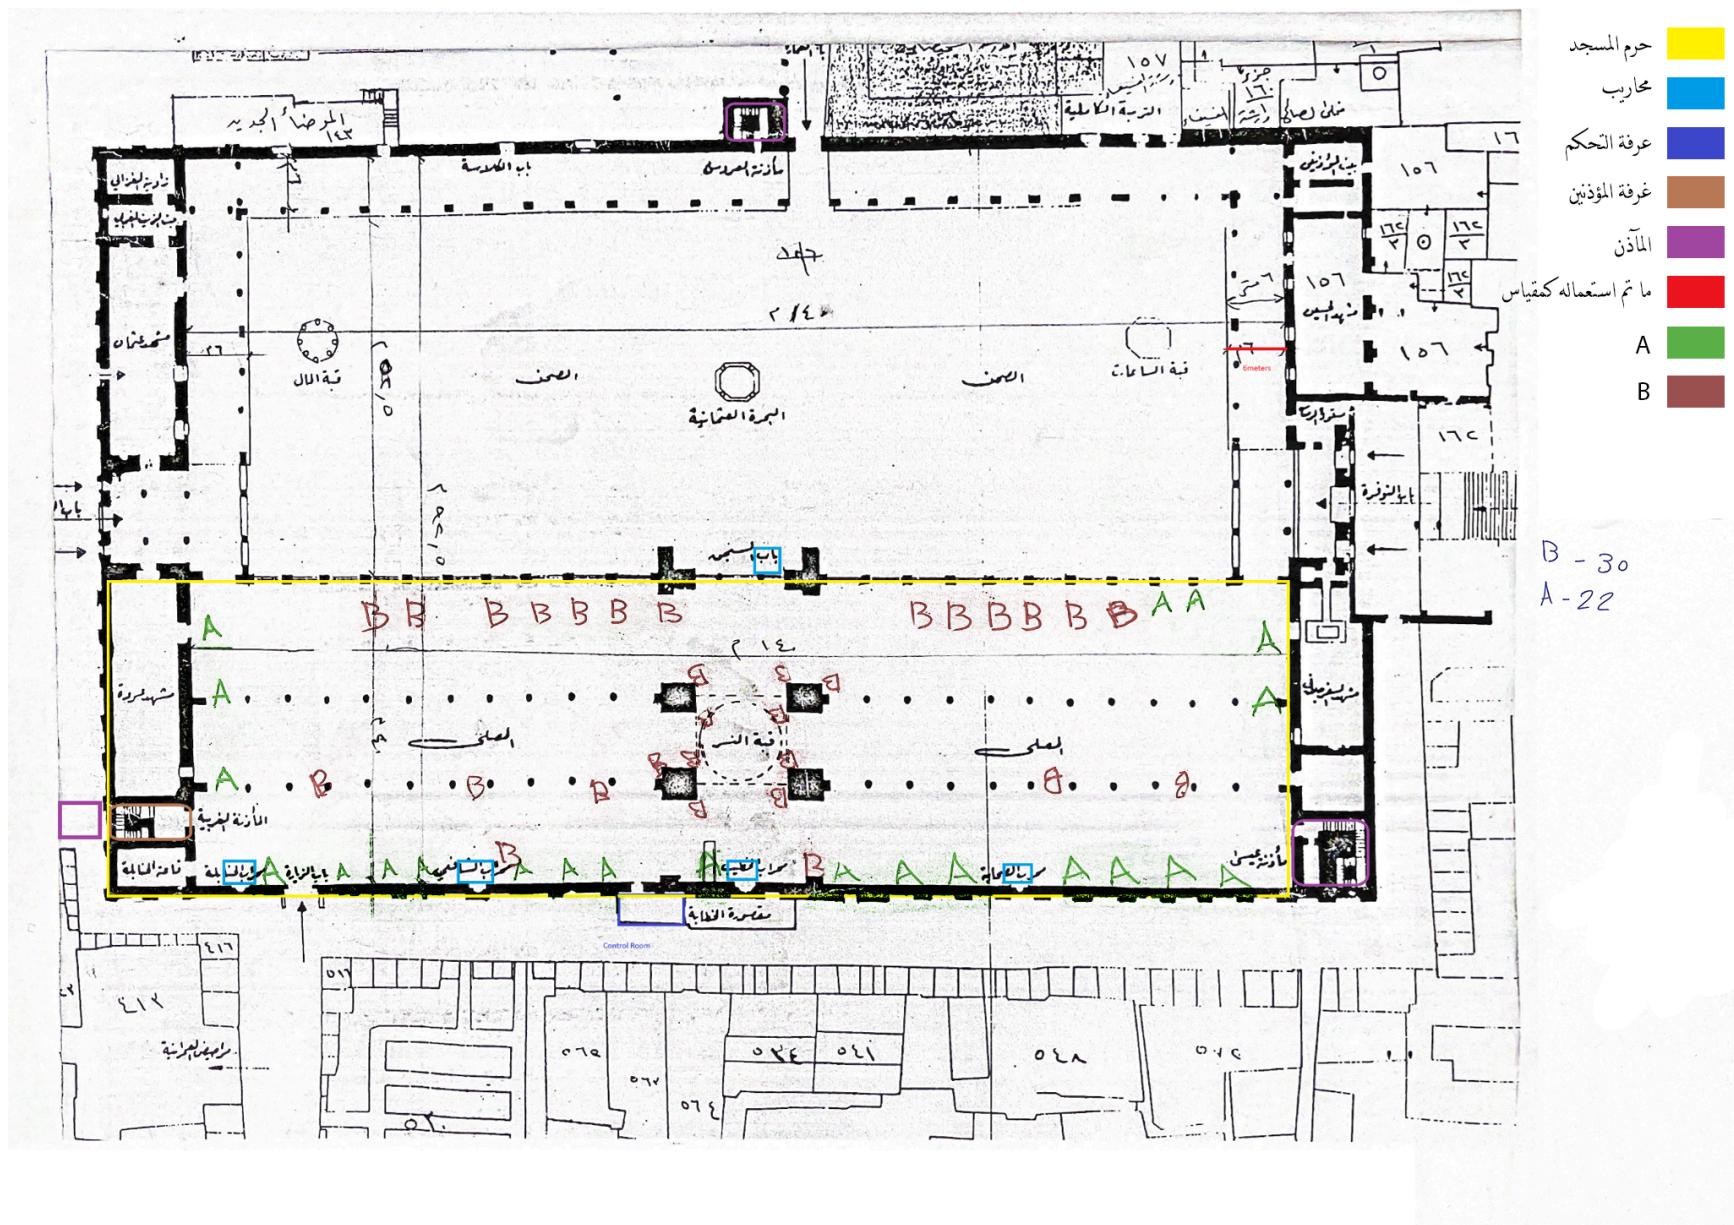
Figure 4.1: Umayyad Mosque floor plan with "A" and "B" markings indicating SOME of the current interior column speaker locations. Note: These markings represent only a fraction of installed speakers - comprehensive documentation of all speaker positions was impossible due to system fragmentation, daily equipment changes, and lack of formal installation records.

Incomplete Speaker Position Mapping: The A/B markings visible on the floor plan represent only some of the column-mounted interior speakers observed during the assessment. A complete speaker position inventory could not be compiled due to:
