## Replace the defective wind vane and defect wind sensor

**Replace the defect Nacelle TOI Unit**

**Replace the new Yaw gear unit**

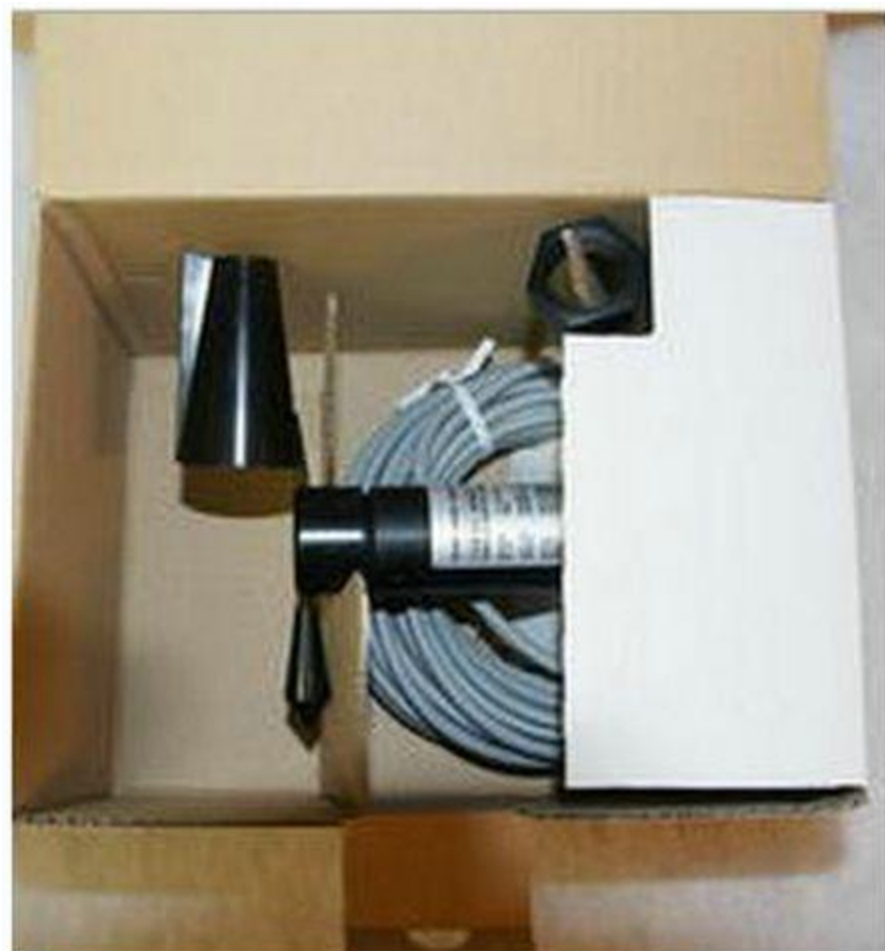
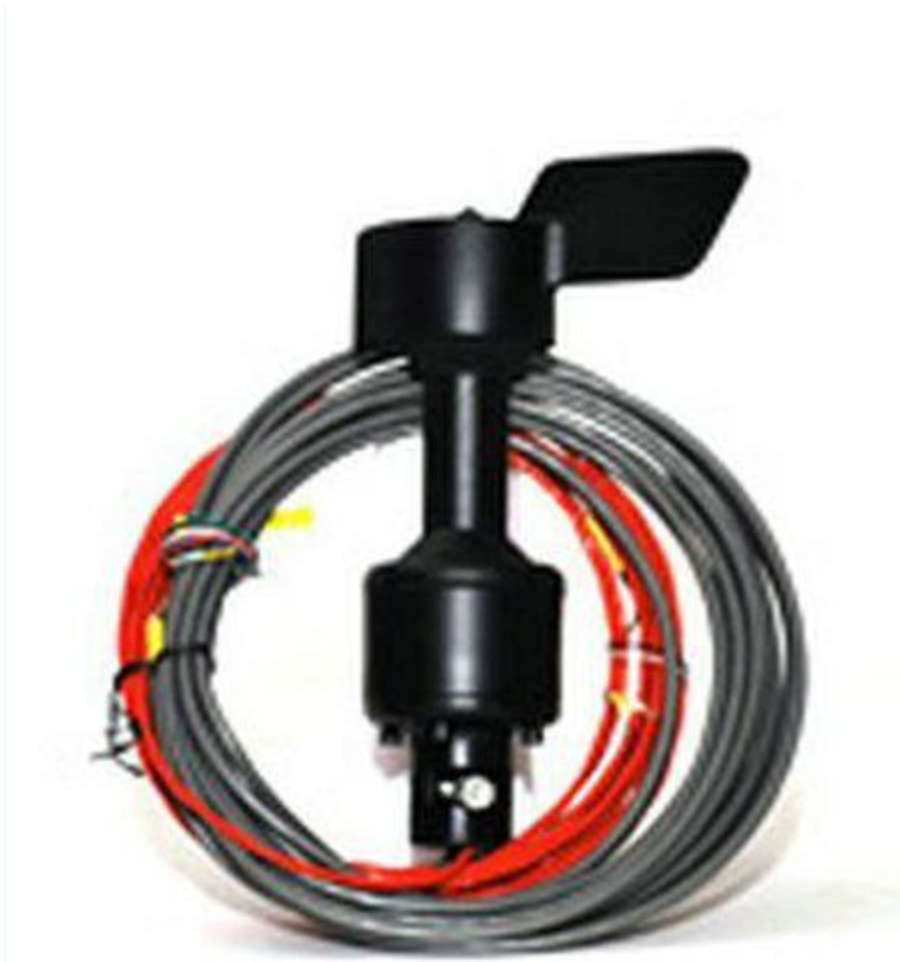
If the wind vane is defective replace with new wind vane.

Relevant spare parts	
Description	Item No.
WVA HEATED DWS-D-DAC-13 (CG)	<a href="#">60092777</a>
WINDVANE NRG 2 ICEFREE, ARCTIC (NRG)	<a href="#">60009349</a>

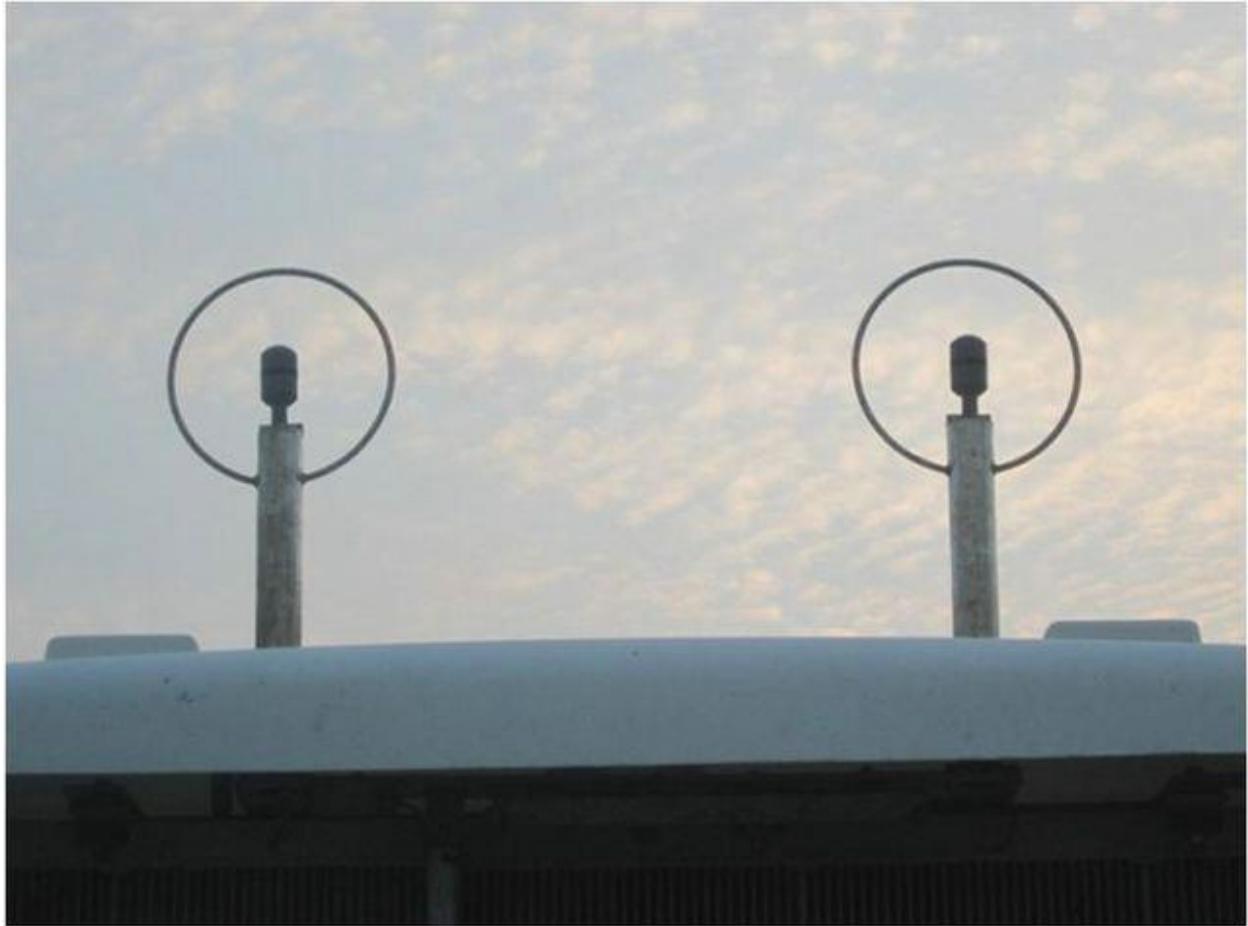
Check the FT sensor alignment and working condition.

If found to be defective, replace with new one.

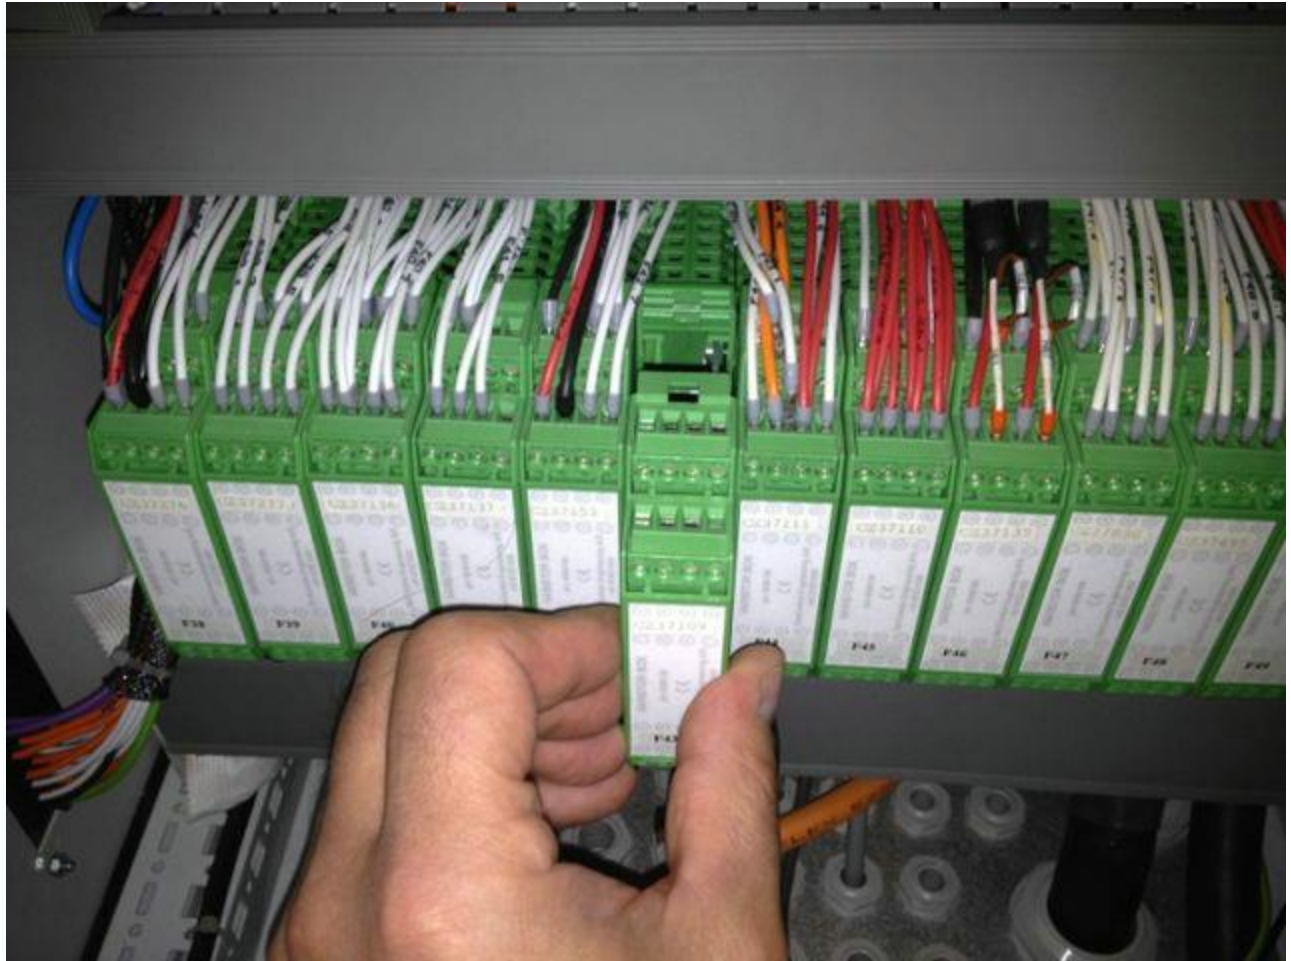
Press clip on top and bottom of varistor box and remove varistor assembly from housing:

The varistor box is made up of eight varistors and has provisions for 16 wire connections (protection for 8 signals)

Both wind sensor 1 (left) and wind sensor 2 (right) use varistor box F46. Terminals 1-4 (top and bottom) are for wind sensor 1 and 5-8 (top and bottom) are for wind sensor 2.

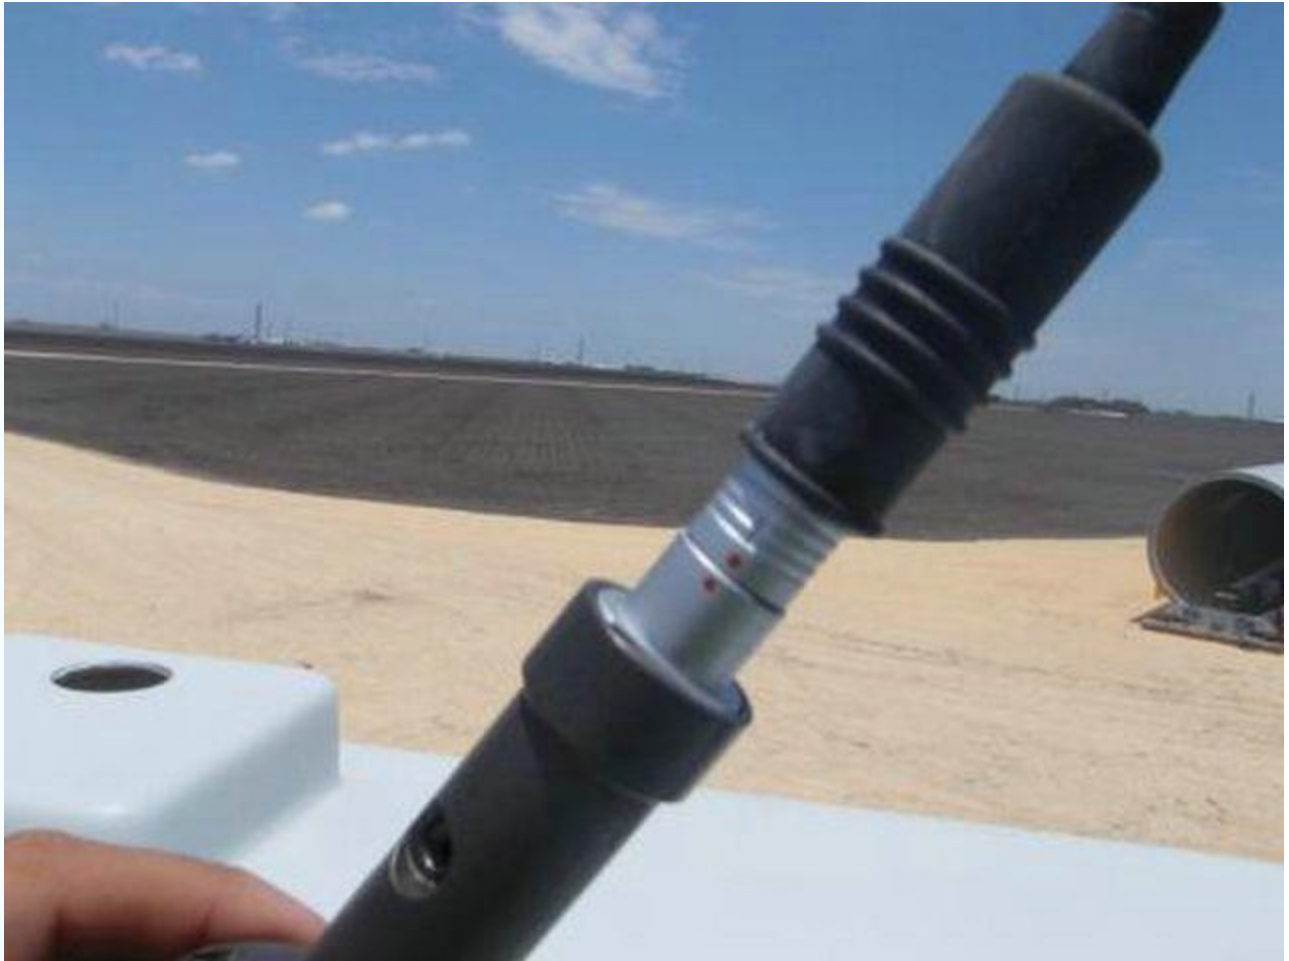
Cable plug and protective boot:

If the cable is mounted tight and it pulls in the sensor connector, it must be connected so that it is not pulling the plug.

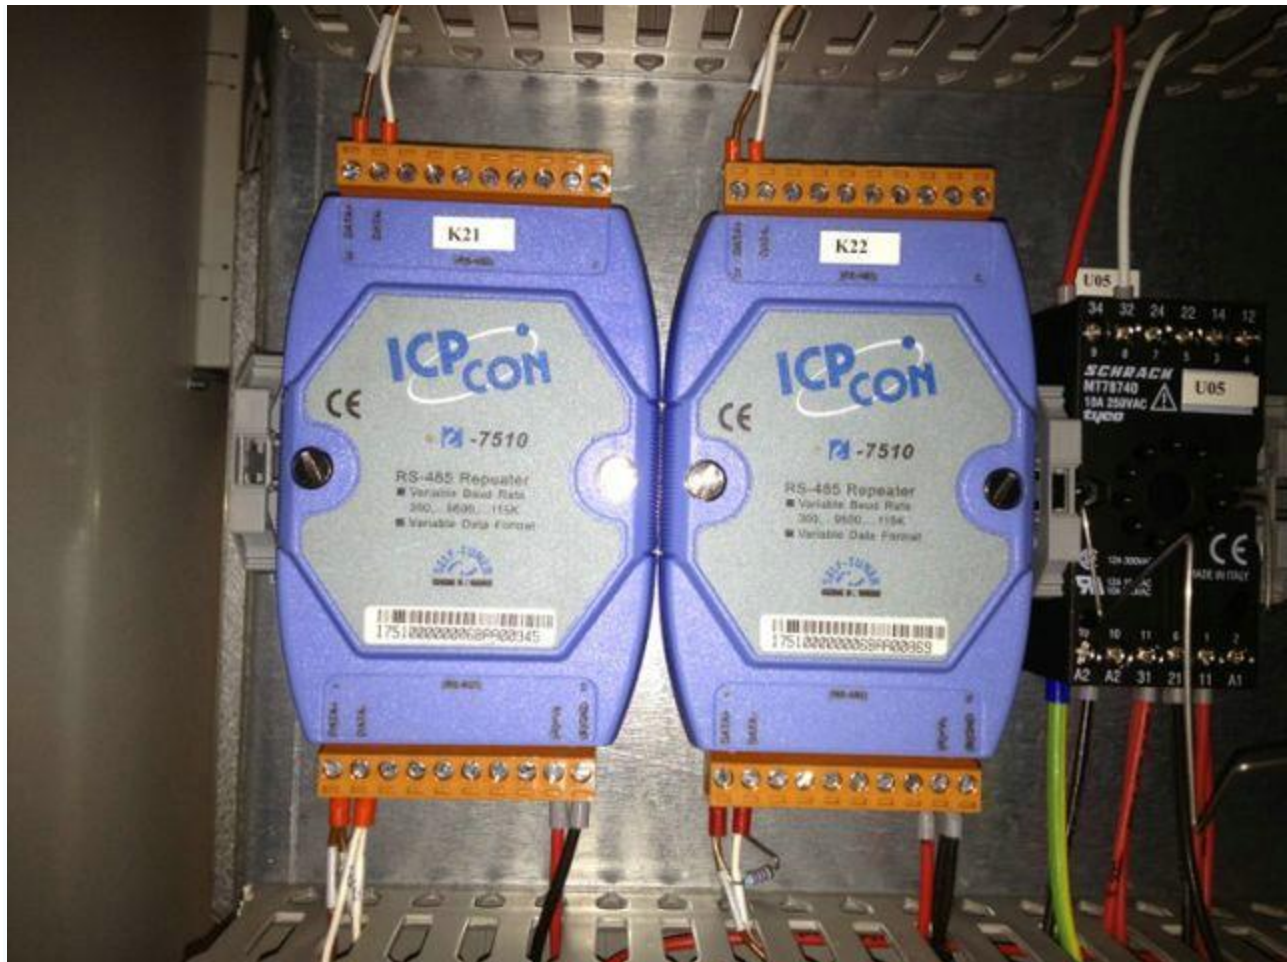
Check the connections at the ICP RS485 repeaters (K21 & K22) in the AN1.

Check for loose wires and plugs or corrosion at the repeater.

If there is no communication on one sensor, switch the ICP RS485 repeaters to see if the communication returns. If communication returns when the repeaters are switched, replace the faulty repeater. Item number:

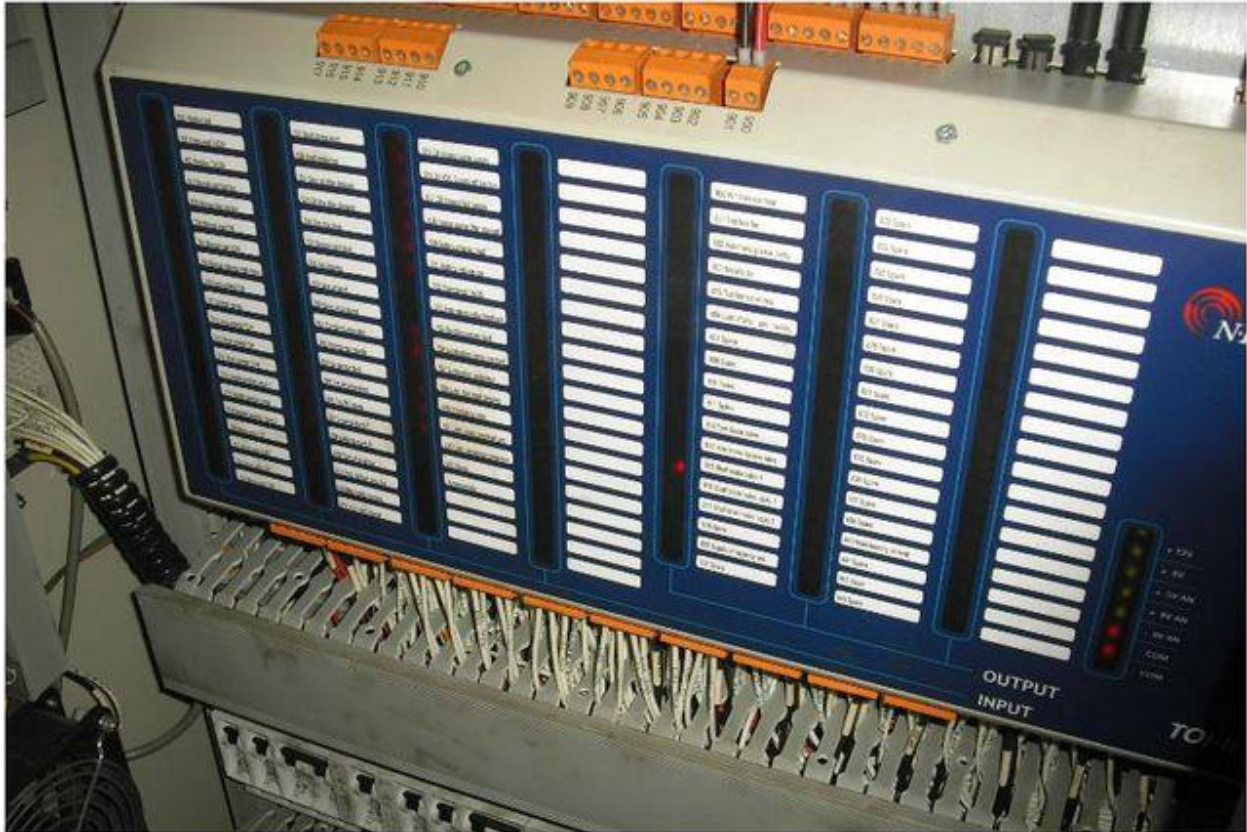
Check the indication of nacelle TOI unit during yawing, the LED should be blink and TAC yaw counter value will change.

If the value does not change in the TAC, then the cause is likely a faulty Nacelle TOI.

**Nacelle TOI part Number:**

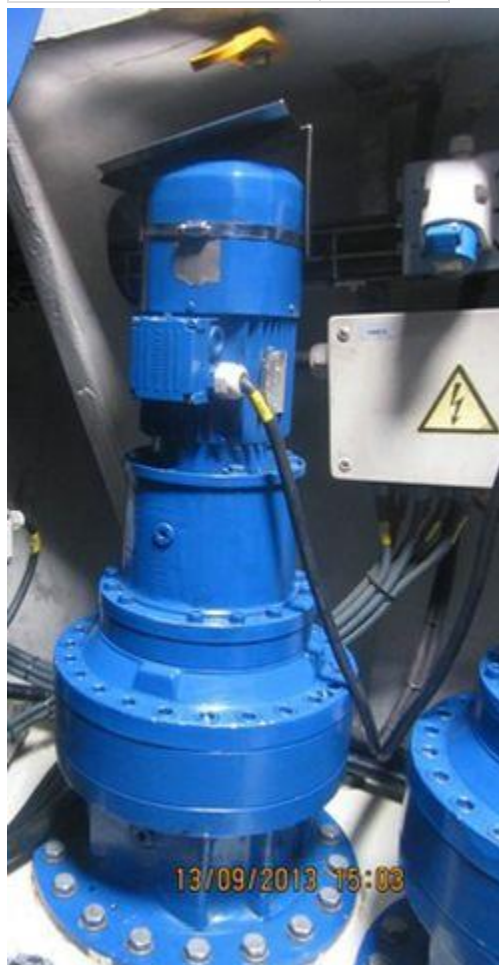
Check the yaw gear which is connected in the yaw system.

Check the teeth in the remaining yaw gear pinion wheels if any damage.

If abnormal sound can be heard in the yaw gear unit it is likely defective.
