OpenRiverCam in Indonesia: What the Pilot Taught Us, and the Path Forward

Indonesia ORC Deployment — Spring 2026

American Red Cross / Palang Merah Indonesia

Version 2026-08-31 (draft for internal review — not yet circulated) | Audience: IPB and BHLK leadership | Built 2026-08-31

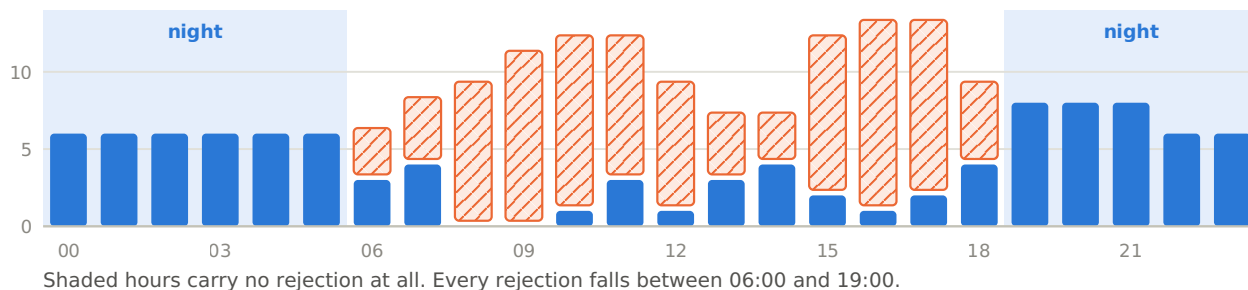
Figure 2 Reading the water level from video, 8 to 14 July 2026

Water level is read from the image, and daylight defeats it. Sukabumi has no water-level sensor and derives the level from the video. In a sample of 200 captures every rejection fell between 06:00 and 19:00, and none at night. Because the water level is worked out first, a daytime rejection costs the whole discharge measurement and not only the level.

200 captures. A rejection costs the whole discharge measurement, not only the water level.

Rejected captures are not near misses: half sit at 1.63 or below, and only 23 of the 100 reach 1.8.
Accepted captures spread well above the threshold, though 36 of them sit between 2.0 and 3.0.

Captures counted by hour of day, and the confidence score of all 200 captures against the threshold at which a water level is accepted. Rejections peak in mid-morning and again in mid-afternoon, with fewer in the early afternoon — the pattern a sun-angle effect produces and a general brightness effect would not.

The cause is most likely reflected sunlight, and that reading is well supported by the shape of the day, but it is not settled. The recommendation below rests on the failure, which is measured, and not on the explanation.

What we would build instead: an independent water-level reference — a sensor, or a staff gauge inside the camera's view — so the measurement does not depend on a single optical method succeeding. Deriving the level from the image is a good capability to have and a poor one to rely on alone. That is R1, and it is the change with the clearest benefit.
