Indoor Air Quality Assessment

Screening-Level IAQ Assessment Report

FACILITY	Meridian Commerce Tower (sample)
ADDRESS	1450 Asherton Park Drive, Suite 600, Calverton Heights, MD 20899
SCOPE	Floors 7, 8, and 12
ASSESSMENT DATE	March 14, 2026
ASSESSOR OF RECORD	John Smith, CIH, CSP
REPORT ID	PSEC-IAQ-2026-0314-MCT

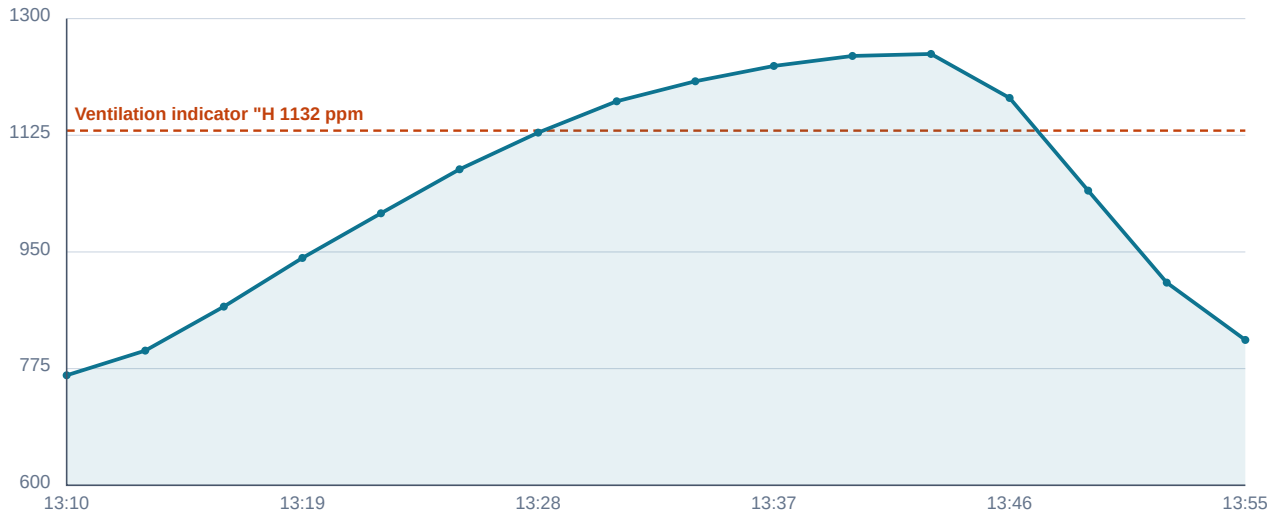
Figure 2 — CO₂ trend, Zone 8-D conference room (1-min logger)

Observed: Outdoor baseline averaged 432 ppm. Indoor concentrations ranged 612–1247 ppm (site mean 856 ppm). ASHRAE 62.1 prescribes ventilation rates rather than a CO2 limit; an indoor-to-outdoor differential above roughly 700 ppm is commonly used as an indicator of under-ventilation relative to occupant load. The conference-room peak of 1247 ppm in Zone 8-D — captured during a six-person meeting — represents 815 ppm above outdoor baseline, exceeding the indicator by ~115 ppm during the measurement window. All other zones remained within the indicator range.

Beyond the grab readings above, a data logger captured CO₂ at one-minute intervals in the interior conference room (Zone 8-D) across a six-person meeting. AtmosFlow Logger Studio charts the series and overlays the ventilation-indicator threshold. The trend shows concentrations climbing through the occupied period and recovering once the room cleared — the signature of outdoor-air delivery lagging occupant load.

Logger Studio export. Peak 1,247 ppm at ~13:43 during the meeting; baseline recovery within roughly ten minutes of adjournment.

- Increase outdoor-air supply to Floor 8, Zone 8-D during occupied hours. Verify VAV damper position and economizer operation through the building automation system (BAS).
- Until balanced, relocate meetings of more than four persons to perimeter conference rooms with higher supply capacity.
- Confirm the copy/print room (8-F) door-undercut and any transfer-air path; if a local exhaust fan is present, verify it runs during business hours.

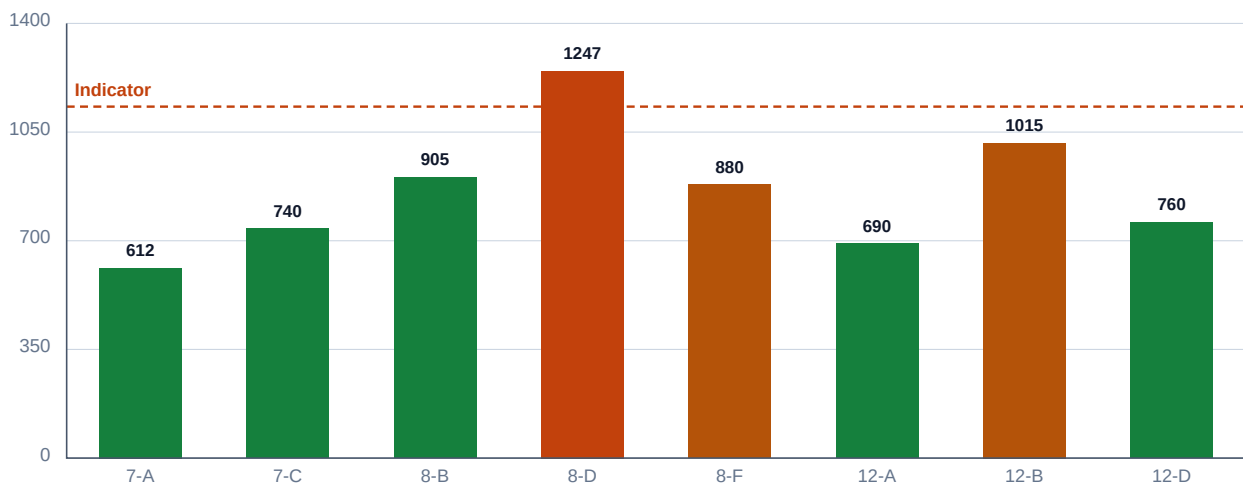
Figure 3 — Peak CO₂ by zone vs. ventilation indicator

Across the eight zones, only the interior conference room (8-D) exceeds the ventilation indicator; every other space falls below it.
