### Replace the defective wind sensor

#### IN THE NACELLE:

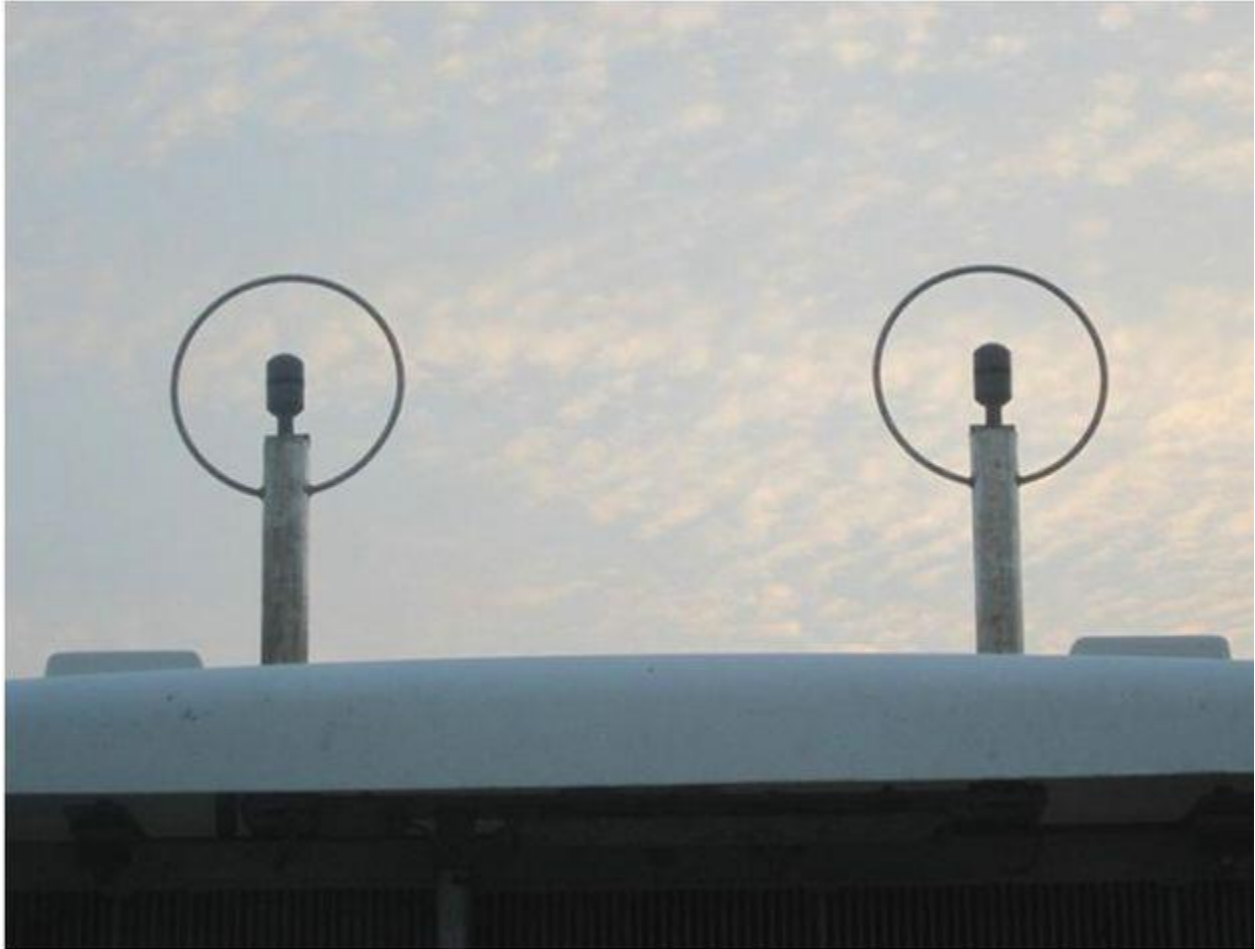
If the fault is intermittent and occurring often

Set up the TAC data-logger to trigger on fault 219 and record wind direction and speed for both sensors. If signal is consistently missing at the exact same time from both sensors then it is likely a problem with communication between the TAC controller and the sensor.

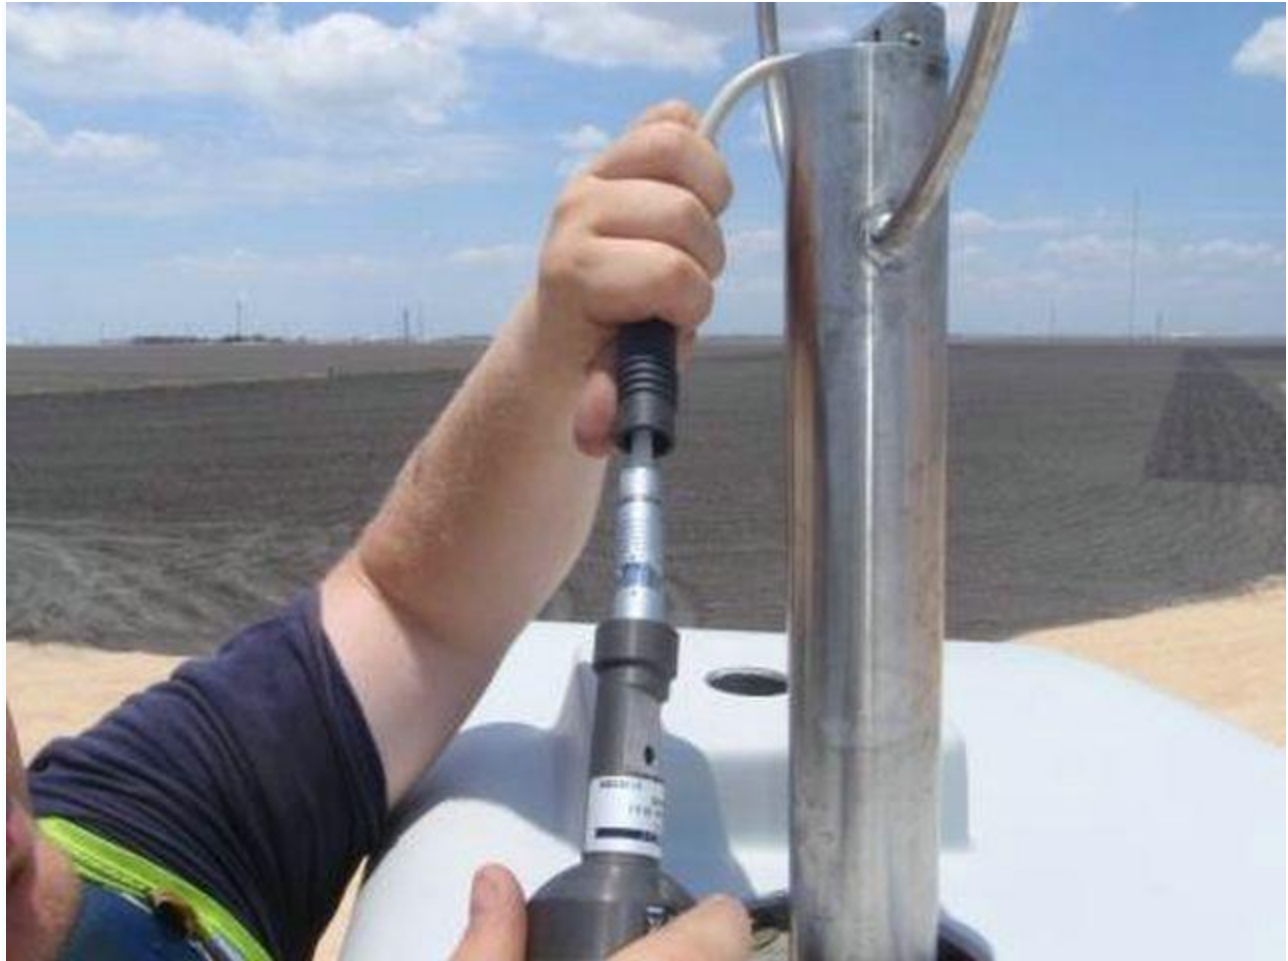
Remove connector on the wind sensors and check for signs of moisture/corrosion/damage.

If the cable or plug has been damaged or shows signs of corrosion that cannot be repaired, replace the respective cable with a new one.

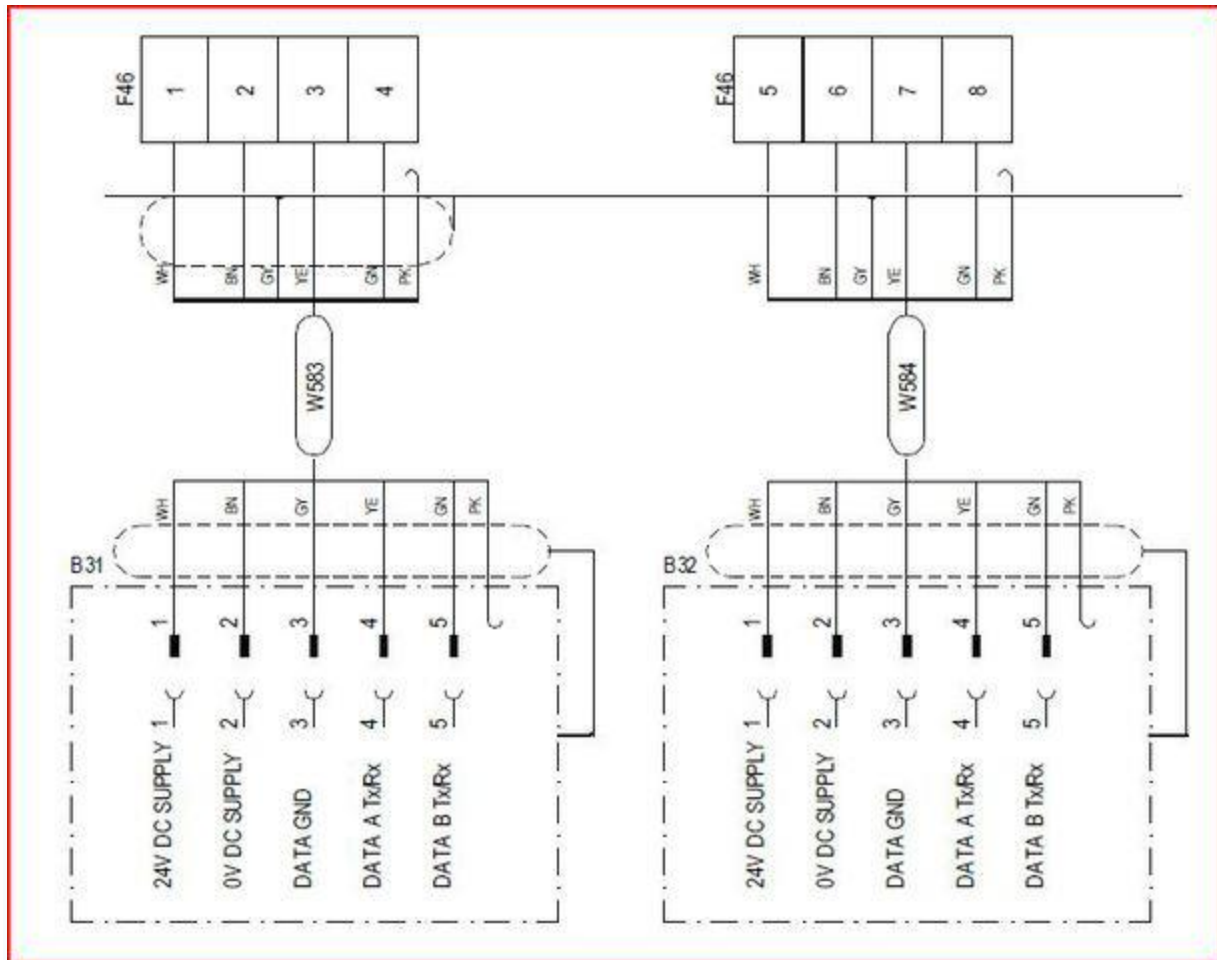
Check the wind direction signal in the TAC computer.

Observe the wind direction for any deviation from both sensors.

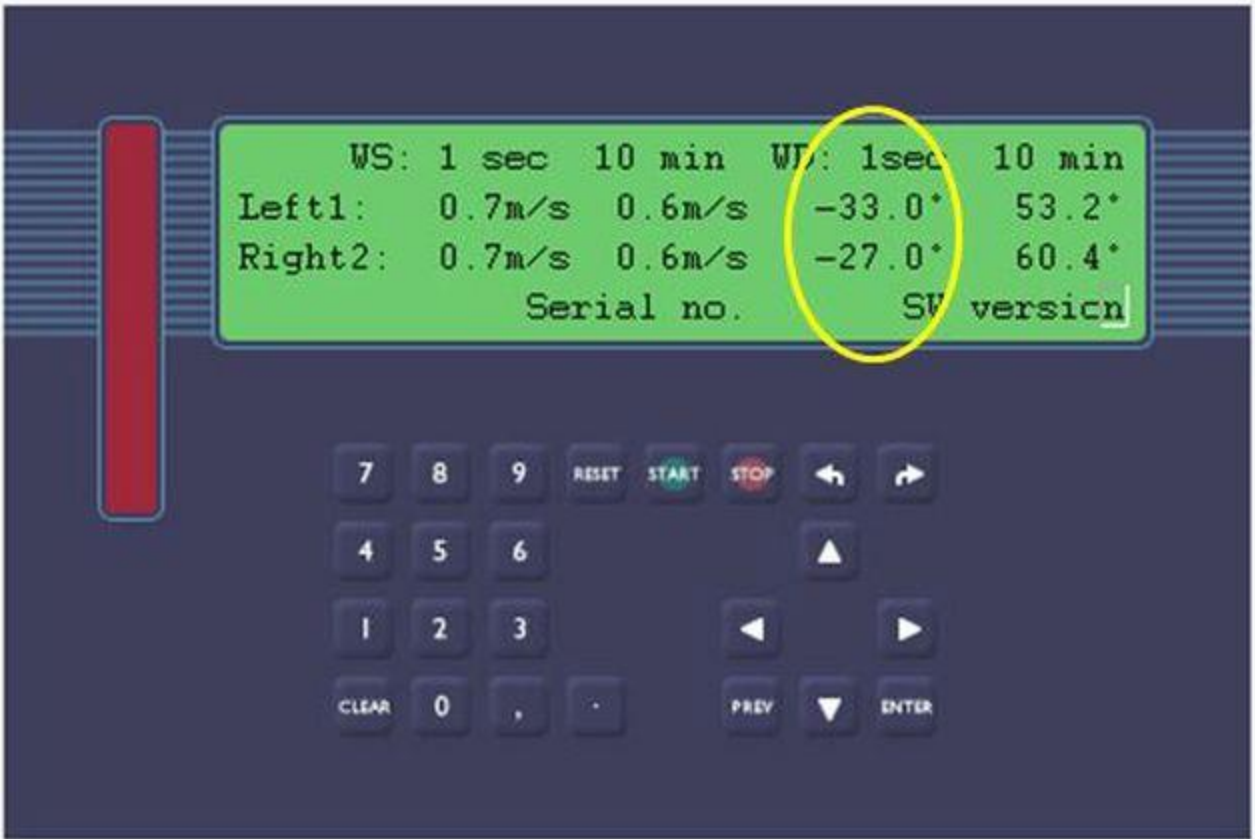
Part number for FT sensor:

60111943- WIND SENSOR US FT702LT V7-10

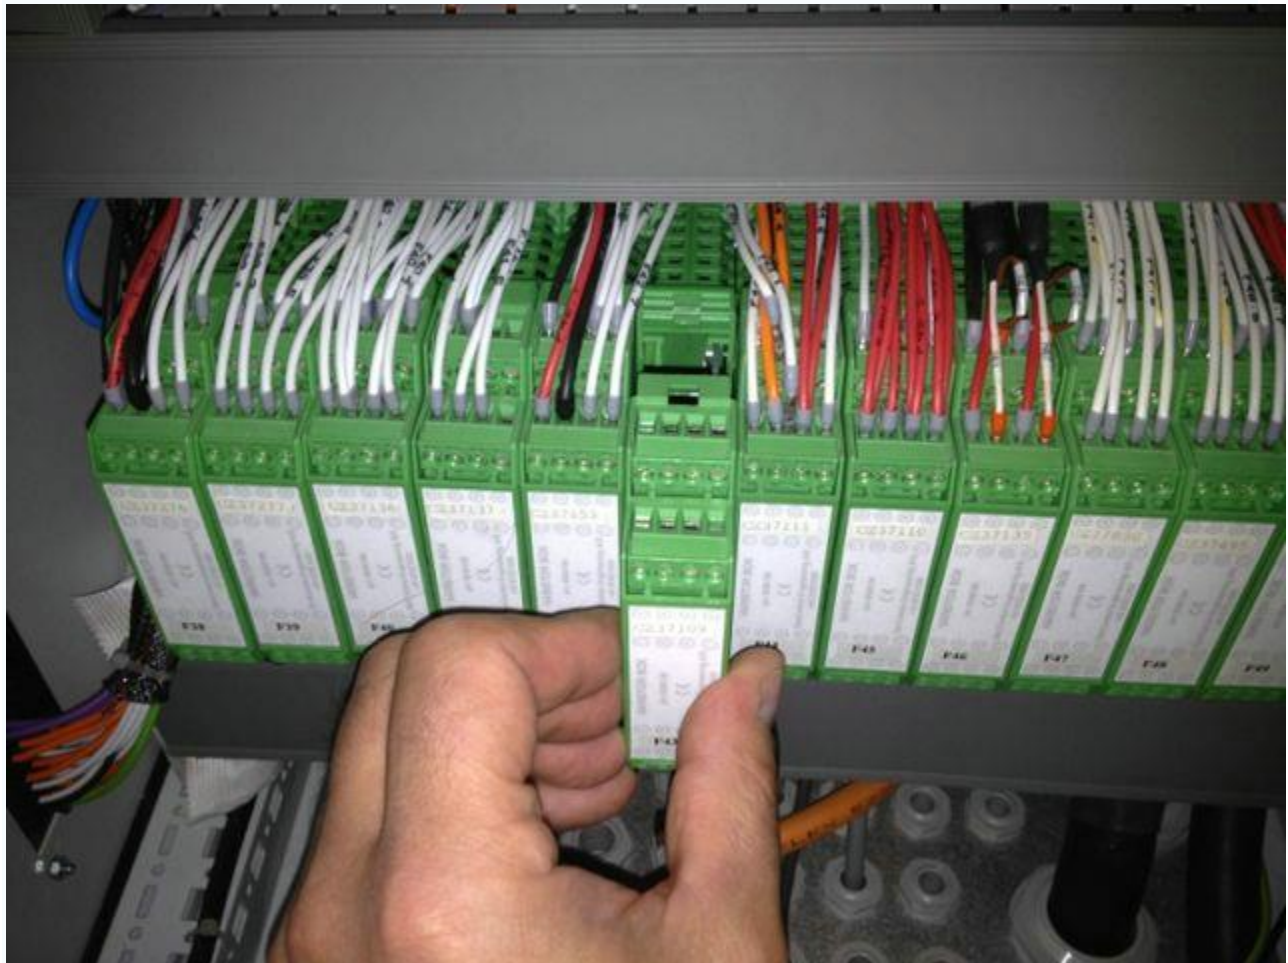
Press the clip on top and bottom of the varistor box and remove varistor assembly from housing:

The varistor box is made up of eight varistors and has provisions for 16 wire connections (protection for 8 signals)

#### **Varistor box F46:**

**Part number for Varistor: 51706201 VARISTOR BOX X8**

Both wind sensor 1 (left) and wind sensor 2 (right) use varistor box F46. Terminals 1-4 (top and bottom) are for wind sensor 1 and 5-8 (top and bottom) are for wind sensor 2.

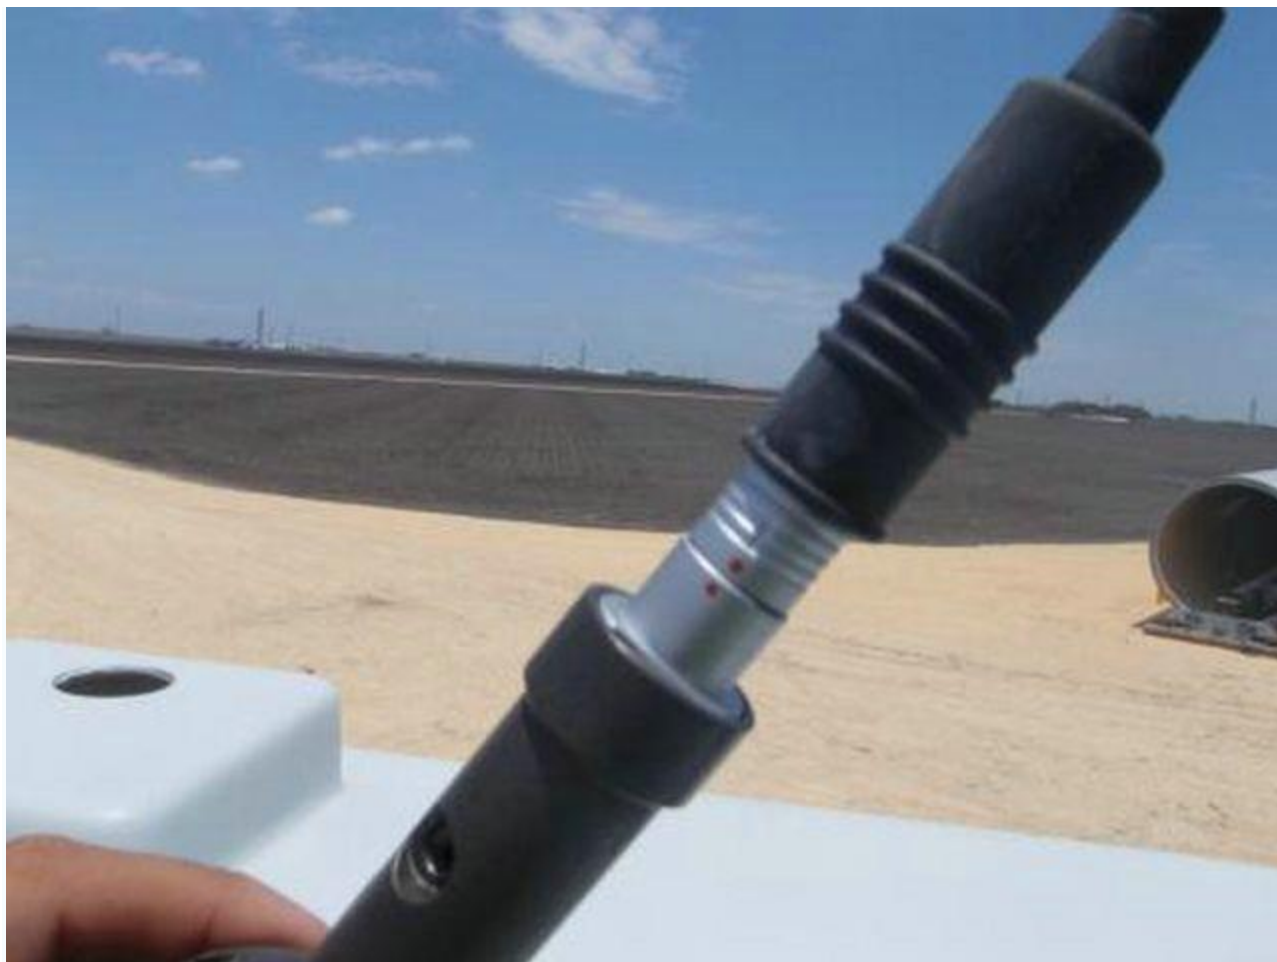
Cable plug and protective boot:

If the cable is mounted tight and it pulls in the sensor connector, it must be connected so that it is not pulling the plug.
