Channel-to-Channel Crosstalk in a 32-Channel Dry-Electrode ADS1299 Cap

A single-driven-input measurement, and why it sets only an upper bound

EEG_MI project — hardware metrology

3 August 2026

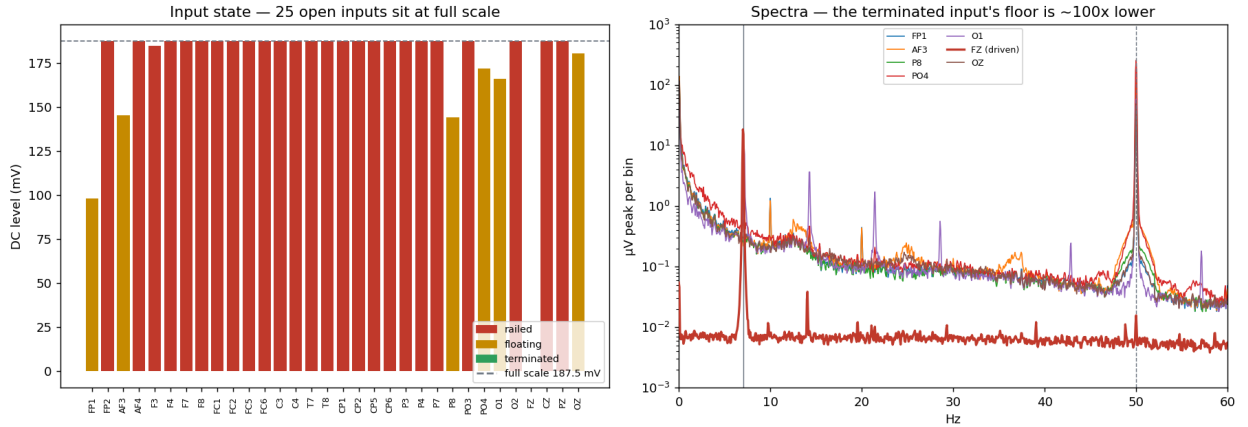
An ADS1299 input with nothing attached has no DC path to set its operating point, so it drifts to a rail. That is exactly what happened: 25 of the 32 inputs sit pinned at $+187\,500\,\mu\text{V}$ for 100 % of the record. A channel at the rail is not a quiet channel — it is a channel carrying no information at all, and it cannot show crosstalk even if crosstalk exists. Six further inputs had drifted to 98 to 180 mV without saturating; those are high-impedance nodes, i.e. antennas.

The driven channel was not declared by the operator. It is identified from the data as **FZ** (VHDCI pin 31): it is the only input at 0 V DC, it carries the largest tone by a factor of 20, its noise floor is $100\times$ lower than any other channel, and its 50 Hz content is $1218\times$ lower. All four are the signature of an input connected to a low-impedance source.

Figure 1: Left: DC level per input. Twenty-five inputs sit exactly at full scale. Right: amplitude spectra of the seven channels that are not saturated. The terminated channel (red) has a noise floor roughly two decades below the floating ones and essentially no 50 Hz; the floating channels carry 3.5 to $26.5\,\mu\text{V}$ of mains and a large low-frequency drift skirt.

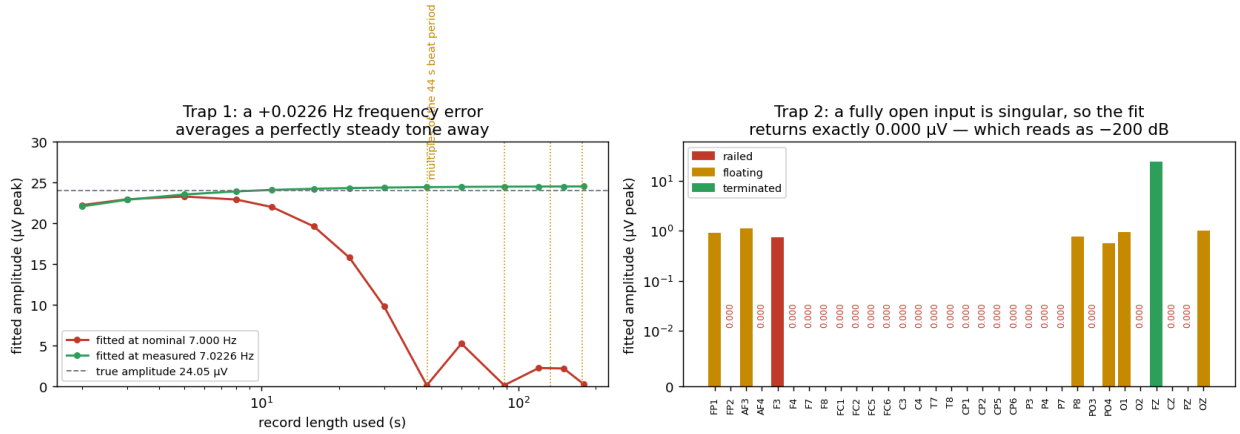
Figure 2: Left: the same steady 24.05 μV tone, fitted at the nominal 7.000 Hz (red) and at the measured 7.0226 Hz (green), as a function of how much of the record is used. The red curve collapses at multiples of the 44 s beat period. Right: fitted amplitude per channel. The 24 fully saturated inputs return exactly 0.000 μV because the least-squares system is singular — which a decibel conversion turns into -200 dB, i.e. “perfect isolation”.

Trap 1: fitting the nominal frequency. The tone is at 7.0226 Hz, not 7.000 Hz. A least-squares projection onto a fixed 7.000 Hz sinusoid accumulates $2\pi \times 0.0226 t$ of phase error, so over a record spanning several 44 s beat periods the projection averages the tone away. Measured on this record, the same signal reads:

Trap 2: railed channels read as zero. For a channel pinned at a constant value the least-squares design matrix is singular and the fit returns exactly 0.000 μV . Converted to decibels that becomes -200 , which is indistinguishable in a results table from “no crosstalk”. In the first run of this measurement 24 channels landed in that state, and the worst-case crosstalk figure was then computed across the six *floating* channels only — producing a headline “ -4.8 dB worst-case crosstalk” that was an artifact end to end. Open inputs must be reported as unmeasurable, not as zero.

Read down the first row and the source appears to be dying exponentially across three successive recordings. It is not: it is flat to $\pm 0.1\%$ throughout. The fix is to estimate the frequency once on the driven channel and use that same value for every channel, so source and victims are measured on the same basis.

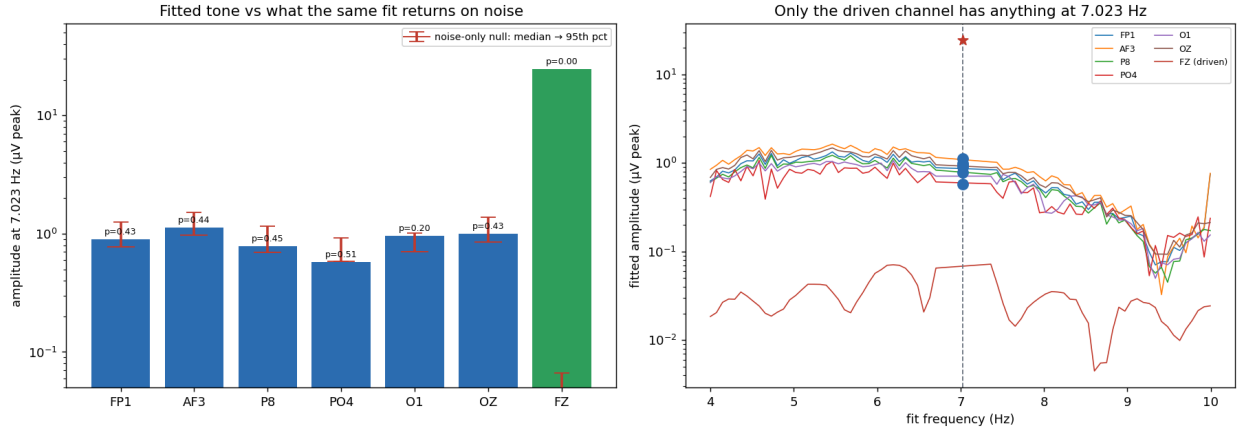
An amplitude fit always returns a positive number. On a drifting channel with a 1 μV -scale noise skirt it returns roughly 1 μV whatever frequency is requested, so an absolute value alone establishes nothing. The test used here builds the null from the channel’s own noise: fit the amplitude at 75 frequencies spread over 4 to 10 Hz, excluding f_0 and its first three harmonics, and ask what fraction of those null frequencies return an amplitude at least as large as the one at f_0 .

Figure 3: Left: fitted amplitude at f_0 per channel (bars) against the noise-only null median and 95th percentile (red). Every floating channel’s “signal” sits inside its own noise distribution. Right: the same fit swept across frequency. The floating channels trace a smooth $\sim 1 \mu\text{V}$ curve with **no feature at f_0** ; the driven channel sits at 0.02 to 0.07 μV everywhere except the single point at 7.023 Hz. The right panel is the whole result in one image.

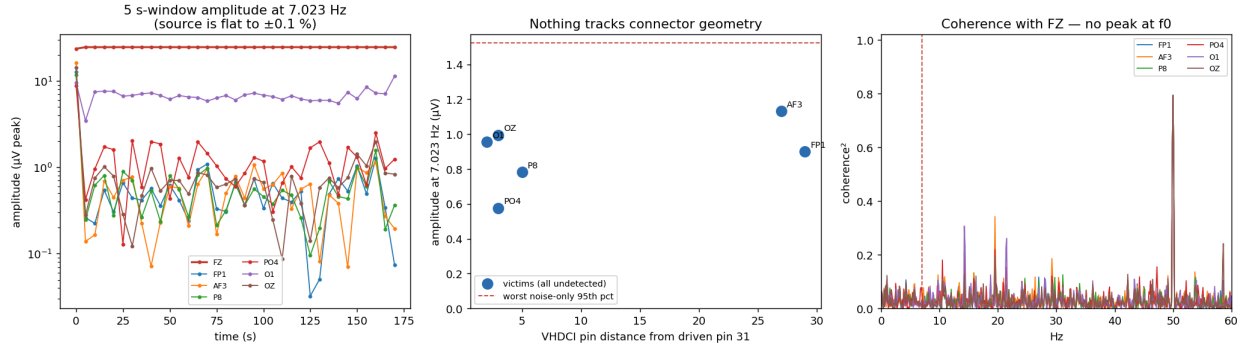
Figure 4: Left: 5s-window amplitude at f_0 ; the source is flat, the floating channels wander around 1 μV with no relationship to it. Centre: amplitude against VHDCI pin distance from the driven pin. Right: magnitude-squared coherence with the driven channel — no peak at f_0 .

Correlation with the source. The decisive control. Broadband Pearson correlation between the driven channel and each floating channel: +0.0011, +0.0011, +0.0015, +0.0018, +0.0021, +0.0022. The driven channel is uncorrelated with every other channel in the cap.

Connector geometry. Amplitude versus VHDCI pin distance from the driven pin 31 gives $r = +0.47$ over $\Delta\text{pin} = 2\text{--}29$ — weakly *increasing* with distance, the opposite of what ribbon lead-to-lead capacitance would produce. FP1 at $\Delta\text{pin} = 29$ reads more than PO4 at $\Delta\text{pin} = 3$. Consistent with there being no geometric coupling to find.

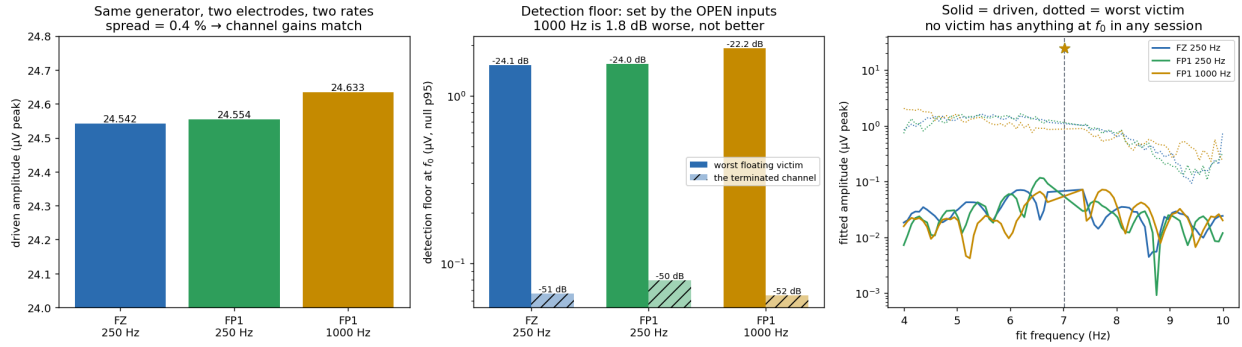
The result replicates. No victim is detectable in any session ($p = 0.20\text{--}0.45$), the broadband correlation with the driven channel stays below 0.004 in all three, and the bound lands within 2 dB of the same place. Driving pin 2 and pin 31 — opposite ends of the VHDCI — gives the same answer, which also partly discharges the “move the driven channel” item in Section 8: whatever lead-to-lead coupling exists is below the floor at both ends of the connector.

Figure 5: Left: driven amplitude across the three sessions — 0.37 % total spread. Centre: the detection floor, split into the terminated channel (hatched) and the worst floating one. The gap between them, roughly 27 dB, is the entire cost of leaving inputs open. Right: the frequency sweep for all three sessions overlaid; solid is the driven channel, dotted is that session’s worst victim. Every dotted curve passes smoothly through f_0 .

1000 SPS is worse, not better. This was worth testing rather than asserting, and the prediction held: the bound got *worse* by 1.8 dB, and the worst victim’s noise floor rose from 1.542 to 1.914 μV (24 %). The reason is that the detection floor at 7 Hz is set by the noise *density* there and by the total observation time ($\propto 1/\sqrt{T}$) — neither of which a higher sample rate improves. What a higher rate does change is that the ADS1299 averages less per sample, so per-sample input-referred noise rises (the terminated channel’s 20 to 45 Hz noise went 0.090 $\rightarrow$ 0.098 μV rms), and the board sends four times the UDP traffic.

For this measurement **stay at 250 SPS and record longer instead**: doubling the record buys 3 dB, quadrupling it buys 6 dB, and it costs nothing but time. A high sample rate would only be the right tool for a different question — whether coupling grows with frequency, which is the signature that separates capacitive from resistive paths, and which needs a generator running at hundreds of hertz rather than at 7.

1. **Terminate every unused input to generator ground.** This is the single change that matters. It takes the victim noise floor from $\sim 1.0\ \mu\text{V}$ to $\sim 0.07\ \mu\text{V}$ and the bound from -24 to about $-51\ \text{dB}$, on the same 179 s record and the same source amplitude.
