## Replace the defective pressure transmitter

- **Explanation**  
**IN THE HUB:**

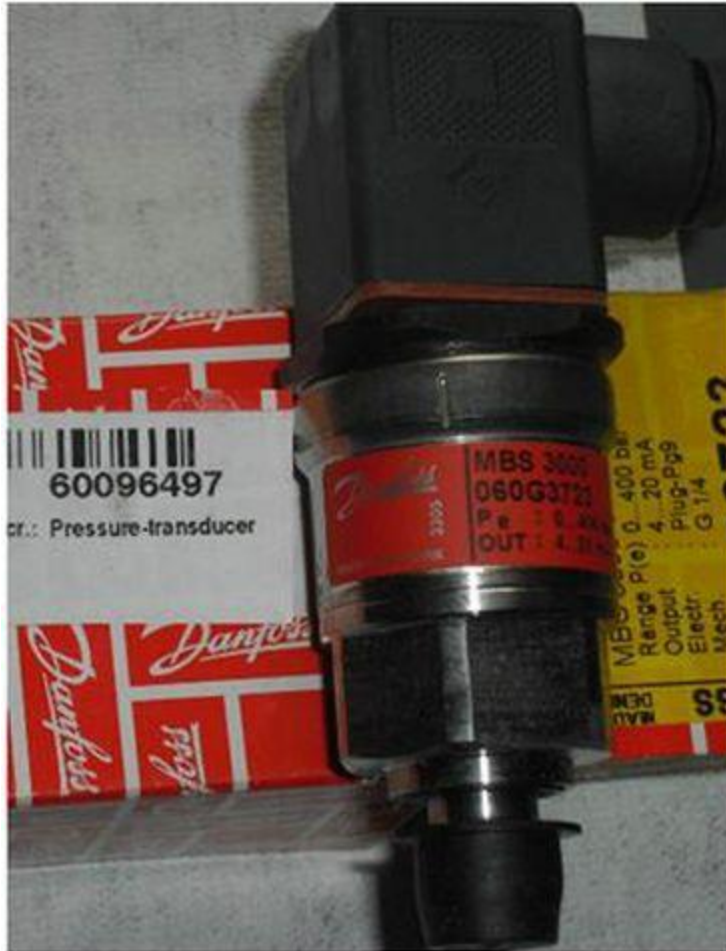
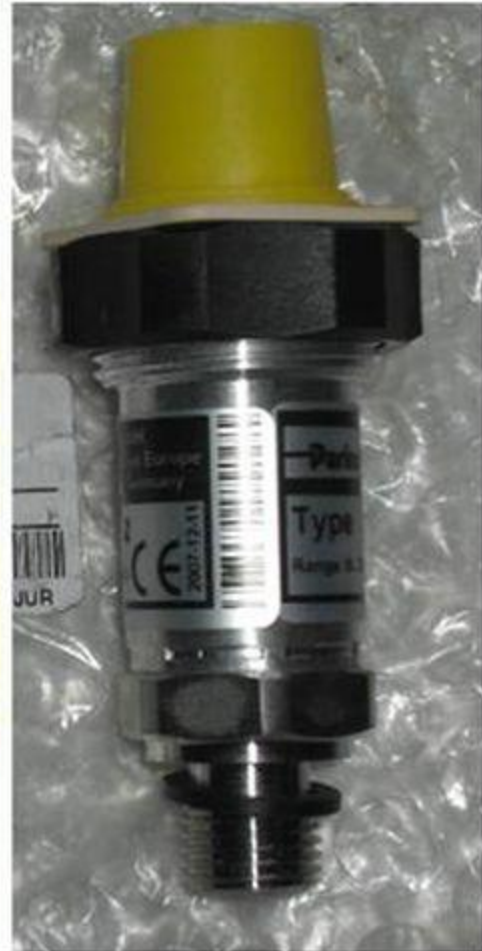
If the pressure sensor is defective, replace with new.

Relevant spare parts	
PRESSURE TRANSDUCER MBS3000-36	<a href="#">60096497</a>

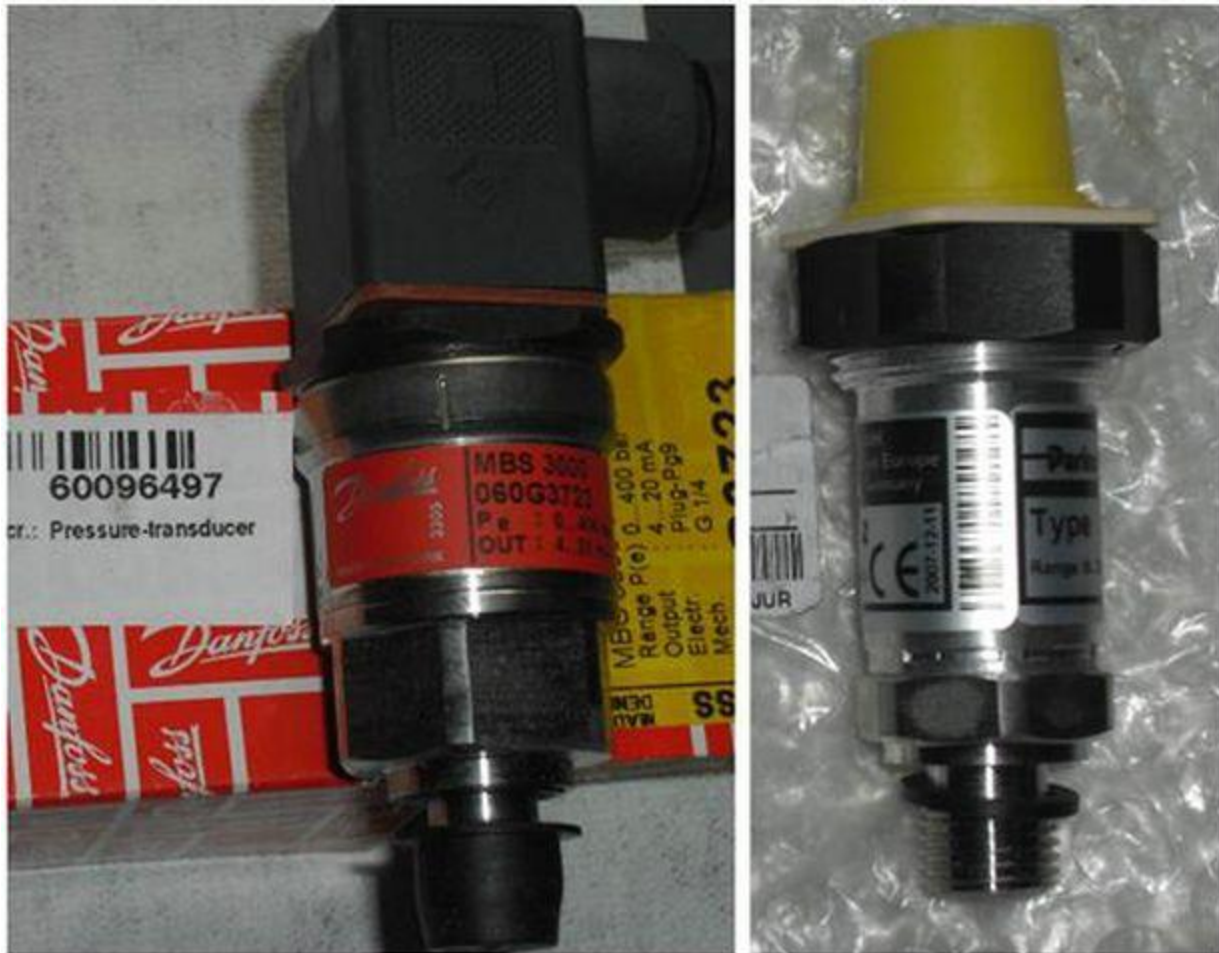
If the pressure sensor is defective, replace with new.

PRESSURE TRANSDUCER MBS3000-36	<a href="#">60096497</a>
--------------------------------	--------------------------

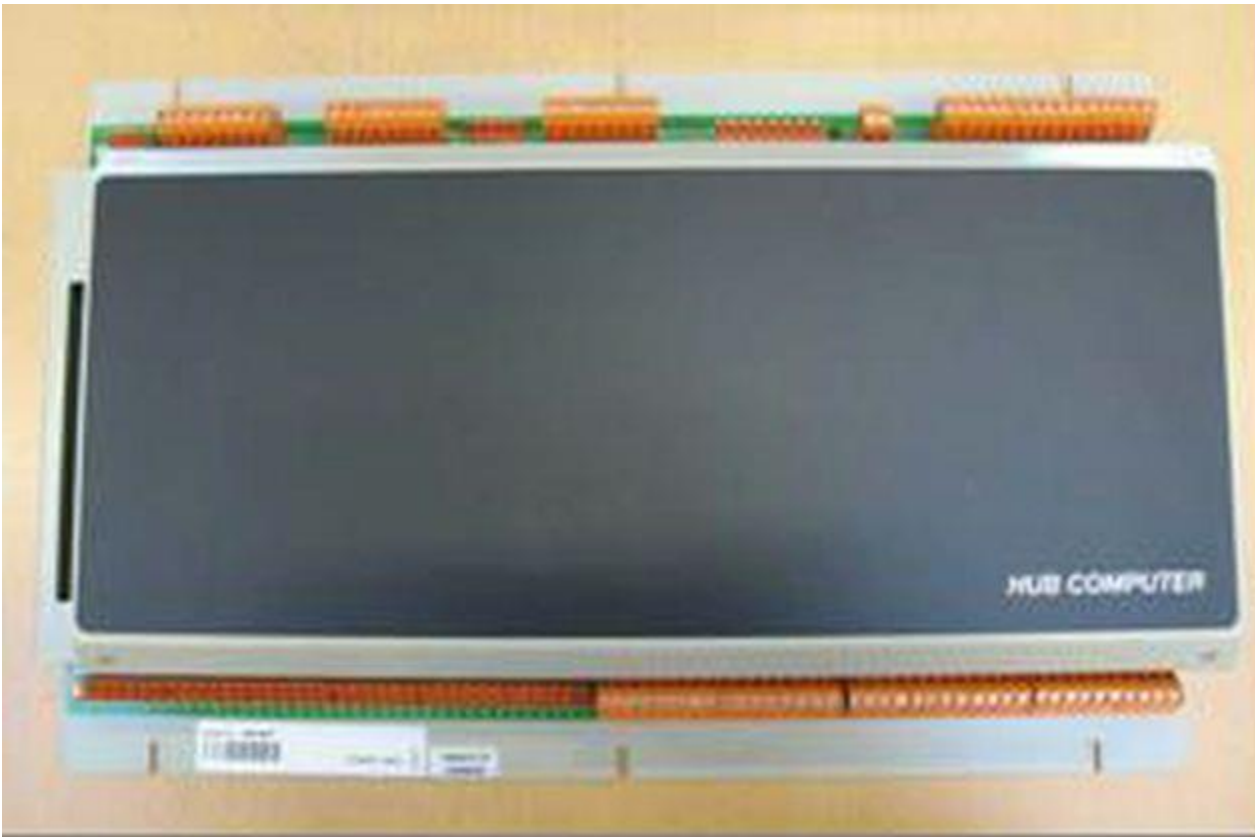
If after checking all related cables and sensors the fault persists, there is likely a faulty hub computer that has caused this alarm.

If the Hub computer is found to be defective, replace it with new.

Relevant spare parts	
SIF HUB COMPUTER CABINET EVOII	<a href="#">51701801</a>
