Channel-to-Channel Crosstalk in a 32-Channel Dry-Electrode ADS1299 Cap

A single-driven-input measurement, and why it sets only an upper bound

EEG_MI project — hardware metrology

3 August 2026

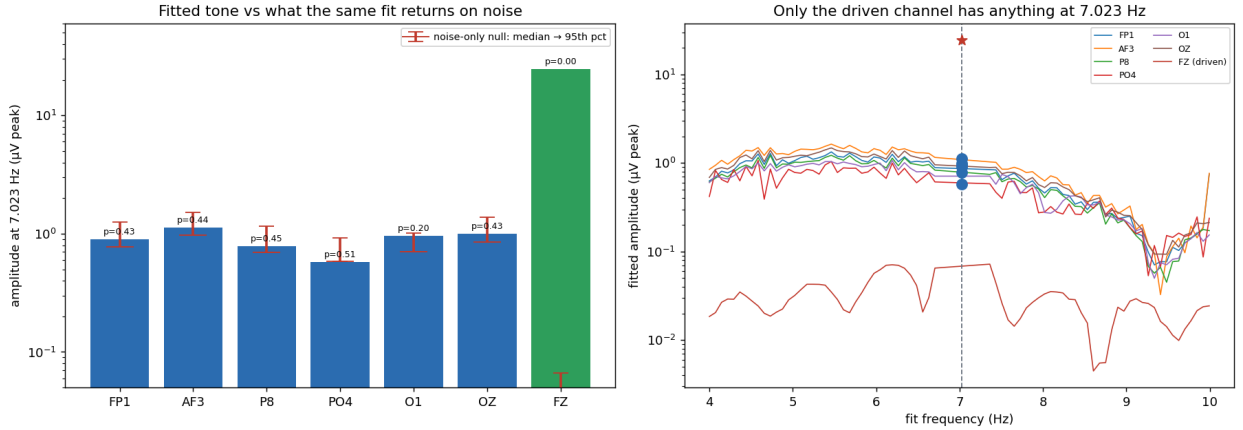
An amplitude fit always returns a positive number. On a drifting channel with a 1 μV -scale noise skirt it returns roughly 1 μV whatever frequency is requested, so an absolute value alone establishes nothing. The test used here builds the null from the channel’s own noise: fit the amplitude at 75 frequencies spread over 4 to 10 Hz, excluding f_0 and its first three harmonics, and ask what fraction of those null frequencies return an amplitude at least as large as the one at f_0 .

Figure 3: Left: fitted amplitude at f_0 per channel (bars) against the noise-only null median and 95th percentile (red). Every floating channel’s “signal” sits inside its own noise distribution. Right: the same fit swept across frequency. The floating channels trace a smooth $\sim 1 \mu\text{V}$ curve with **no feature at f_0** ; the driven channel sits at 0.02 to 0.07 μV everywhere except the single point at 7.023 Hz. The right panel is the whole result in one image.

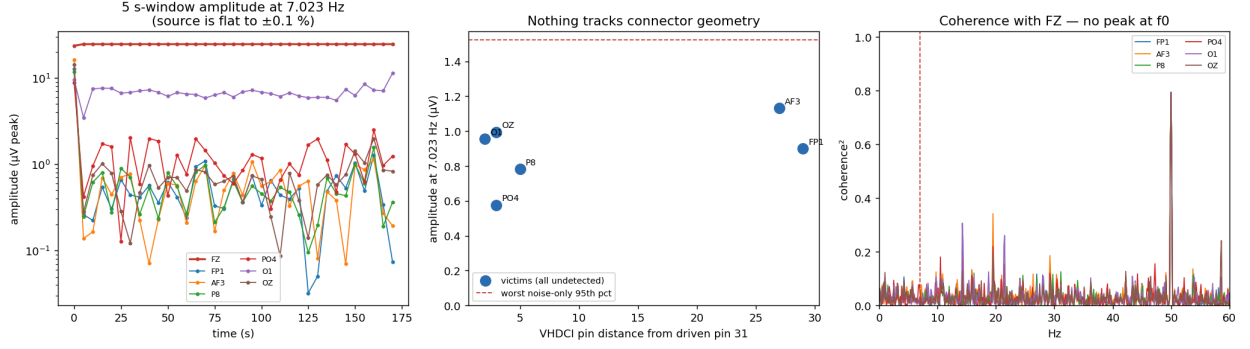
Figure 4: Left: 5s-window amplitude at f_0 ; the source is flat, the floating channels wander around $1\mu\text{V}$ with no relationship to it. Centre: amplitude against VHDCI pin distance from the driven pin. Right: magnitude-squared coherence with the driven channel — no peak at f_0 .

Correlation with the source. The decisive control. Broadband Pearson correlation between the driven channel and each floating channel: $+0.0011$, $+0.0011$, $+0.0015$, $+0.0018$, $+0.0021$, $+0.0022$. The driven channel is uncorrelated with every other channel in the cap.

Connector geometry. Amplitude versus VHDCI pin distance from the driven pin 31 gives $r = +0.47$ over $\Delta\text{pin} = 2\text{--}29$ — weakly *increasing* with distance, the opposite of what ribbon lead-to-lead capacitance would produce. FP1 at $\Delta\text{pin} = 29$ reads more than PO4 at $\Delta\text{pin} = 3$. Consistent with there being no geometric coupling to find.

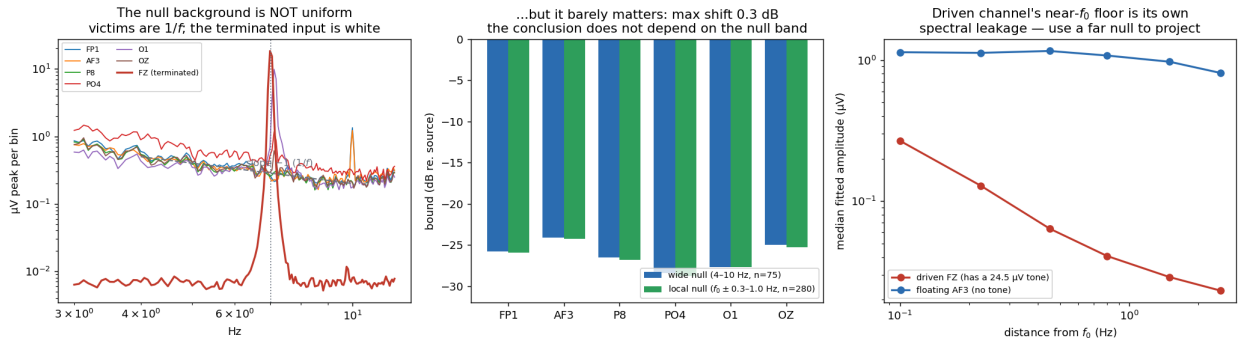
Figure 5: Left: the background over the null band. Every floating channel follows $1/f$; the one terminated channel is white there (slope $+0.21$), which is what a properly biased input should look like. Centre: the bound computed from the wide null against a local null hugging f_0 . Right: the driven channel’s fitted amplitude against distance from f_0 — a monotonic decay that is leakage from its own tone, absent on a channel that carries no tone.

It was checked, and it does not matter. Re-running the test with a *local* null — $f_0 \pm 0.3$ to 1.0 Hz, 280 frequencies, a band narrow enough that the $1/f$ tilt across it is negligible — moves every victim’s bound by at most 0.32 dB, and moves the p -values *up* (e.g. AF3 0.440 $\rightarrow$ 0.500, P8 0.453 $\rightarrow$ 0.536). The conclusion is if anything slightly stronger on the local null, and does not depend on which band is used.

The one place the choice does matter. On the *driven* channel the two nulls disagree by 4.8 dB (0.066 wide vs 0.116 μ V local), and that disagreement is real rather than a nuisance: it is spectral leakage from its own 24.5 μ V tone. The fitted amplitude decays monotonically with distance — 0.281, 0.134, 0.065, 0.039, 0.029, 0.023 μ V at $|\Delta f| = 0.1, 0.2, 0.45, 0.8, 1.5, 2.5$ Hz — while a floating channel over the same bins is flat at ≈ 1.1 μ V.

The consequence is a rule, not a correction: **project a terminated victim’s noise floor from a null far from the tone, never from one sitting beside it.** A terminated victim carries no tone of its own, so it has nothing to leak; the right proxy is the driven channel’s floor away from f_0 , which is 0.023 to 0.066 μ V. The -51 dB projection in Section 9 uses the conservative end of that range and stands.

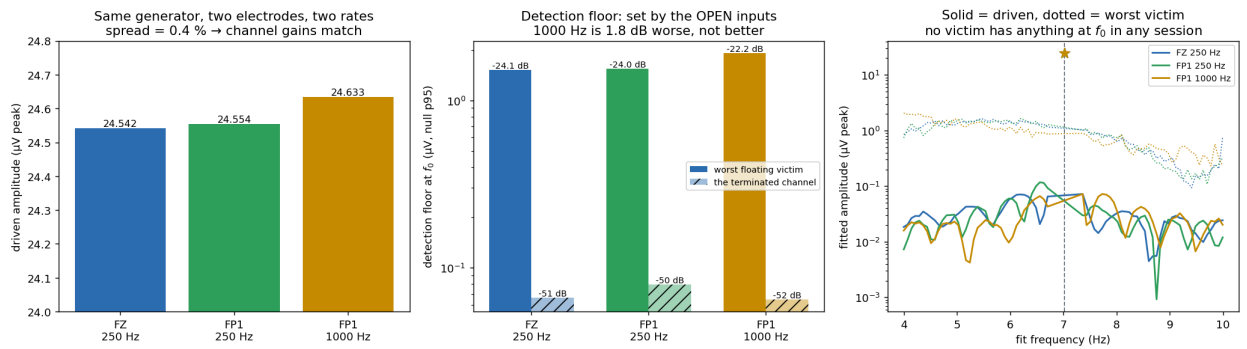
Figure 6: Left: driven amplitude across the three sessions — 0.37 % total spread. Centre: the detection floor, split into the terminated channel (hatched) and the worst floating one. The gap between them, roughly 27 dB, is the entire cost of leaving inputs open. Right: the frequency sweep for all three sessions overlaid; solid is the driven channel, dotted is that session’s worst victim. Every dotted curve passes smoothly through f_0 .

The result replicates. No victim is detectable in any session ($p = 0.20$ – 0.45), the broadband correlation with the driven channel stays below 0.004 in all three, and the bound lands within 2 dB of the same place. Driving pin 2 and pin 31 — opposite ends of the VHDCI — gives the same

1000 SPS is worse, not better. This was worth testing rather than asserting, and the prediction held: the bound got *worse* by 1.8 dB, and the worst victim’s noise floor rose from 1.542 to 1.914 μV (24 %). The reason is that the detection floor at 7 Hz is set by the noise *density* there and by the total observation time ($\propto 1/\sqrt{T}$) — neither of which a higher sample rate improves. What a higher rate does change is that the ADS1299 averages less per sample, so per-sample input-referred noise rises (the terminated channel’s 20 to 45 Hz noise went 0.090 $\rightarrow$ 0.098 μV rms), and the board sends four times the UDP traffic.

For this measurement **stay at 250 SPS and record longer instead**: doubling the record buys 3 dB, quadrupling it buys 6 dB, and it costs nothing but time. A high sample rate would only be the right tool for a different question — whether coupling grows with frequency, which is the signature that separates capacitive from resistive paths, and which needs a generator running at hundreds of hertz rather than at 7.

1. **Terminate every unused input to generator ground.** This is the single change that matters. It takes the victim noise floor from ~ 1.0 μV to ~ 0.07 μV and the bound from -24 to about -51 dB, on the same 179 s record and the same source amplitude.
2. **Use the largest calibrator output.** At 2000 μV instead of 24.5 μV the bound improves by a further 38 dB, to roughly -89 dB — below any level that could matter for EEG.
3. **Measure the tone frequency; never assume the nominal.** One `refine()` call on the driven channel, then fit every channel at that frequency.
4. **Report open inputs as unmeasurable.** Never let a singular fit become -200 dB.
