## Replace the defective power net

- **Explanation**  
**IN THE HUB:**

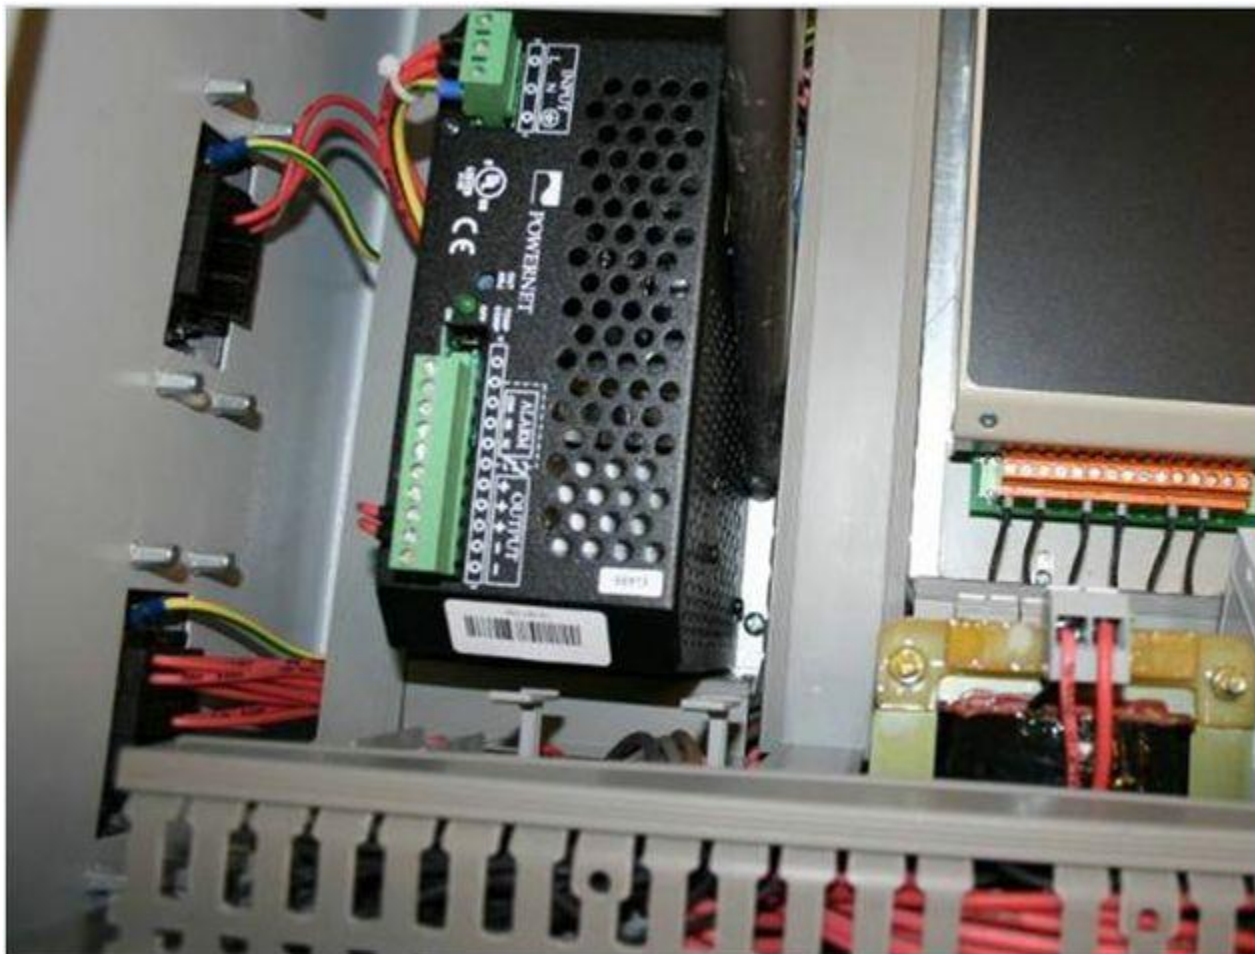
Check for any loose connections at the power net (Pos: G401).

Check input and output voltage 230/115VAC /24VDC

If defective replace the power net.

Part number for power net:

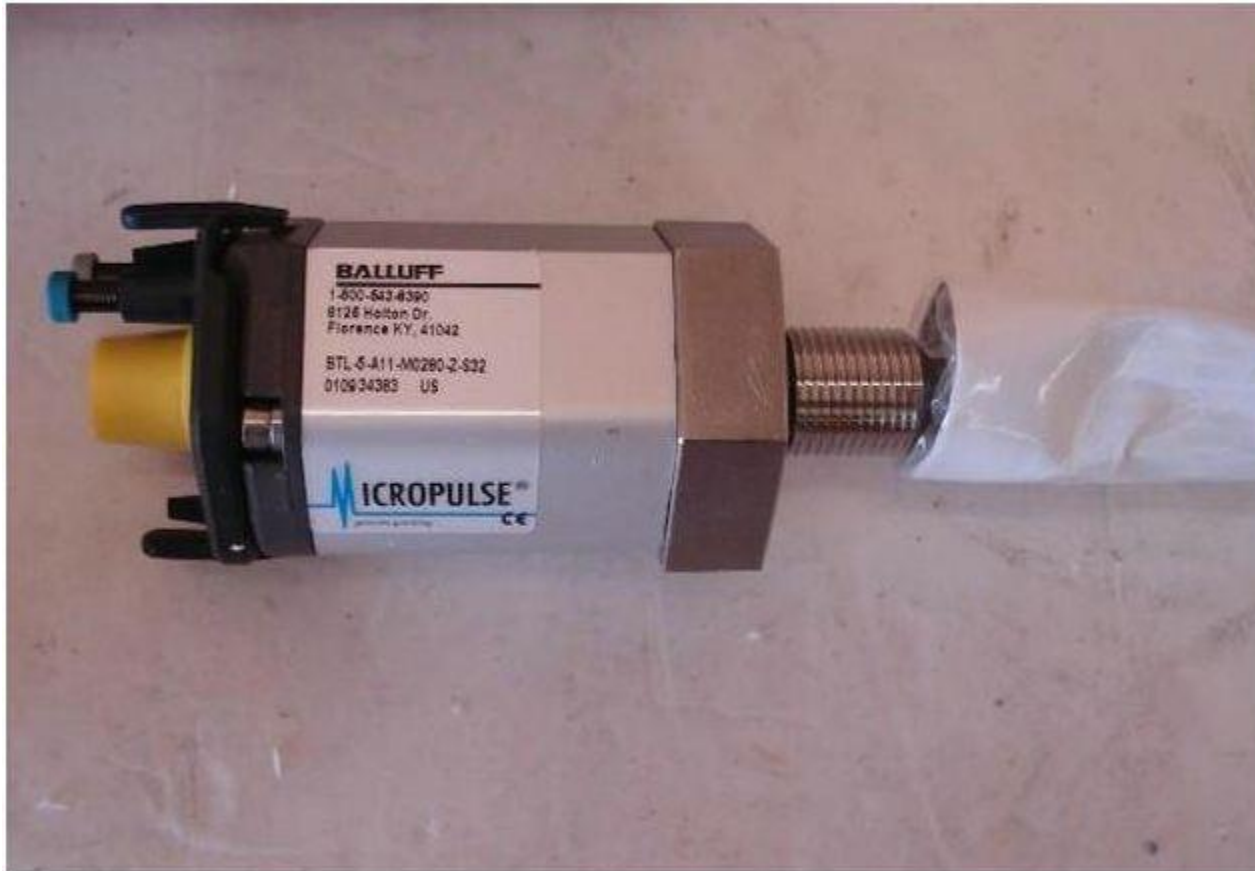
**Pitch position sensor Item number :**

Description	Item No.
TRANSDUCER BTL5-E10-M0950-A-S	<a href="#">60098816</a>

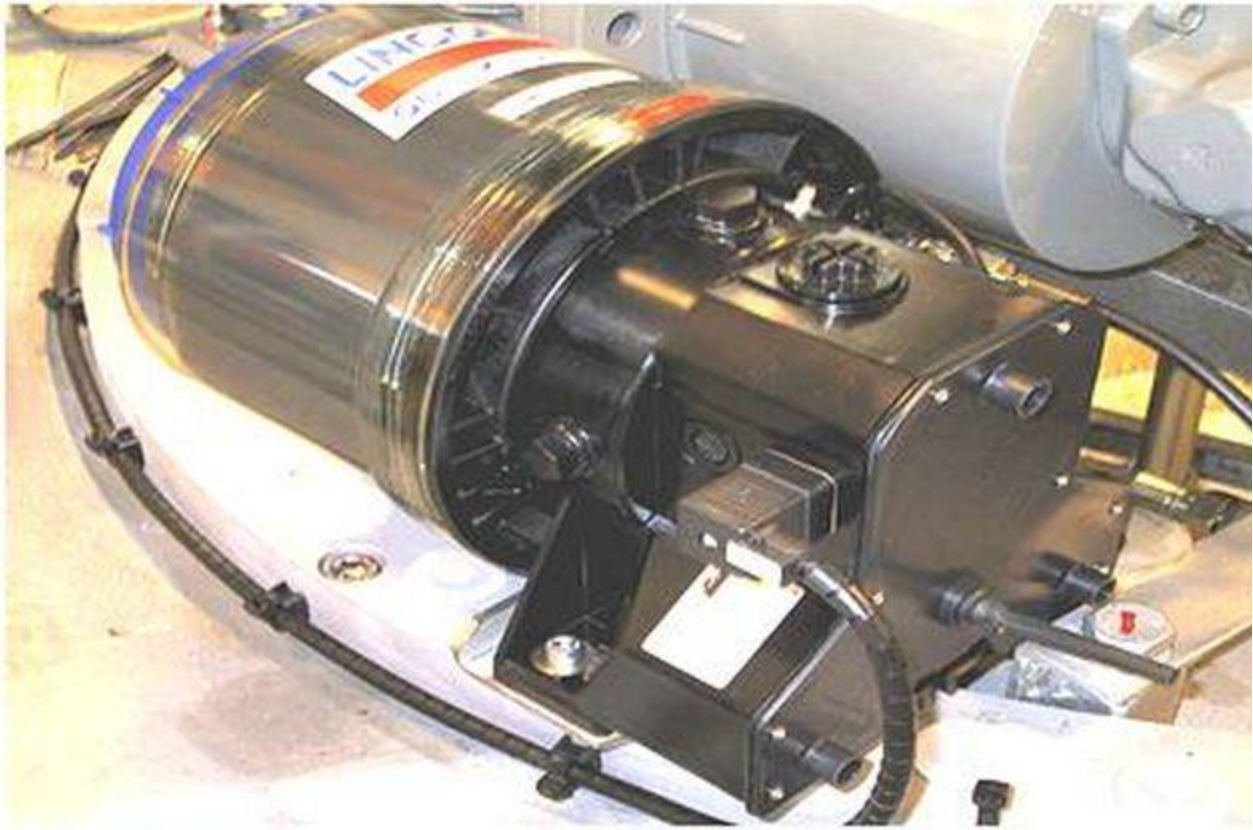
**Part number for Grease pump with main manifold and hoses**

( does not include blade hoses& manifolds)

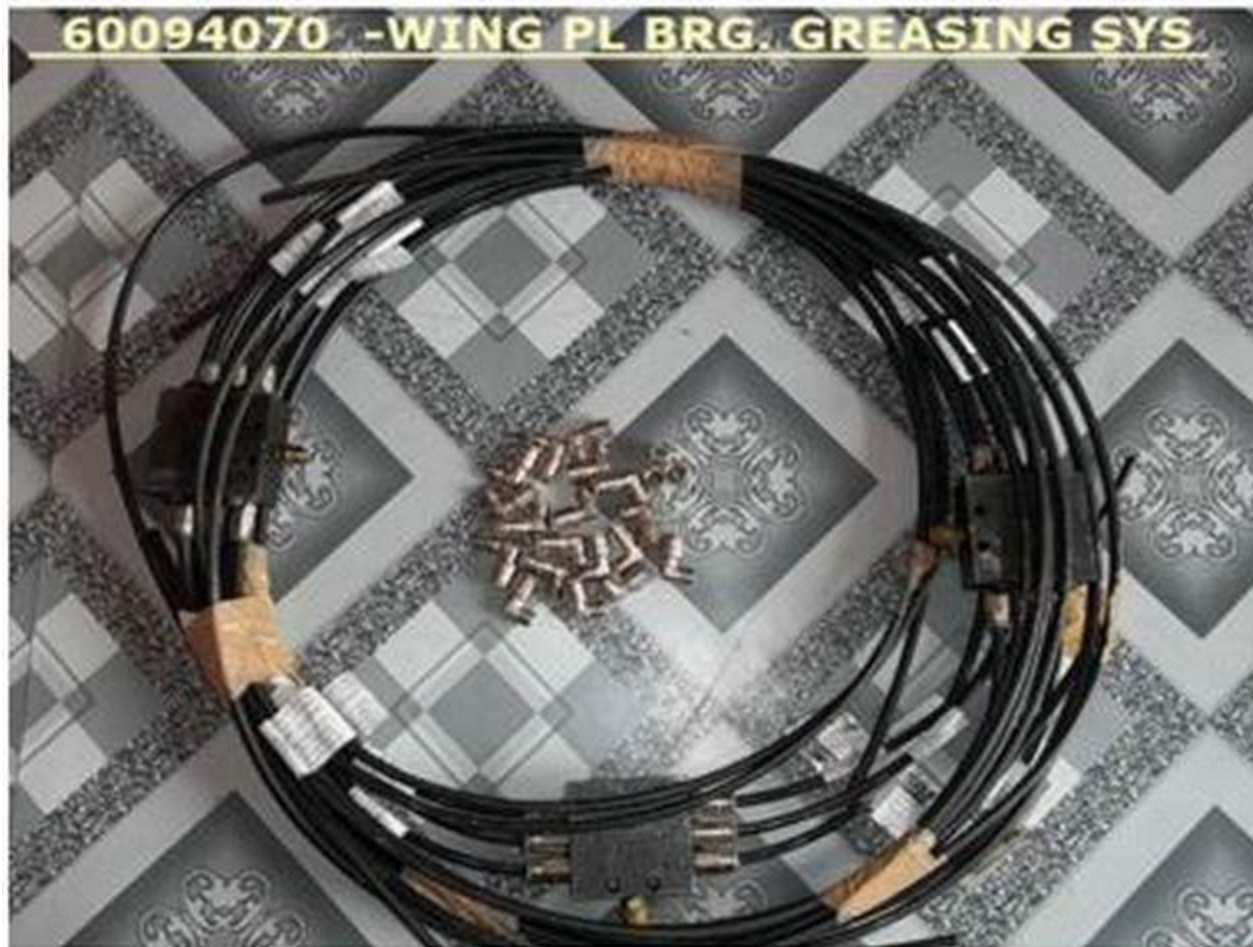
Sub - Part number details for hose accessories

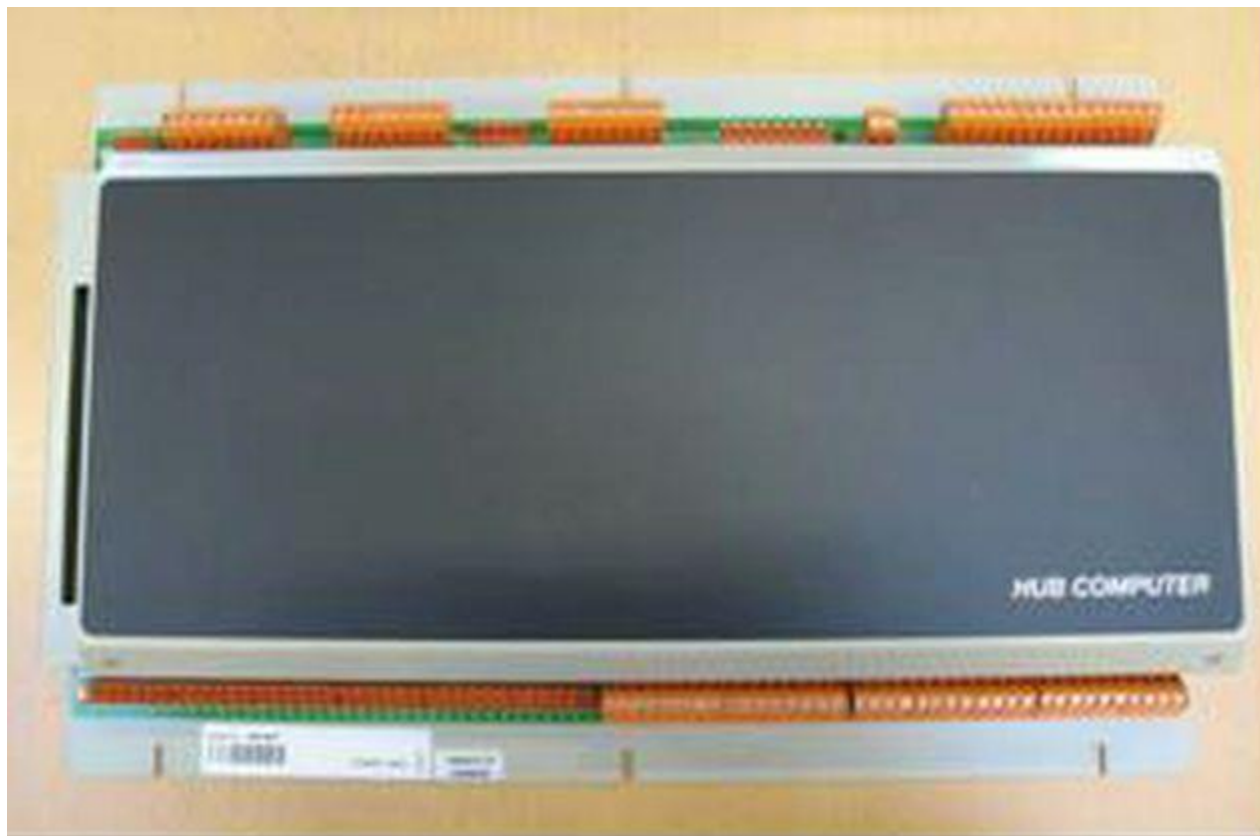
## Hub Computer

If after the blade calibration, pitch angles deviate, or angle values show constant when pitching the blades, the hub computer may be defective.

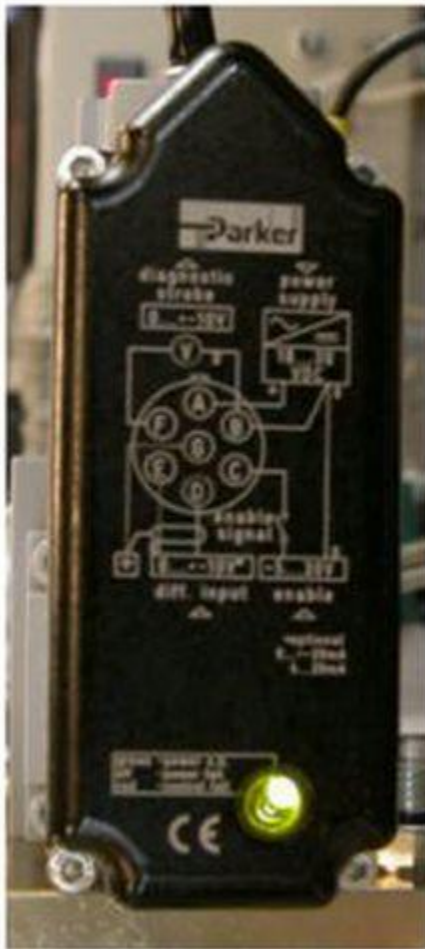
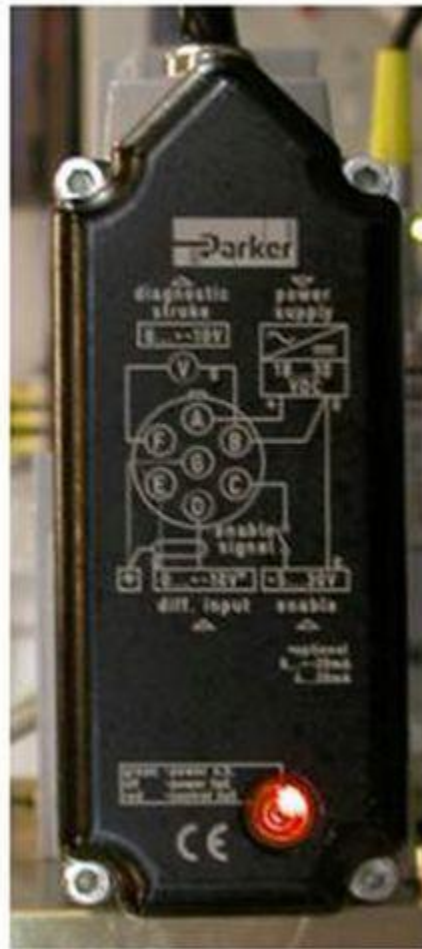
For Parker proportional valves check to see the color of the LED on the valve circuit board.

The LED should be green with the pitch system pressurized.

If it is red and there is pressure verified on test port MP, then the valve may also be defective.

Display Color	Indicates
Green	Normal operation
Off	Supply voltage outside permissible range of 18 to 30 VDC
Red	Spool position error / Low pilot pressure

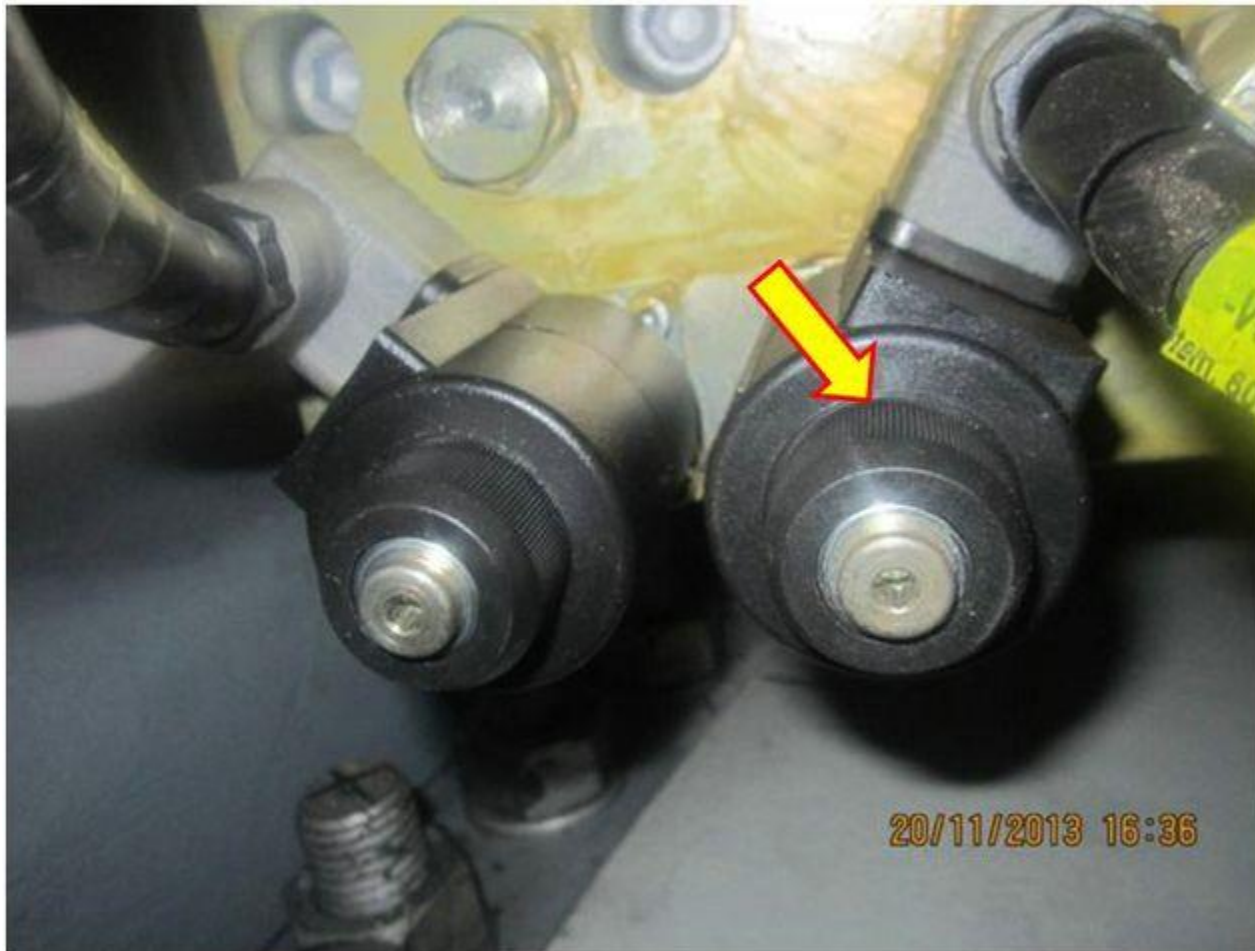
Swap POS. 215 Solenoid valve with one from another blade.

If the valve operates normally, replace the original faulty valve.
