Replace the defect MCB

IN THE AT2 CABINET:

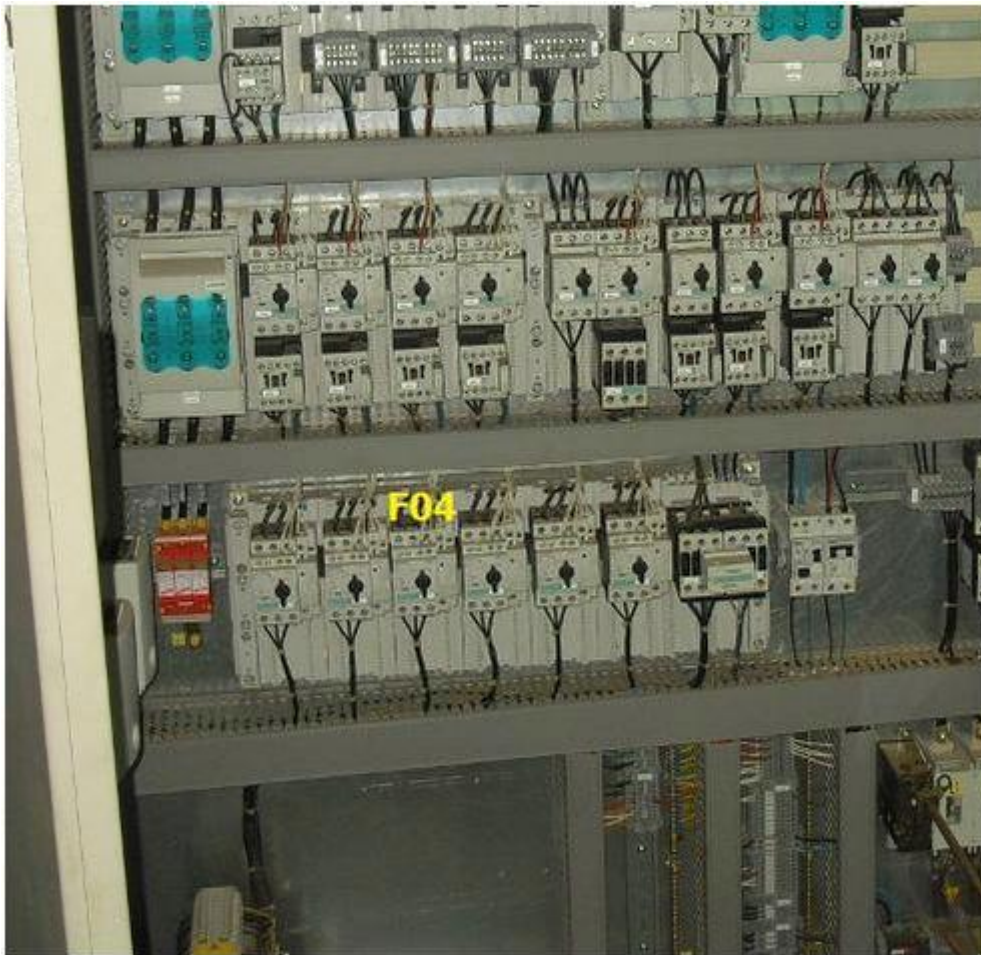
Components View in AT2 Panel:

- Item no for MCB - 60004746
- Item no for MCB - 60004749
- Item no for auxiliary Relay - 60004778

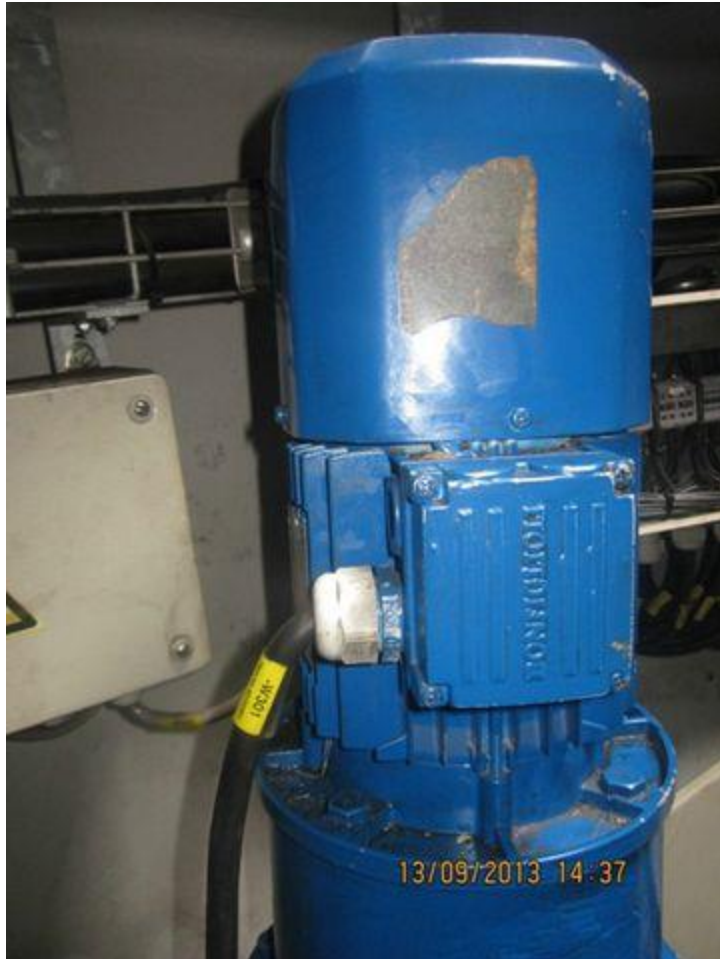
Picture view yaw gear:

IN THE NACELLE:

- Remove the yaw motor with connection

- Keep the yaw motor safely
- Check the oil level in gears. If necessary, top up yaw gears with correct type of oil.
- Master Reset the WTG and Switch on yaw controller.
- To make ensure yaw gear rotate or not.
- To ensure rotate the yaw gear unit and listen abnormal noise of any kind.
- If not rotate the yaw gear unit or create abnormal noise, change the yaw gear unit as per WKI.
- To ensure yaw gear unit bed bolt torque value as per I & S data

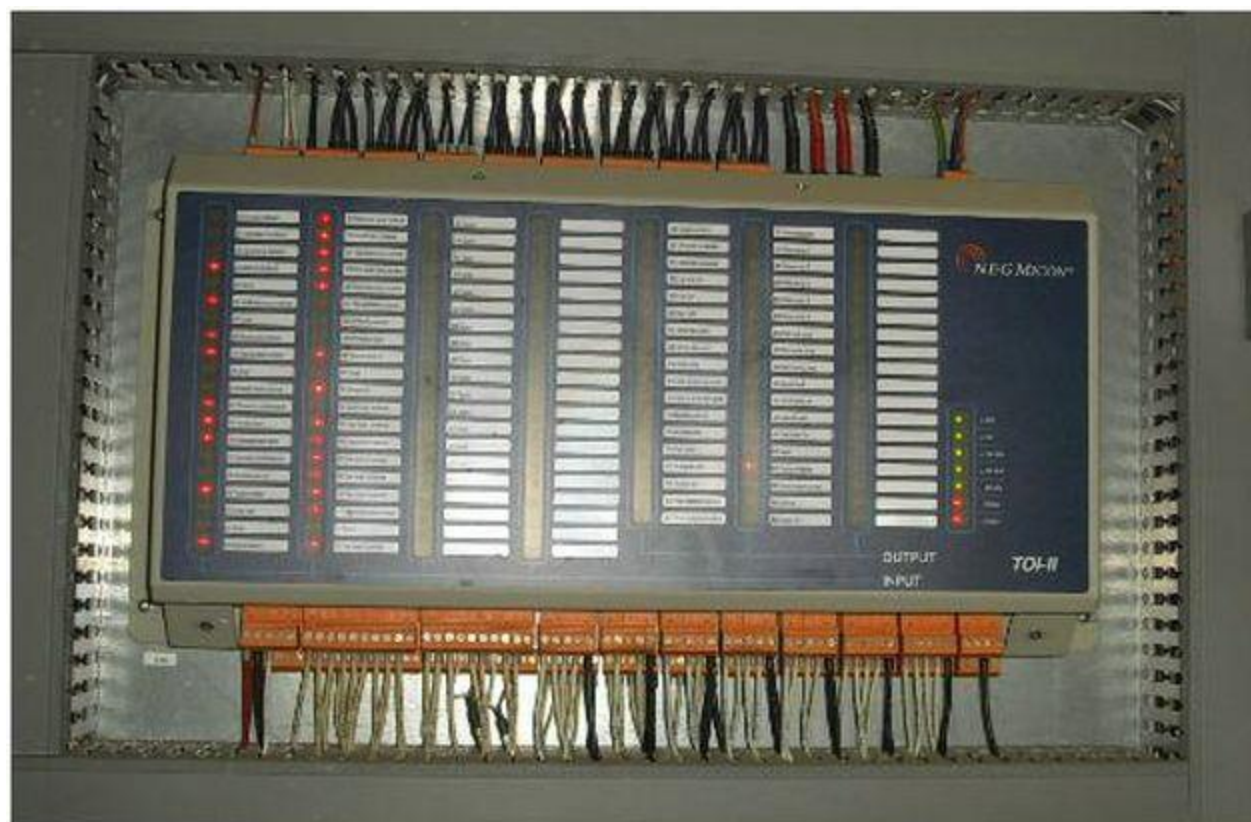
TOI Controller:

INPUT 525-613

- Main bearing pump overload
- Nacelle fan overload
- Yaw brake pump overload
- Pitch feeder pump o.load
- Pitch main pump overload
- Pitch softstarter feedback
- UPS load protected
- UPS battery fault
- External alarm 2
- Service key
- Safety relay feedback
- Yaw motor 1 overload
- Yaw motor 2 overload
- Yaw motor 3 overload
- Yaw motor 4 overload
- Yaw motor 5 overload
- Off-line filter pump overload
- Gear oil heater overload
- Yaw motor 6 overload

- Change the TOI if no signal from TOI
- To check tightness of the connection.
