Fault Code: 2266

Electric Lift Pump for Engine Fuel Supply Circuit - Voltage Below Normal or Shorted to Low Source

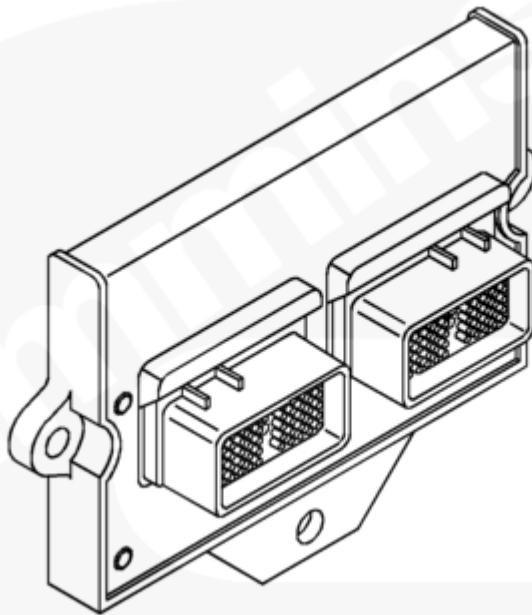
19900397

The fuel pump relay is controlled by the engine control module (ECM), and provides power to the lift pump 1 and lift pump 2. The fuel pump relay has 4 circuits: battery 1 voltage supply, lift pump 1 supply, lift pump relay signal, and battery 1 voltage return. The ECM monitors the lift pump relay signal circuit.

The electric lift pump is located on the right bank rear high position or on the left bank front high position.
