Fault Code: 285

SAE J1939 Multiplexing PGN Timeout Error - Abnormal Update Rate

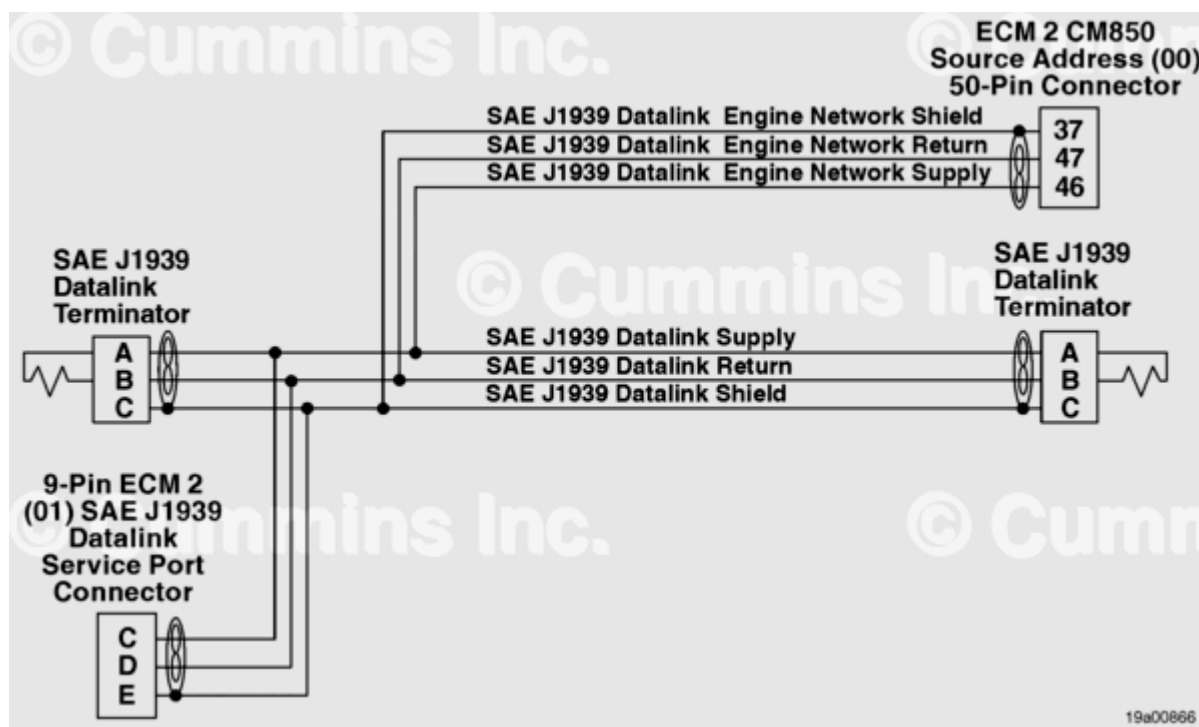
J1939 Datalink Circuit

The ECM identified another device on the J1939 datalink network has stopped communicating on the network. The devices on the J1939 datalink network include: ECMs', and the Generator Interface Module. The harness for the J1939 datalink network has a shielded twisted pair of

wires that connect each of the network devices and termination resistor.
