Project On:

# Placement and Routing

Course No:  
EEE 4231

**Objectives:** The objective is to place and route a chip for which synthesized Verilog code is given. Given its constraints and timing libraries, it should be placed with minimum violations and following all constraints.

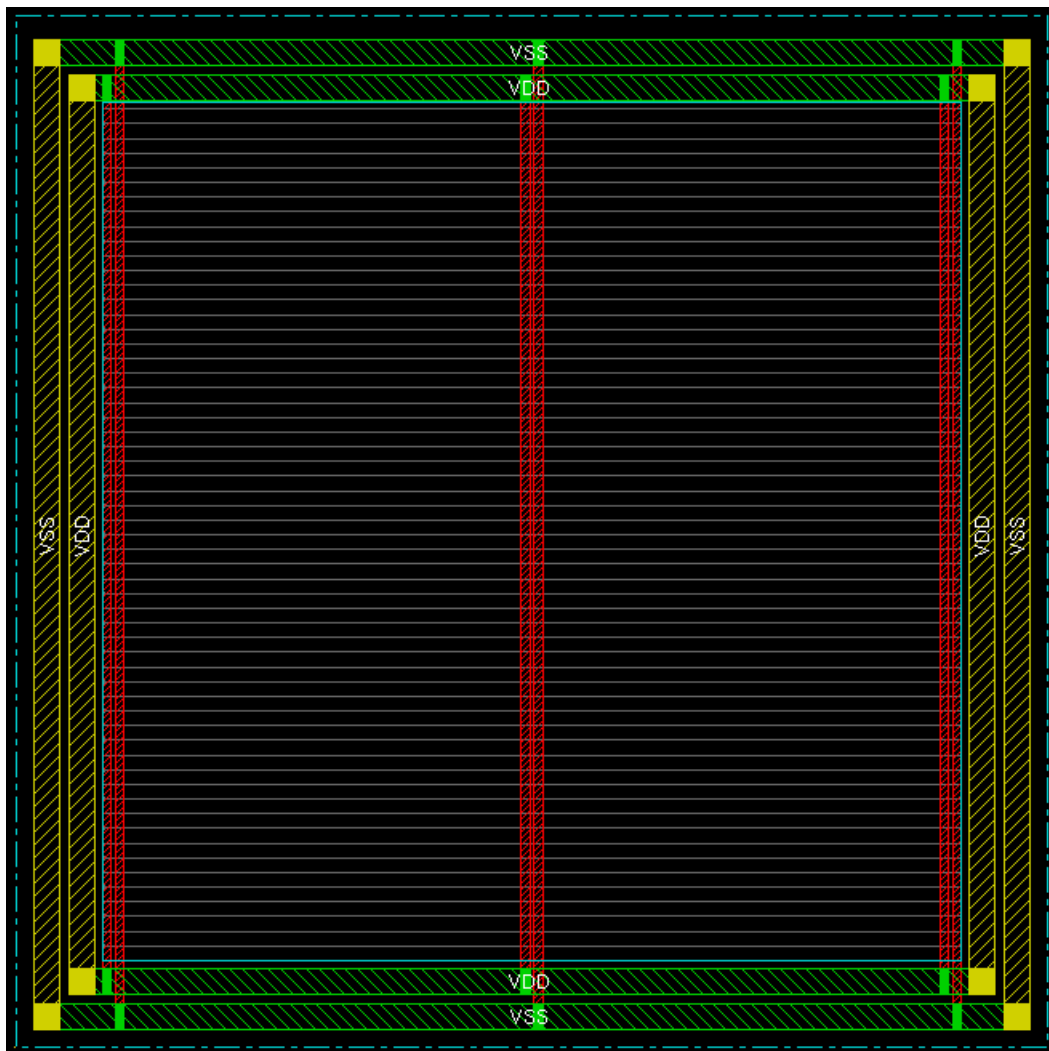
After that, power stripes should be set up. From power section, it can be done easily.

Here 3 sets of stripes are used for convenience and a ring is formed. All the power connections will go through this path. Then special routing is performed. And the blocks looks like the following:

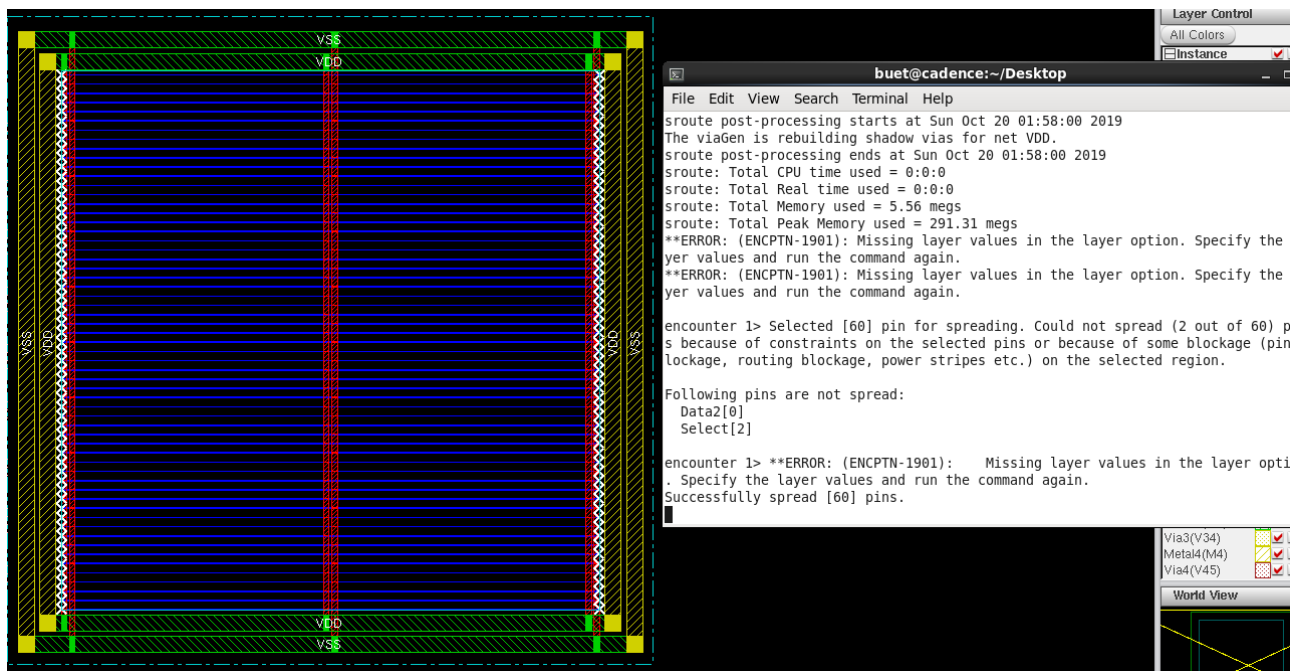
Fig: Pins are connected

After special routing, Pins should be connected. After connecting pins the blocks looked like below. Spacing was 1.4 micron and Metal 1 was used.

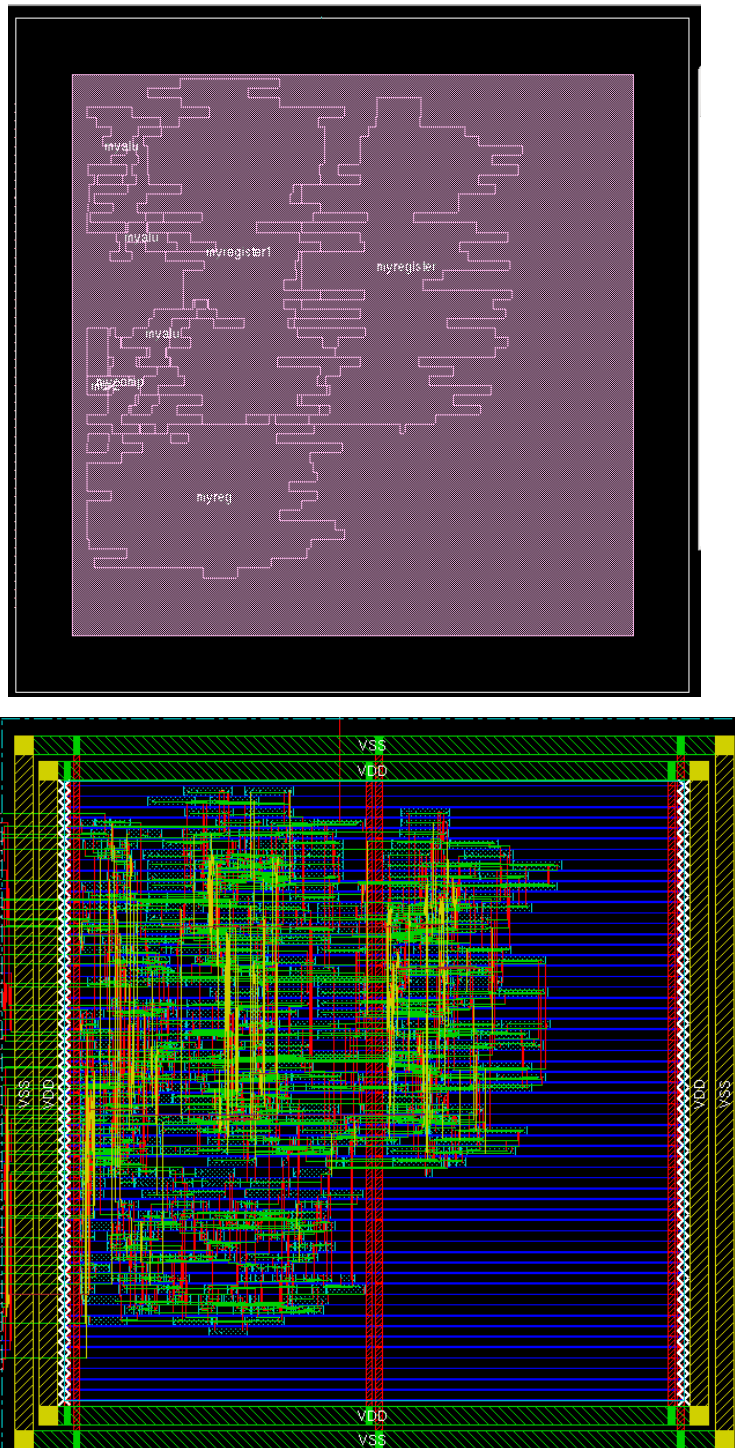
Fig: After placing cells

After Special routing, the cells are placed. The area of the whole block was kept large intentionally. There was no intention of making it efficient and least place required. Rather, the intention was to lessen the errors only.

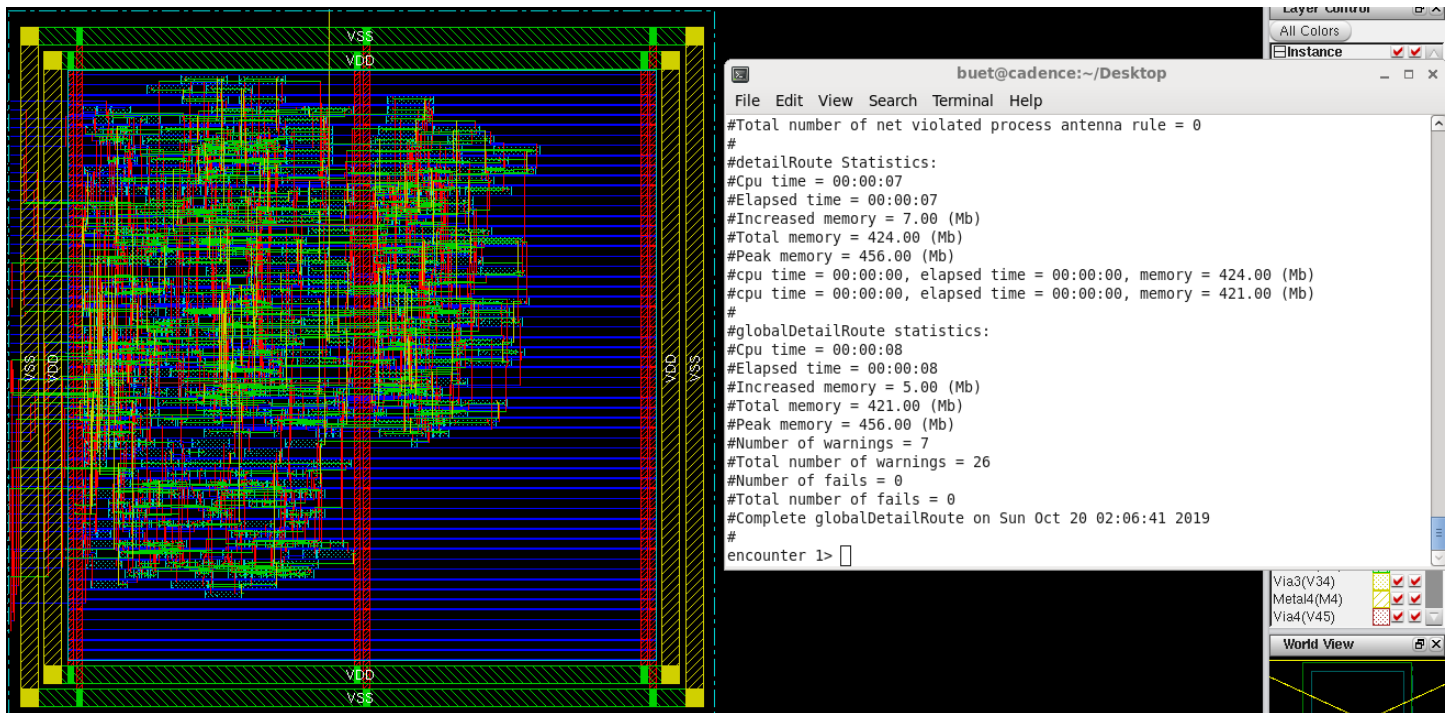
Fig: After Routing

After placement, here comes the routing part. It can be done using CIW or GUI. I have tried GUI mode. After routing, the block looked like this

We can see most of the places are blank. Here it needs to add some fillers. So It was done.

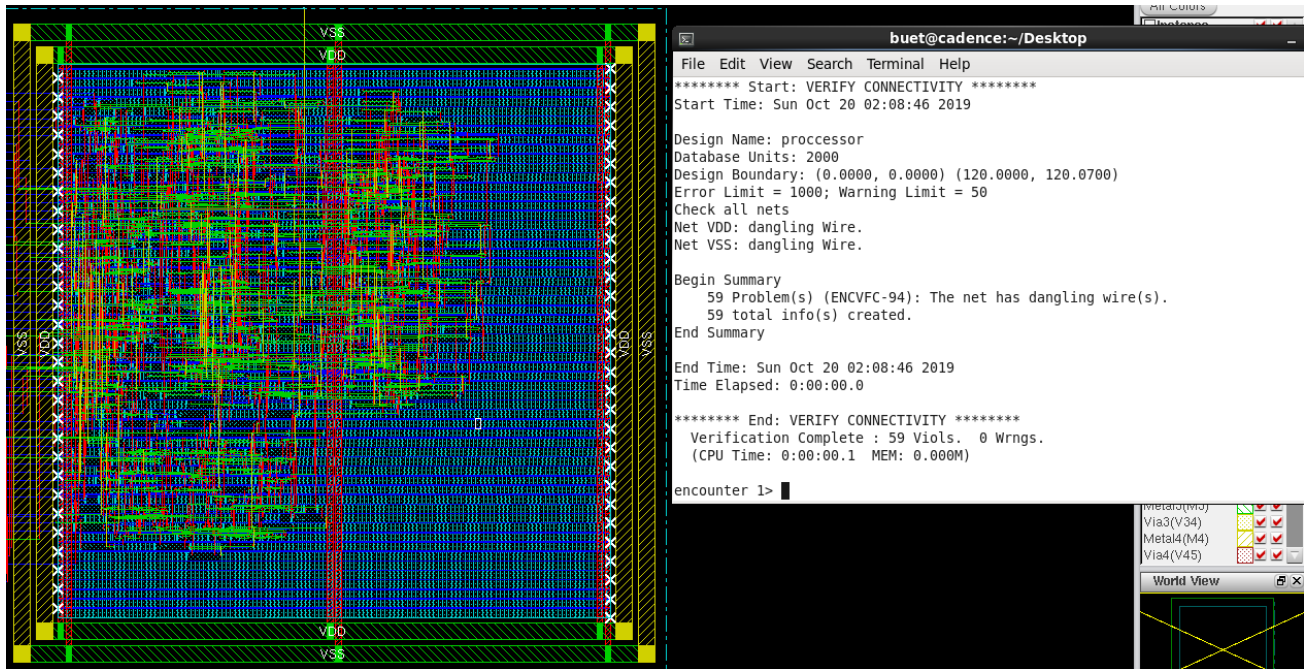
Fig : Connectivity check report

Primary placement and routing are done. Now it has to be checked. First the connectivity check

Here we can see 59 violations. We'll correct it later. Then I have performed geometry check

To solve connectivity violations, we'll have to make VDD and VSS global. After using commands it looks like the following

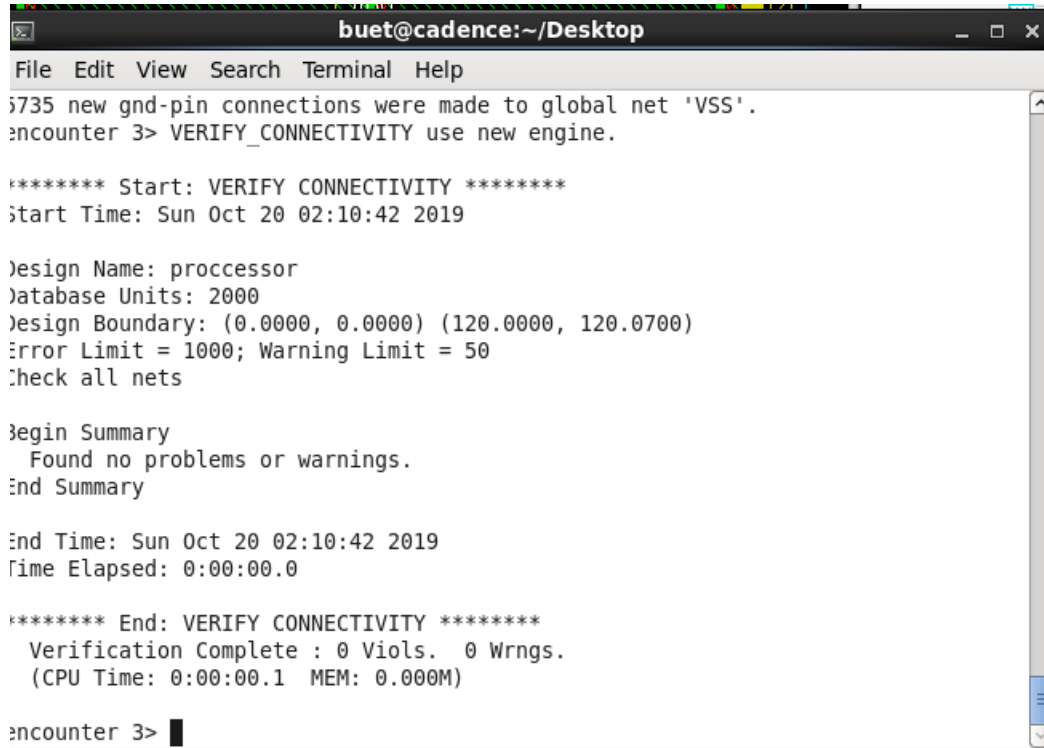
Fig: 0 connectivity violations

```
bu et@cadence:~/Desktop
File Edit View Search Terminal Help
5735 new gnd-pin connections were made to global net 'VSS'.
encounter 3> VERIFY_CONNECTIVITY use new engine.

Begin Summary
  Found no problems or warnings.
End Summary

***** End: VERIFY CONNECTIVITY *****
Verification Complete : 0 Viols.  0 Wrngs.
(CPU Time: 0:00:00.1 MEM: 0.000M)

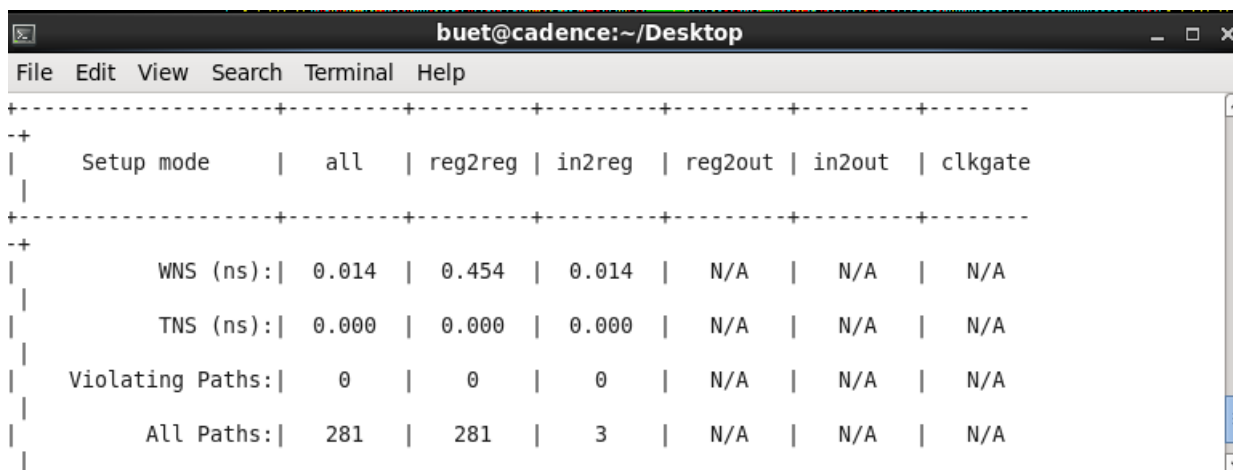
Fig: Setup violations

Then we have checked the timing violations, setup and hold. And also the DRVs. The reports are provided sequentially.

Setup mode	all	reg2reg	in2reg	reg2out	in2out	clkgate
WNS (ns):	0.014	0.454	0.014	N/A	N/A	N/A
TNS (ns):	0.000	0.000	0.000	N/A	N/A	N/A
Violating Paths:	0	0	0	N/A	N/A	N/A
All Paths:	281	281	3	N/A	N/A	N/A
