14.2.16 Troubleshooting moulded product faults

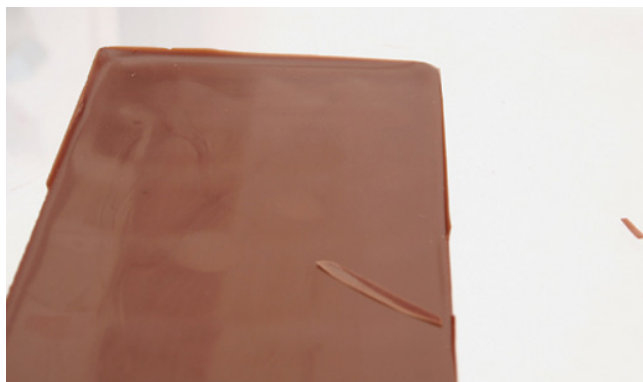
Figure 14.15 Picture of meniscus on a chocolate bar, showing a piece broken off.

Feathering is a thin rim of chocolate or meniscus around the edge of the bottom of a chocolate product (Figure 14.15). It can be caused by the mould being too deep, or by shaking a solid product too much. Some additional depth is necessary to avoid spillage, but there should be no more than 0.5 mm (0.02 in) in a small piece (less than 50 g (1.8 oz)) or 1 mm (0.04 in) in a bigger item. When a meniscus occurs and breaks off during demoulding or wrapping, chocolate
