Fault Code: 426

J1939 Network #1 - Data Erratic, Intermittent, or Incorrect

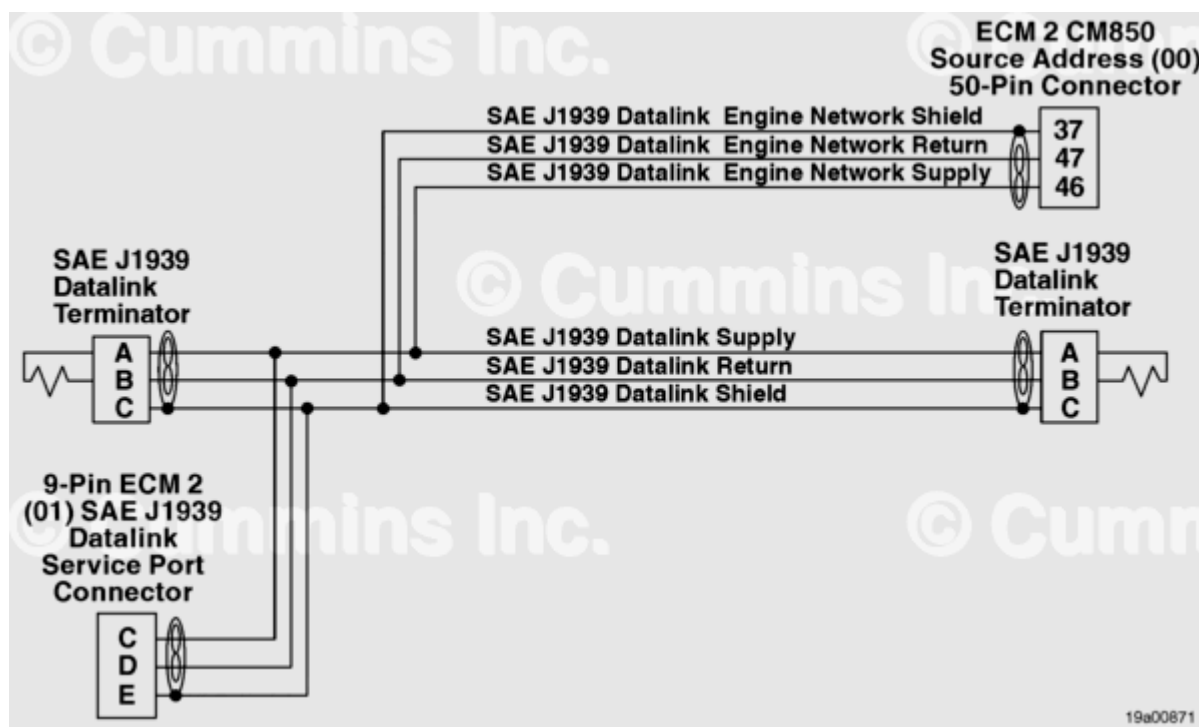
J1939 Datalink Circuit

The ECM identified another device on the J1939 datalink network has stopped communicating on the network. The devices on the J1939 datalink network include: ECMs', and the Generator Interface Module. The harness for the J1939 datalink network has a shielded twisted pair of wires that connect each of the network devices and termination resistor.

The Engine Control Module (ECM) detected an open or short circuit condition in the J1939 datalink wiring harness.

- Malfunctioning or damaged J1939 datalink wiring harness.
- Malfunctioning or damaged OEM wiring harness.
- Communication failure between J1939 devices

- To validate the repair, start the engine and let it run for 1 minute at no load.
- The generator set controller will turn off the fault code immediately after the user presses reset.
- The “Reset All Faults” command in the recommended Cummins® electronic service tool or equivalent can be used to clear active faults.
