Fault Code: 198

ICON™ Lamp

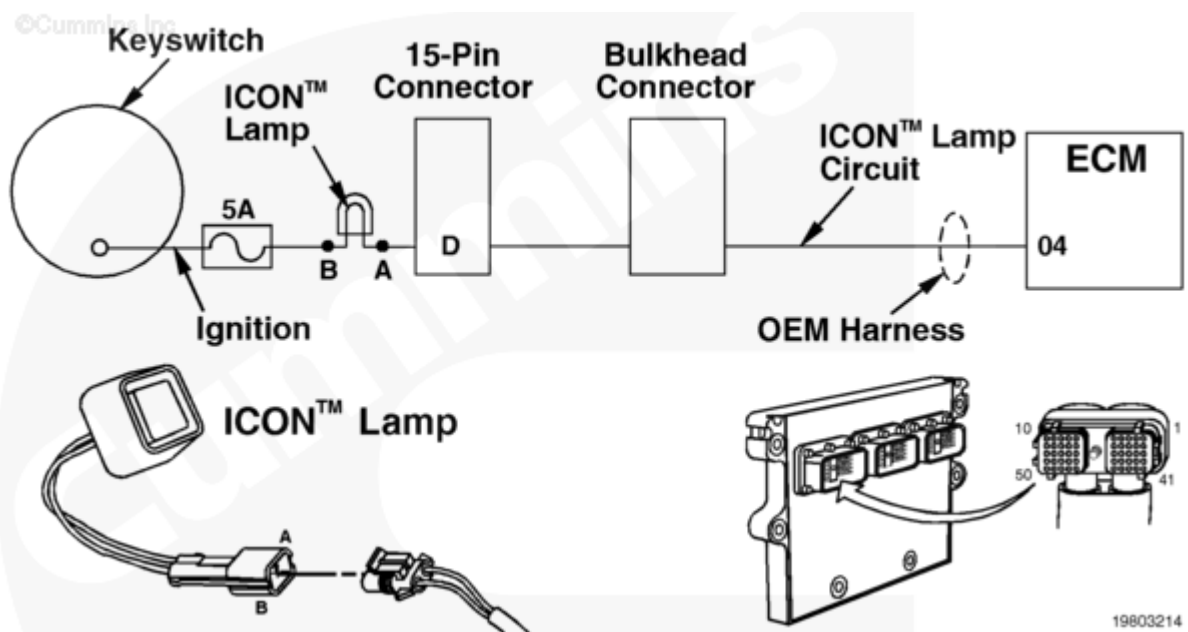
ICON™ Lamp Circuit

Codes	Reason	Effect
Fault Code: 198 PID(P): S122, 3 SPN: 612 FMI: 3 Lamp: Yellow SRT:	High voltage detected at the ICON™ lamp circuit when low voltage was expected by the ECM.	The ICON™ system will be disabled. Only mandatory shutdown will be enabled.

The ICON™ lamp circuit illuminates the ICON™ lamp to indicate when the ICON™ system is active. In addition, ICON™ fault codes will be flashed out on this lamp. The lamp circuit requires a specific flash timing (on/off timing). If the on/off voltage is incorrect, ICON™ will be disabled. The lamp circuit **must** be functional to enable ICON™.

This fault indicates a short circuit to battery voltage. The ICON™ lamp will **only** flash out the active fault codes.

Refer to Troubleshooting Fault Code t05-198 (</qs3/pubsys2/xml/en/procedures/82/82-t05-198.html>)
