# Post-earthquake structural damage assessment, lessons learned, and addressing objections following the 2023 Kahramanmaras, Turkey earthquakes

## Abstract

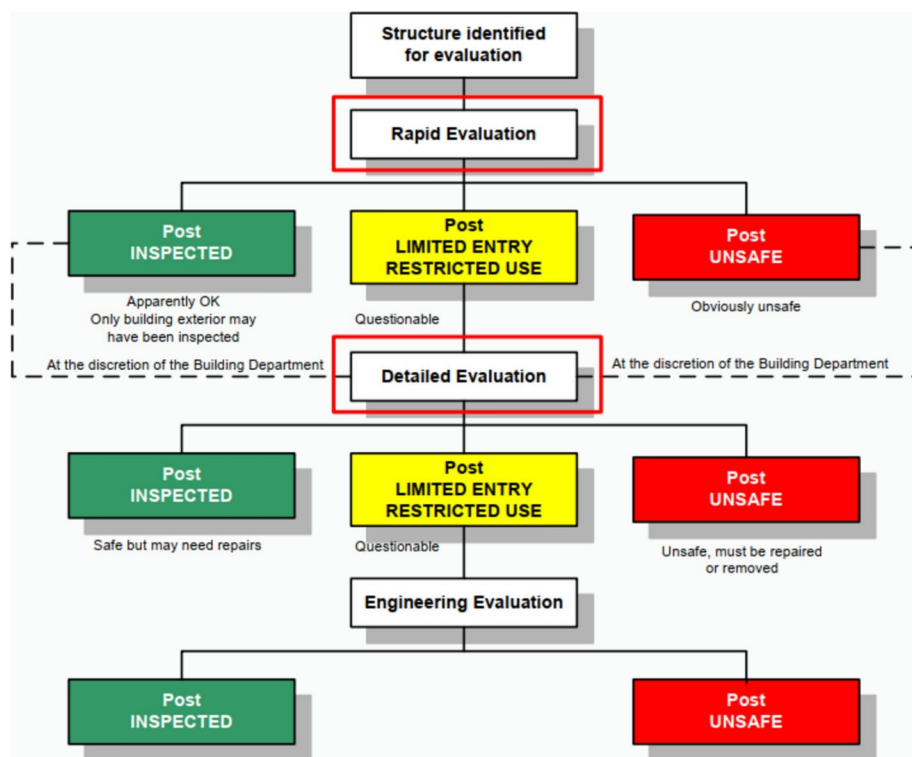
**Fig. 1** Evaluation process of ATC-20-1 Field Manual (ATC-20 2005)

The ATC-20 documents are specifically crafted for use by qualified professionals tasked with making immediate evaluations and decisions regarding the continued use and occupancy of damaged buildings. The Evaluation process of the ATC-20-1 Field Manual is illustrated in Fig. 1. The current methodology outlines procedures for swift and detailed assessments, resulting in categorizations as INSPECTED (green placard), RESTRICTED USE (yellow placard), or UNSAFE (red placard). Special provisions are included for evaluating essential buildings, non-structural elements, geotechnical hazards, and limited guidance on post-earthquake human behavior. The document has three evaluation methods: rapid, detailed, and engineering evaluation. The rapid evaluations, typically lasting 10–30 min per building, offer an initial general assessment of damage and safety, primarily from the exterior, involving personnel like building inspectors, civil and structural engineers, architects, and disaster workers. The rapid evaluation criteria of ATC-20-1 are given in Table 1. On the other hand, detailed evaluations, taking one to four hours per building, provide a more thorough visual examination, often following an initial Rapid Evaluation,

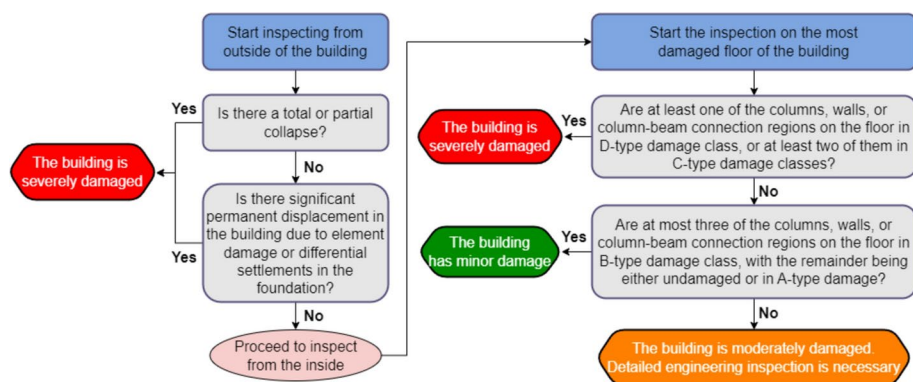
**Fig. 2** Flowchart for post-earthquake structural damage assessment procedure developed by the MoEUCC (Adapted from HTED 2023)

The flowchart for the assessment procedure details is presented in Fig. 2. The assessment procedure devised by the MoEUCC entails two key stages. Firstly, an “External Inspection”

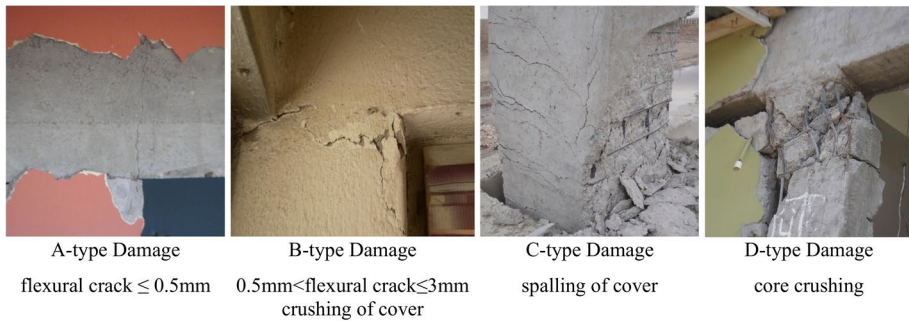
**Fig. 3** Structural component damage types (HTED 2023)

The determination of structural component damage is conducted based on the classification provided in Table 2 below. It mainly depends on crack width and compression damage on the members. As it progresses from "O-type damage" to "D-type damage" within the damage type classification, the level of damage within the structural component increases. An example of structural component damage types is illustrated in Fig. 3. As a result of these inspections, structures are categorized into five different damage levels based on the classification provided in Table 3. The classification of buildings' damage level during this phase adheres to the following criteria:

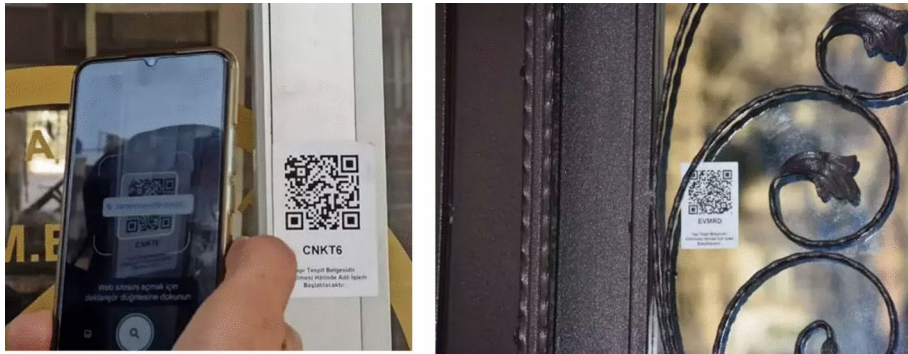
**Fig. 4** QR code examples attached to structures after their post-earthquake damage assessment (Cnnturk 2023)

After the evaluation is completed, a QR code containing information about the condition of the buildings is attached to the entrance of the structures. This QR code can be scanned with a mobile phone to access the building’s damage status information. Some examples of QR codes attached to buildings after post-earthquake damage assessment are depicted in Fig. 4.

After damage assessment, some difficulties have been experienced in understanding the barcodes attached to the entrances of structures, as shown in Fig. 4, to learn the damage status of the building. These barcodes did not provide visual information directly about the damage status of the structure but required the barcode to be scanned, access to an intelligent mobile phone, an internet connection, and the presence or installation of a barcode reader application on the respective telephone to access the information it contains. Some people do not have smartphones, while others may not have had the opportunity to retrieve their phones after urgently evacuating the building following the earthquakes. Moreover, some individuals may lack experience using smartphones and installing and using such a barcode application. Moreover, after earthquakes, telecommunication infrastructure in many regions has suffered significant damage, causing disruptions in internet access for an extended period. At the same time, the electrical infrastructure has also been damaged, resulting in difficulties in charging phones. On the other hand, due to the small size of the attached barcodes, it is necessary to approach them closely for scanning. Primarily due to significant and frequent aftershocks in the region, approaching damaged buildings poses a considerable risk. For these reasons, it has been observed that the applied barcode system has created significant challenges and risks in informing people about the damage situation of structures. To prevent this situation, as suggested in ATC-20 (2005), more easily

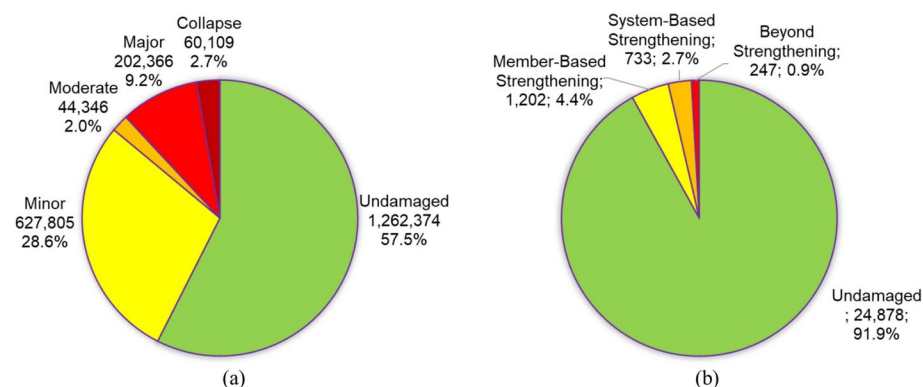
**Fig. 5** Damage distribution of existing structures (a) and existing incomplete structures (b) after post-earthquake damage assessment as of June 12, 2023, reflecting the level of required intervention for each structure

The Kahramanmaraş earthquakes have also adversely affected the structures under construction in the region. Due to the high peak ground accelerations measured by seismic stations (TADAS 2023; Demir et al. 2024) and the significant damage and destruction caused by the earthquakes in existing structures (Fig. 5a), there is a need to assess the post-earthquake damage status of these buildings and evaluate whether construction should continue. For this purpose, collaboration has been established between the Ministry of Environment, Urbanization, and Climate Change and the Council of Higher Education. Post-earthquake damage assessments of the structures under construction were carried out by faculty members at universities nationwide. The assessments categorized the buildings under construction into four different categories: Undamaged, in need of Element-Based Strengthening, in need of System-Based Strengthening, and Beyond Strengthening due to severe damage. As of June 12, 2023, a total of 27,060 structures under construction in the region have been examined, and the findings are presented in Fig. 5b. According to the assessments, 247 buildings (0.9%) were determined as beyond repair due to severe damage, 733 buildings (2.7%) required system-based strengthening, 1202 buildings (4.4%) needed element-based strengthening, and the remaining structures (91.9%) were found to be undamaged and could continue construction (Gurbuz and Aslan 2023).

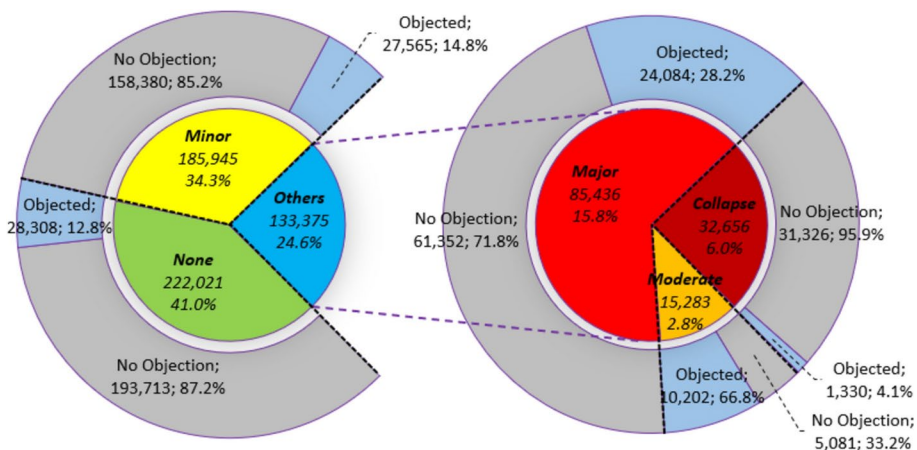
**Fig. 6** Damage assessment results and the objections made to initial damage assessment results of eleven provinces

As can be seen from Fig. 6, out of the total assessed 541,341 structures, 15,283 (2.8%) were determined to have moderate damage, 85,436 (15.8%) were identified as heavily damaged, and 32,656 (6.0%) were found to be collapsed. The remaining 407,966 structures were either undamaged (41.0%) or had suffered minor damage (34.3%), as depicted in Fig. 6. Objections were raised for 28,308 cases (12.8%) among structures identified as undamaged, and for structures with minor damage, objections were made in 27,565 cases (14.8%). Additionally, objections were lodged for the damage assessment of 10,202 structures (66.8%) with moderate damage, 24,084 structures (28.2%) with severe damage, and 1,330 collapsed structures (4.1%). In summary, objections have been raised for 91,489 buildings (16.9%) out of a total of 541,341 structures where post-earthquake damage assessment has been conducted. As Fig. 6 illustrates, objections are predominantly raised for structures with moderate damage and then severe damage, with collapsed buildings receiving the least ratio of objections.

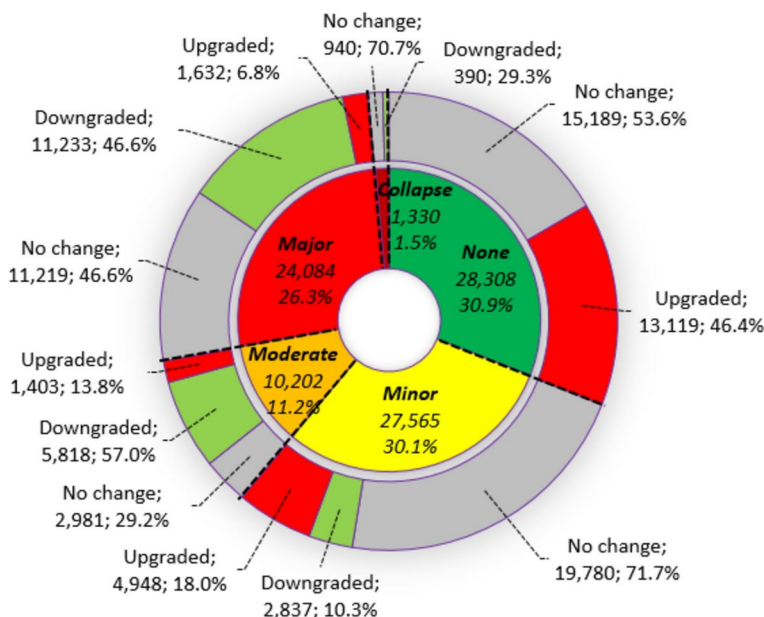
Fig. 7 The results of objections to the damage assessment findings

The results of objections are detailed in Table 6 in the Appendix and Fig. 7. Examining the data reveals that 53.6% of objections to structures identified as undamaged resulted in no change in the damage assessment, while objections to the remaining structures (46.4%) led to an increase in the damage level to a more severe category. Regarding structures with minor damage, 71.7% of objections resulted in no change in the initial damage assessment, 10.3% were downgraded to a lower damage level, and in the remaining cases (18.0%), the damage level was increased to a more severe category. Moreover, in structures with moderate damage, 29.2% remained unchanged, 57.0% downgraded, and 13.8% upgraded in damage level. Among severely damaged structures, 46.6% remained unchanged, 46.6% had a downgrade, and 6.8% had an upgrade in damage level. Finally, 70.7% of structures in collapsed buildings had an unchanged damage level, while 29.3% had a downgraded damage level.

In summary, the reassessment of building damage reveals significant changes in structures with moderate and major damage, where the results are often downgraded to a less severe damage level. Minimal changes are observed in objections to structures with minor damage and collapsed buildings. However, for structures initially identified as undamaged, approximately half have undergone an upgrade to a more severe damage level (see Fig. 7).
