Fault Code: 199

ICON™ Lamp

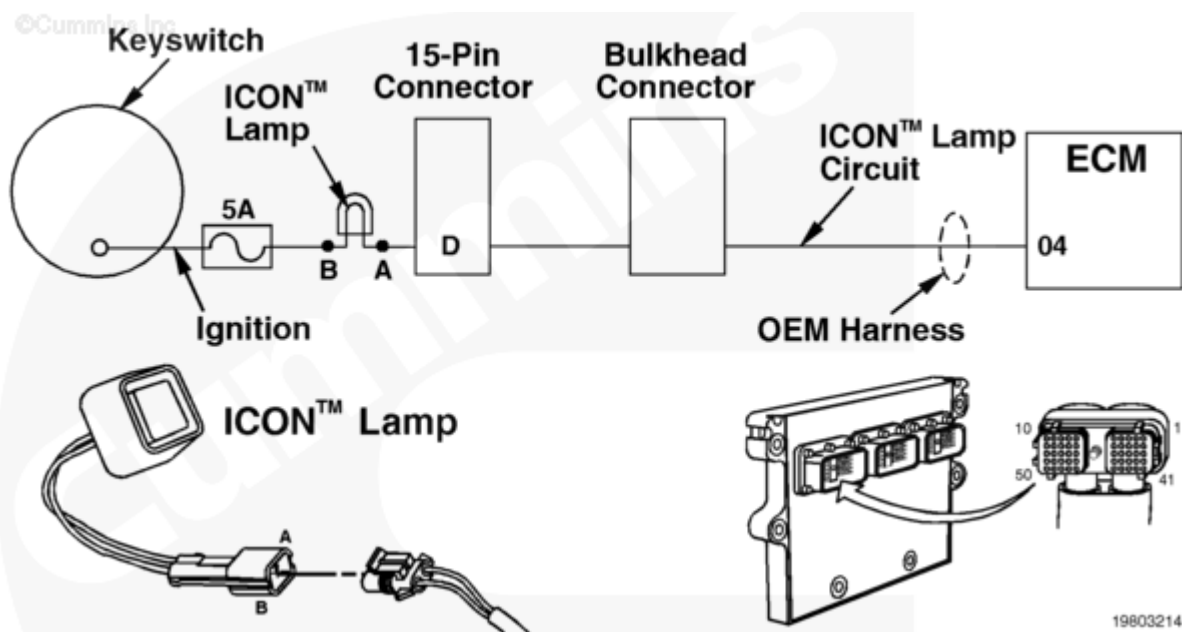
ICON™ Lamp Circuit

Codes	Reason	Effect
Fault Code: 199 PID(P): S122, 4 SPN: 612 FMI: 4 Lamp: Yellow SRT:	Less than 6 VDC (low voltage) detected at the ICON™ lamp circuit when high voltage was expected by the ECM.	The ICON™ system will be disabled. Only mandatory shutdown will be enabled.

The ICON™ lamp circuit illuminates the ICON™ lamp to indicate when the ICON™ system is active. In addition, ICON™ active fault codes will be flashed out on this lamp. The lamp circuit requires a specific flash timing (on/off timing). If the on/off voltage is incorrect, ICON™ will be disabled. The lamp circuit **must** be functional to enable ICON™.

This fault indicates a short circuit to ground or an open circuit.

Refer to Troubleshooting Fault Code t05-199 (</qs3/pubsys2/xml/en/procedures/82/82-t05-199.html>)
