SALISH NAUTICAL SERVICES, INC.

MARINE SURVEY REPORT FOR M/V WY KNOT

On 14 June 2016 at the request of Kylie Keller, our firm performed a pre-purchase survey of a 1970 Tollycraft. The vessel was inspected afloat and hauled for below waterline inspection. A sea trial was performed to check mechanical and navigation equipment. The vessel was located at La Conner Marina.

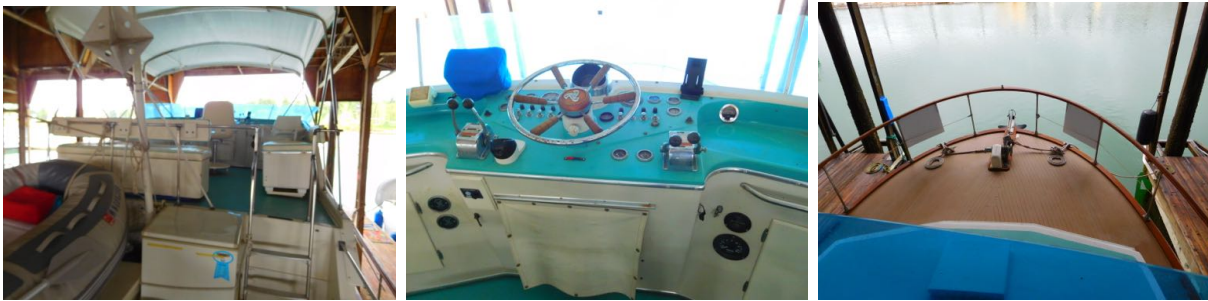
Exterior description of hull and superstructure

The Tollycraft Tri-cabin 40 is a strong build cruising yacht. Built with a Plicor hull, which was only produced in 1970. It has an aft cabin with queen bed and private head and full shower. The salon in up with a galley and starboard side helm forward. There are doors on either side on cabin. Forward and down is the guest suite and head. On deck there is an aft deck with transom door to swimstep. The side decks are wide and lead forward to the bow deck where there is a windlass and anchor at the bow. From the aft deck a ladder goes up to the upper deck, which is large and has storage boxes and the dinghy is stowed on deck. There is a davit with an electric motor for launching dinghy. Steps allow access to the flybridge, which has a center helm and seating for four. There is a bimini top on the flybridge. Railings surround the side, upper deck and bow decks.

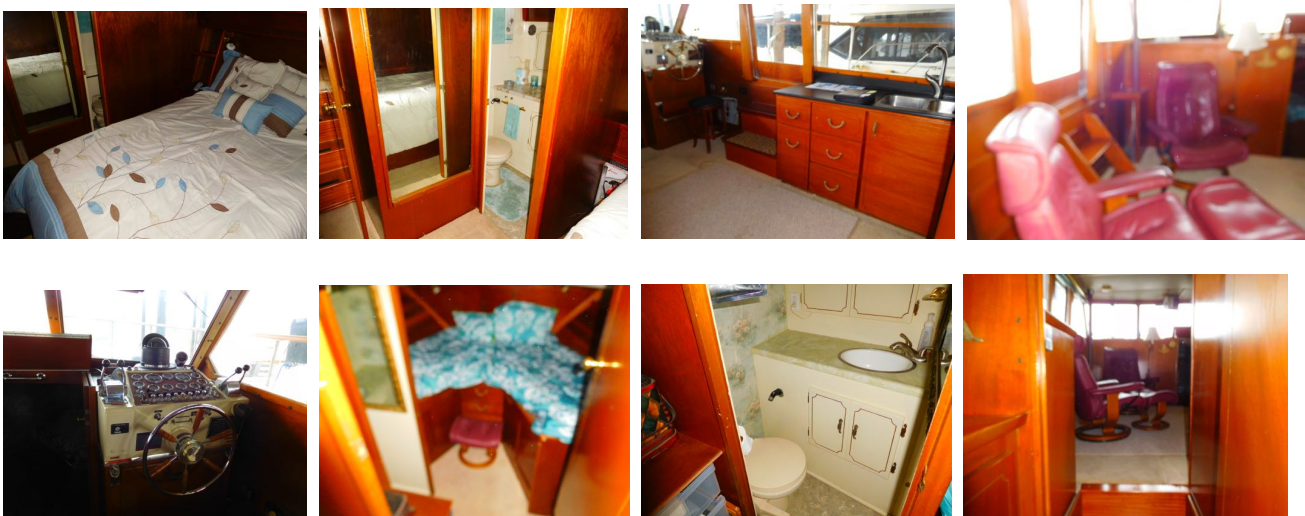
Interior description

The interior is laid out with the master stateroom aft. There are lots of storage cabinets and drawers in the aft stateroom. There is a queen sized walk-around bed. The master stateroom has a private bath with full shower, forward to starboard. The main salon has a full galley aft to starboard. There are two chairs in the salon. The lower helm is forward to starboard. A navigation table is to port. The salon and aft stateroom have large side windows and there are sliding doors on both sides of the salon for accessing side decks. Forward and down is the guest stateroom in the bow. There is a head with hand wand for showering to port. A hanging locker is to starboard. The interior is finished in mahogany.

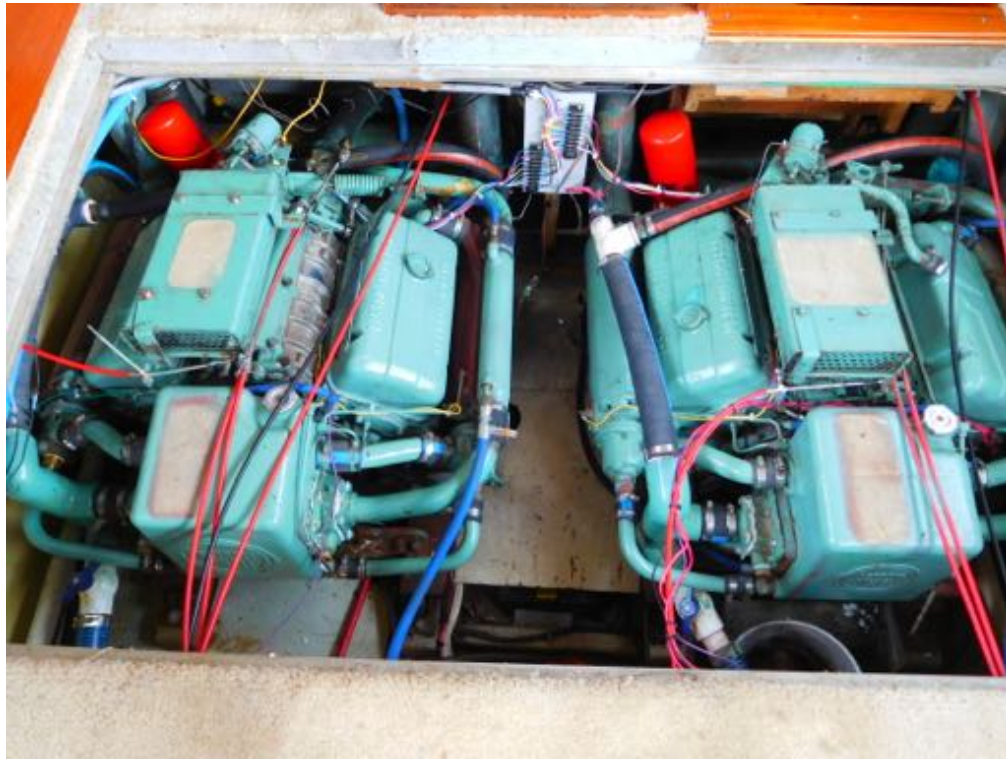
Propulsion machinery

-ENGINE(S): Twin, Detroit 6V-53 diesel engines have been installed in the vessel. The engines were inspected visually and operated. Visually the engines are in clean condition, no major oil or coolant leaks sighted. Components on the exterior of engines are in good condition. Both engines operated within normal parameters during sea-trial. At WOT the port engine reached 2000 RPM and the starboard engine reached 2200 RPM, rated RPM at WOT is 2800. The mounts and stringers for each engine were inspected and found in good condition. Some rust sighted on starboard engine forward mount. The oil and coolant levels were found full and clean. Engines have 4250 hour reported operating time. The meter for the starboard engine showed 3455.4 hrs and the meter for port engine showed 802.7 hrs. Accuracy of meters is unknown.
