# Quality diagnosis of silicon solar cell using LED spotlight irradiation method

Kensho Okamoto\*, Nobuhiro Esaki, and Keishiro Goshima

**Keywords** LED, solar cell, electroluminescence, quality control

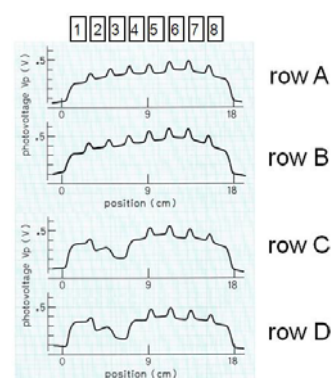
**Figure 5** Change of cell photovoltage with the scan of LED spotlight. Upper: Sample-1, Lower: Sample-2. Feature of LED: 5 mm in diameter. Wavelength: 644 nm, light power: 2 mW (input current 30 mA). Diameter of spotlight: 1.5 cm (measured on the surface of Si cell).

Two Si solar cell samples; named Sample-1 and Sample-2 were diagnosed by the LED spotlight scan method. The results are shown in Fig. 5. It is seen that there are anomalous points in the rows C and D, *i.e.* site address C-2, C-3, D-2 and D-3 in Sample-1. On the other hand, such an anomalous point is not seen in the case of Sample-2. The extraordinary points in Sample-1 are considered to be caused by some internal electrical defects in the Si solar cell. By the way, the small peaks on the  $V_p$  curves in Fig. 5 are occurred when the LED spotlight is laid across the two neighbouring silicon plates as shown in Fig. 6. However, the reason for this is not known at present.

in the electroluminescence image (Fig. 8) at C-2 of Sample-2. Such an anomalous point is considered to be an electrically defective portion. On the contrary, the extraordinary portions of the photo-voltage of sample-1 (see Fig. 5) of photo-voltage seen in the rows C and D of Sample-1 do not agree with the anomalous points which are seen in the infrared pictures Fig. 7 and Fig. 8.
