Ambient Air Pressure Sensor

Codes	Reason	Effect
Fault Code: 295 PID(P): P108 SPN: 108 FMI: 2 Lamp: Yellow SRT:	An error in the ambient air pressure sensor signal was detected by the ECM.	Engine is derated to no air setting.

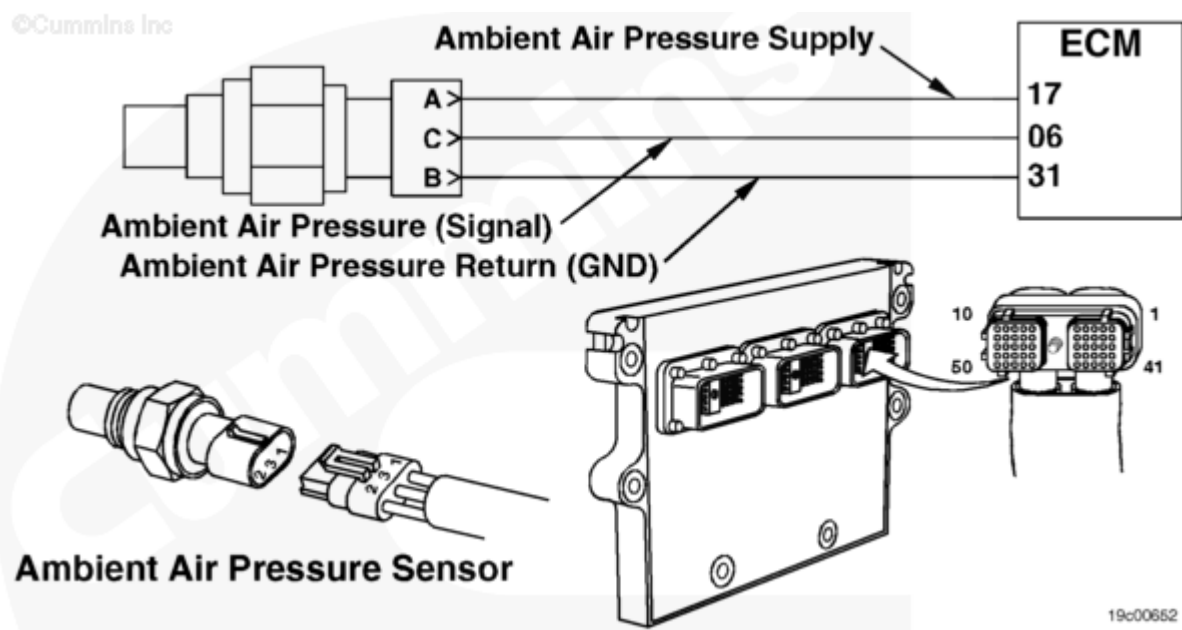
The ambient air pressure sensor is located below the ECM.

At key-on, the readings for ambient pressure from the ambient air pressure sensor, intake manifold pressure sensor, and oil pressure sensor are compared. This fault code occurs if the ambient air pressure sensor reading is different from the other two.

Refer to Troubleshooting Fault Code t05-295 (</qs3/pubsys2/xml/en/procedures/82/82-t05-295.html>)
