Fault Code: 465

Wastegate Actuator Number 1 Circuit

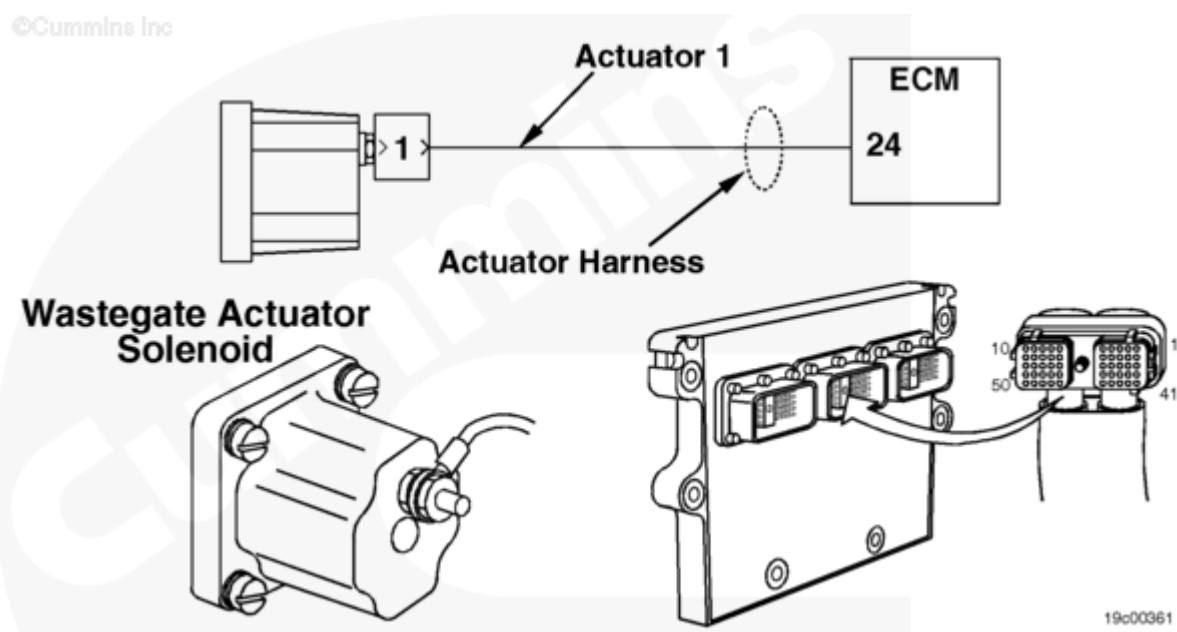
Wastegate Actuator number 1 Circuit

The wastegate actuators are devices used by the ECM to control boost pressure.

The wastegate controller is located on the air inlet horn. Actuator number 1 is the rear-most solenoid on the controller.
