Research on Defect Pattern Recognition of GIS Equipment Based on X-ray Digital Imaging Technology

Abstract: In this paper, the experimental platform composed of Computed Radiography (CR) imaging system and Gas insulated switchgear (GIS) model is established to carry out the gas dissociation and withstand voltage test of SF₆ gas under different tube voltage levels. Taking the loosening of metal screws in the grading shield as an example, the GIS defect type is irradiated by X-ray. Then a typical defect library with three levels of defect: general, severe and critical is established. Meanwhile the corresponding identification criteria belongs to image defect is offered. The experimental results show that the composition and withstand voltage of SF₆ gas in GIS equipment are unaffected by the X-ray irradiation. In addition, X-ray digital imaging technology can effectively diagnose the internal defects and realize visual detection of GIS.

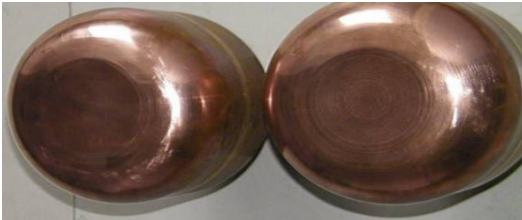
In order to obtain the stable value of the test, the design of the test equipment is shown in Fig. 3, and the contact of the plate electrode is shown in Fig. 4. The pressure of SF₆ gas in tooling is 0.4mpa.

Figure 4. Plate electrode photograph
