# **Intel® 82599 10 GbE Controller**

**Specification Update**

Revision 3.9  
331521-008

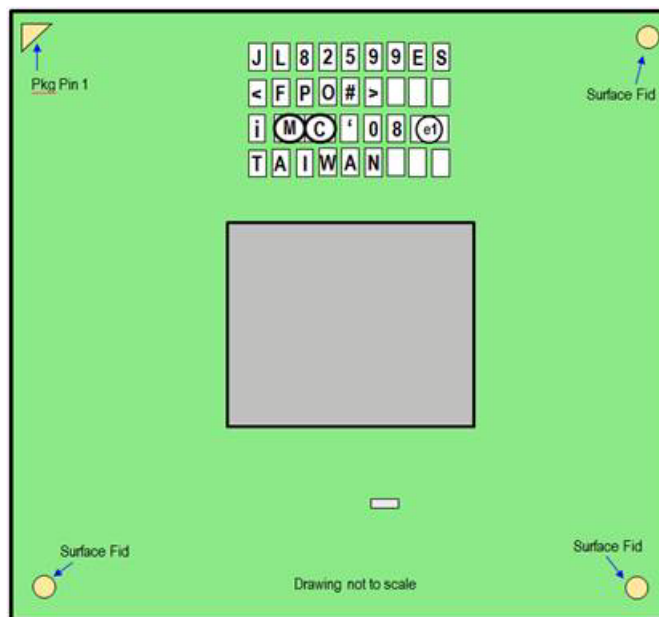
Figure 1-1. Example with Identifying Marks

Lead-free parts will have "JL" as the prefix for the product code.

The "S" designator refers to the specification number. See [Table 1-1](#).

3.1	March 27, 2014	<b>Miscellaneous Updates:</b> <ul style="list-style-type: none"><li>Marking Diagram in Figure 1-1 updated to reflect new substrate.</li></ul>
