Fault Code: 491

Wastegate Actuator Number 2 Circuit

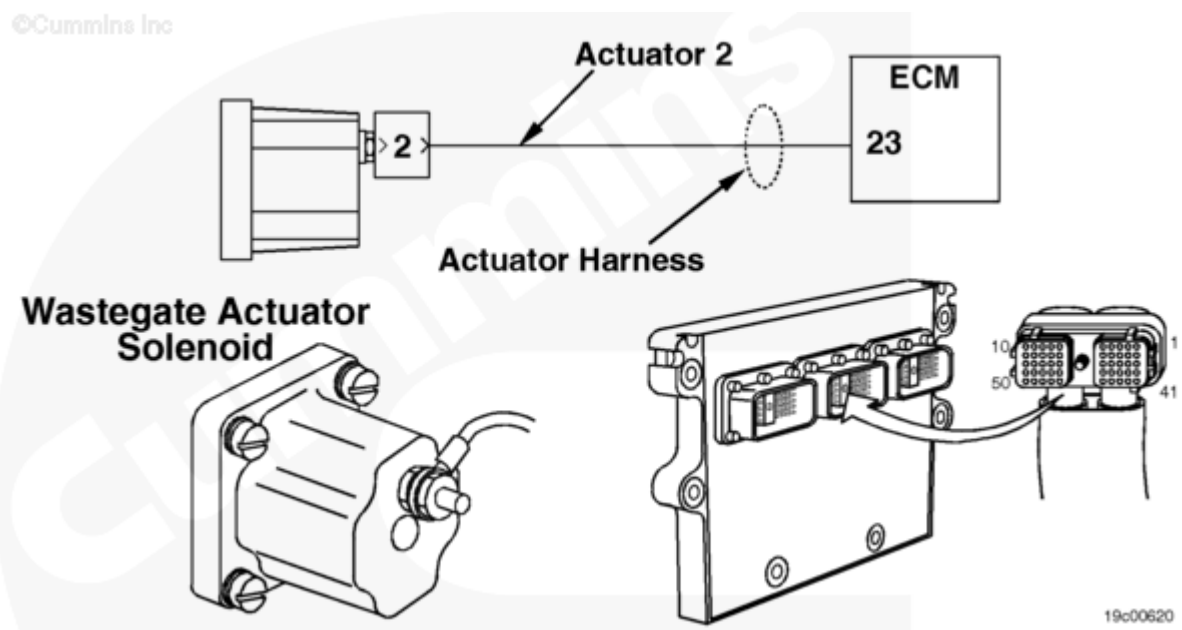
Wastegate Actuator Number 2 Circuit

Codes	Reason	Effect
Fault Code: 491 PID(P): S088 SPN: 1189 FMI: 3/3 Lamp: Yellow SRT:	High voltage detected at the wastegate actuator number 2 circuit when no voltage was being supplied by the engine control module (ECM).	Engine will run derated.

The wastegate controller is located on the air inlet horn. Actuator number 2 is the front-most solenoid on the controller.

- A short circuit to voltage source in the harness
- An open circuit in the harness, connector, or wastegate control valve
- Improperly mounted wastegate actuator solenoid.

Refer to Troubleshooting Fault Code t05-491 (</qs3/pubsys2/xml/en/procedures/82/82-t05-491.html>)
